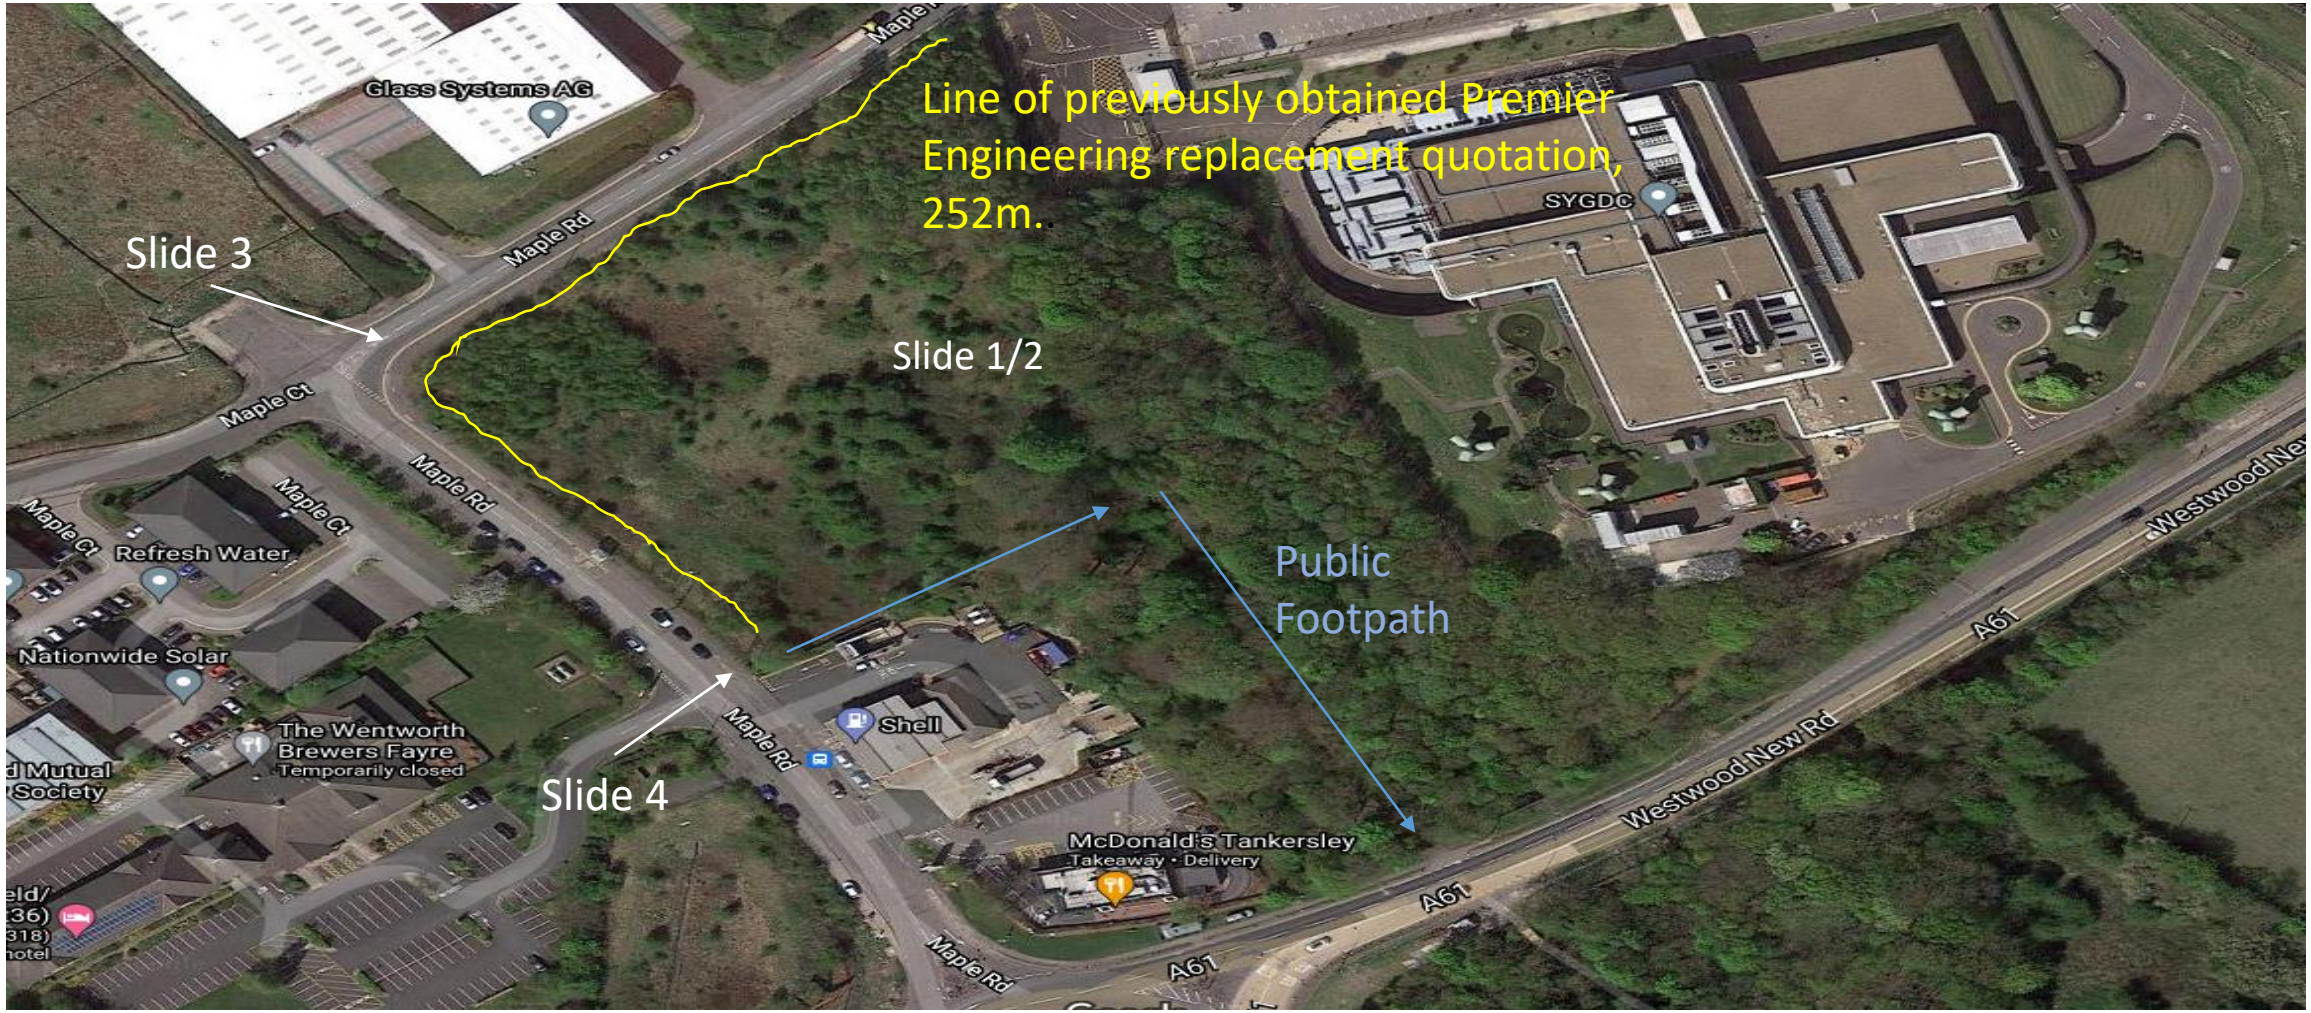
Looking West along Maple Road. Existing demarcation fence is 1000mm H, with 75mm X 75mm wooden posts, set (originally) at approximately 3000mm spacing.

General structure debilitation approximately 50m along. Original fence meshing is 150mm X 90mm galvanised wire, (encouraging foothold climb-over), with top-running tension wire (snipped for access in many places).

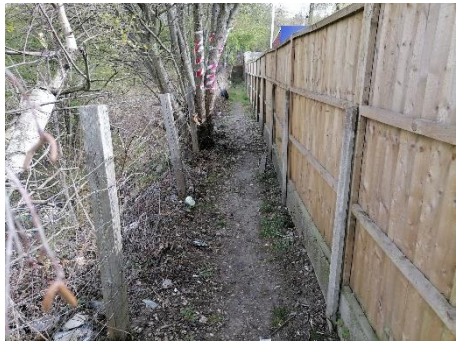
NW Corner fence has had many repairs, tension wires been ‘snipped’ and re-fastened in a multitude of places. West side bus shelter is common gathering, climbing and litter throwing area, (nearby Mc Donald’s).
