Coal Mining Risk Assessment

The Seam, Barnsley

Document Ref: 10052406-ARL-XX-XX-RP-GE-0002-01

JUNE 2022

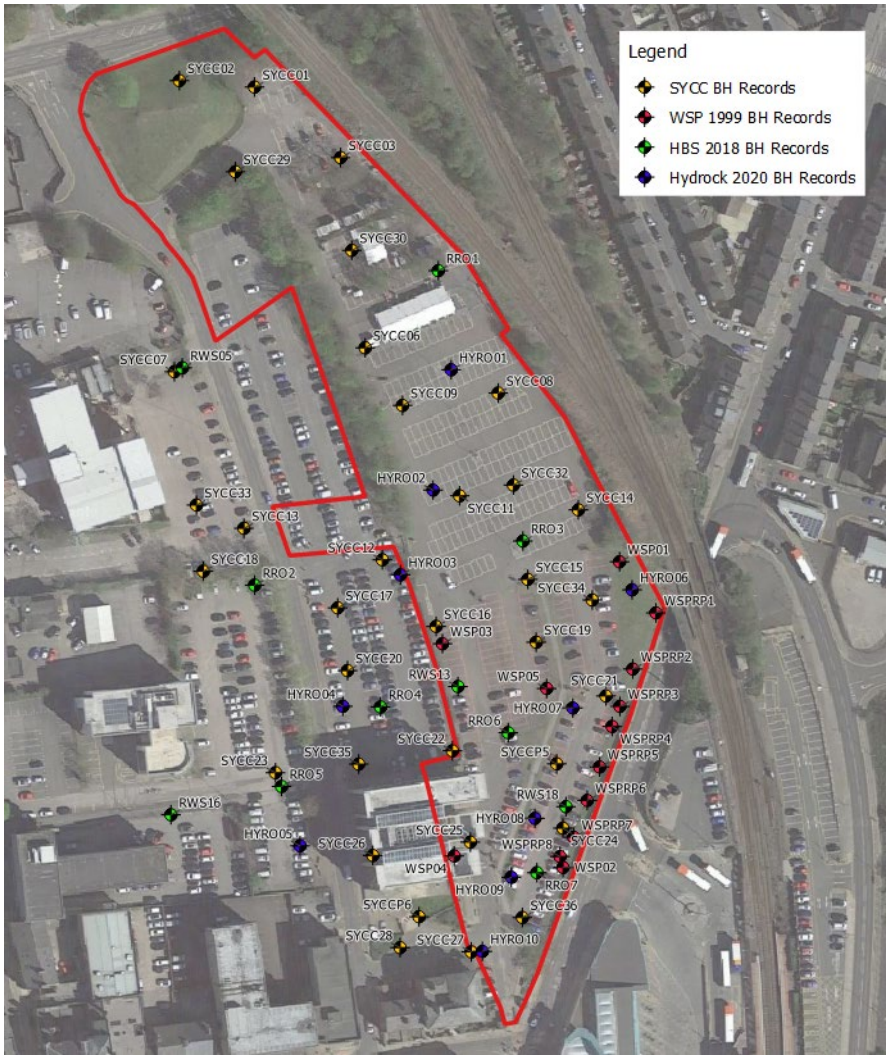
Figure 5 - Previous Ground Investigation Exploratory Hole Locations

WSP 1999	WSPRP5	Coal	4.5 (92.6)	5.0 (92.1)	0.5	Low Beamshaw
WSP 1999	WSPRP6	Coal	4.2 (93.0)	5.0 (92.2)	0.8	Low Beamshaw
WSP 1999	WSPRP7	Coal	3.2 (94.0)	3.7 (93.5)	0.5	Low Beamshaw
WSP 1999	WSPRP8	Coal	4.3 (92.7)	5.0 (92.3)	0.7	Low Beamshaw
HBS 2018	RR01	Void	13.5 (81.8)	14.0 (81.3)	0.5	Possible fracture / bedding joint

Coal	17.3 (78.0)	17.5 (77.8)	0.2	Kent's Thin
		Void	21.5 (73.8)	21.7 (73.6)	0.2	Possible fracture / bedding joint
HBS 2018	RR02 (offsite)	Void	13.3 (87.9)	13.5 (87.7)	0.2	Possible fracture / bedding joint
		Void	22.3 (78.9)	22.4 (78.8)	0.1	Possible fracture / bedding joint
HBS 2018	RR03	Void	13.0 (83.6)	13.3 (83.3)	0.3	Possible fracture / bedding joint
HBS 2018	RR06	Void	12.6 (84.5)	12.9 (84.2)	0.3	Possible fracture / bedding joint
HBS 2018	RR07	Coal	4.0 (93.3)	4.4 (92.9)	0.4	Low Beamshaw
Hydrock 2020	HYRO01	Coal	18.0 (77.95)	19.0 (76.95)	1.0	Kent's Thin
Hydrock 2020	HYRO02	Coal	1.5 (94.78)	2.0 (94.28)	0.5	Low Beamshaw
		Coal	17.8 (78.48)	18.8 (77.48)	1.0	Kent's Thin
Hydrock 2020	HYRO03 (offsite)	Coal	19.0 (82.37)	20.0 (81.37)	1.0	Kent's Thin
Hydrock 2020	HYRO06	Coal	0.7 (96.16)	1.2 (95.66)	0.5	Low Beamshaw
		Loss of flush	12.2 (84.66)	13.2 (83.66)	1.0	Soft / broken or fractured ground
		Loss of flush	13.2 (83.66)	16.0 (80.86)	2.8	Broken ground

Coal	17.0 (79.86)	18.0 (78.86)	1.0	Kent's Thin
Hydrock 2020	HYRO07	Coal	2.5 (94.68)	3.8 (93.38)	1.3	Low Beamshaw
		Loss of flush	19.5 (77.68)	20.5 (76.68)	1.0	Soft / broken or fractured ground
		Loss of flush	20.5 (76.68)	30.0 (67.18)	9.5	Solid ground noted on log – fractured ground
Hydrock 2020	HYRO08	Coal	2.5 (94.71)	3.2 (94.01)	0.7	Low Beamshaw
		Soft/broken ground	19.2 (78.01)	20.2 (77.01)	1.0	Soft / broken or fractured ground
		Coal	23.0 (74.21)	23.5 (73.71)	0.5	Kent's Thin

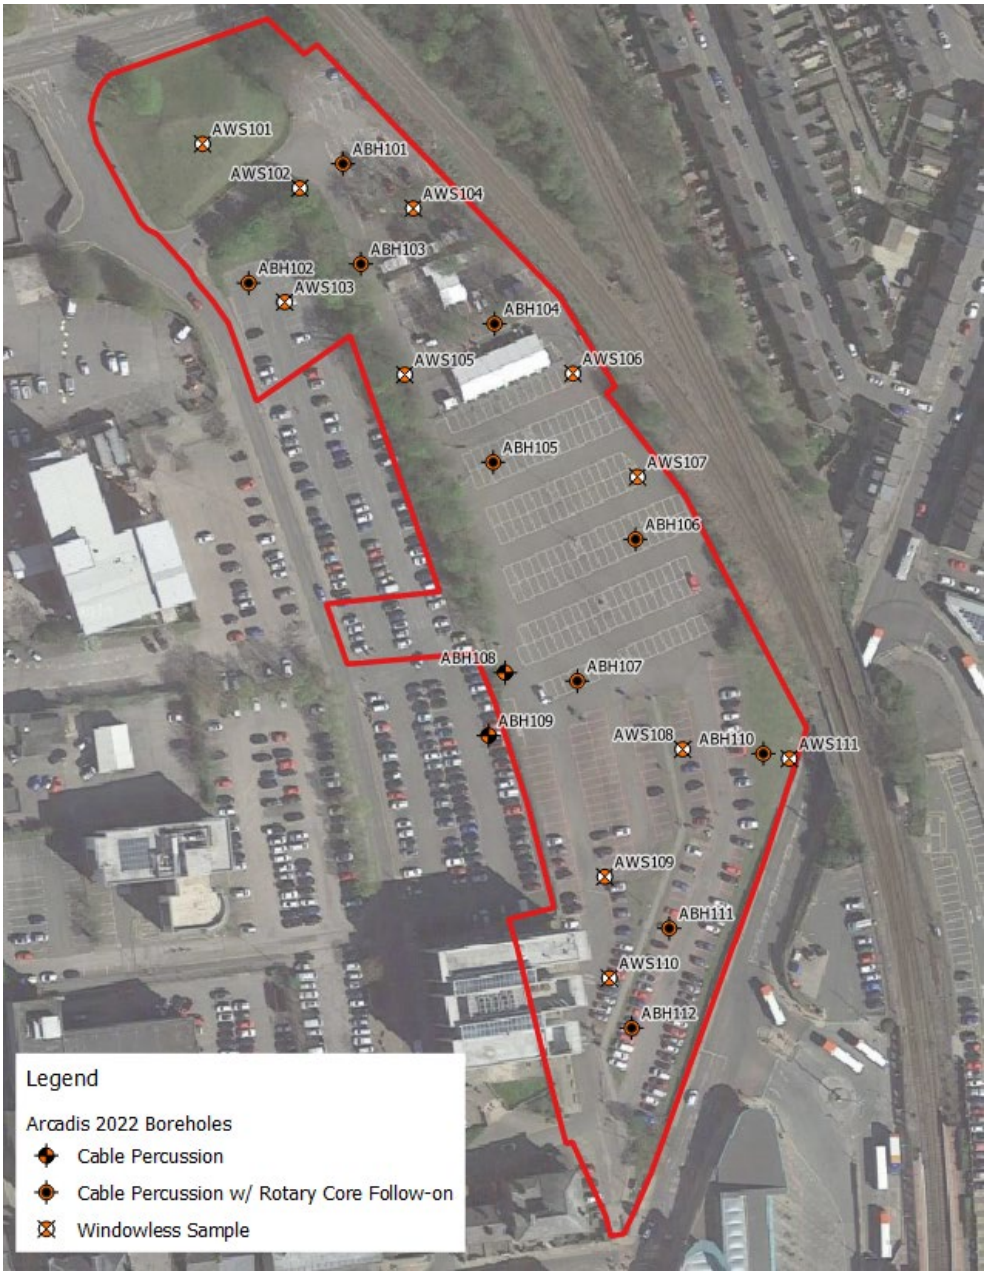
Figure 6 - Supplementary Ground Investigation Borehole Locations

Coal interpreted as the Low Beamshaw was recorded at shallow depth in the three locations along the southern site boundary (ABH110, ABH111 and ABH112). The Low Beamshaw was found beneath Made Ground and a layer of weathered strata (clay), and the seam thickness was recorded as between 0.3 and 0.7m.

Coal interpreted as the Kent's Thin was recorded in five locations to the north of the site (ABH101 – ABH105). The Kent's Thin seam was found underlying a relatively massive sandstone unit (Kent's Rock), beneath Made ground and weathered strata (clay). The seam thickness was recorded as between 0.29 and 0.65m. The Kent's Thin seam is anticipated to lie at greater depths beneath the southern site area.

Exp Hole Ref	Intact Coal / Void	Top m bgl (m AOD)	Bottom m bgl (m AOD)	Thickness (m)	Comment
ABH101	Coal	12.8 (82.76)	13.23 (82.33)	0.43	Kent's Thin
ABH102	Coal	15.7 (85.02)	16.35 (84.37)	0.65	Zone of core loss noted as possible coal, no loss of resistance to drilling. Kent's Thin
ABH103	Coal	12.74 (82.74)	13.16 (82.32)	0.42	Kent's Thin
ABH104	Coal	16.71 (78.63)	17.0 (78.34)	0.29	Kent's Thin
ABH105	Coal	16.85 (79.1)	17.25 (78.7)	0.40	Kent's Thin
ABH110	Coal	5.1 (91.86)	5.5 (91.46)	0.40	Low Beamshaw
ABH111	Coal	2.3 (94.91)	3.0 (94.21)	0.70	Low Beamshaw
ABH112	Coal	3.0 (94.28)	3.3 (93.98)	0.30	Low Beamshaw
