# Wentworth Castle

## Plaster Ceiling Survey

02/08/2024

| <b>Nature of project:</b> | Plaster ceiling survey for multiple rooms |

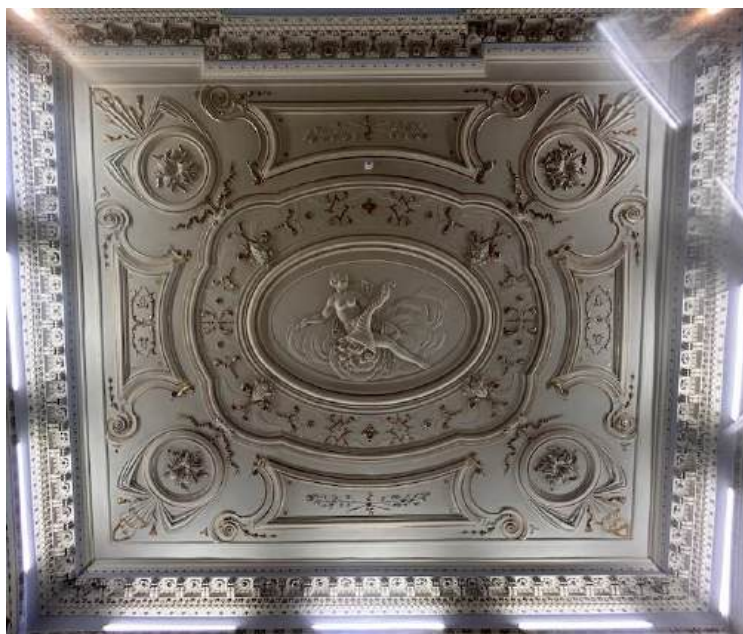
*Figure 2. Blue Room, North End Room Ceiling*

- The Blue Room, North End Room was found to be in good and stable condition.
- Multiple hairline fractures were noted throughout the ceiling and through the decorative details and cornice (Figure 3).
- There were multiple fractures noted at the junction between the ceiling and mouldings.
- The ceiling was found to be solid and stable from push testing.

- The ceiling expanse was found to be in stable condition from observation and tactile testing of the underside.
- If possible, observation of the upper side of the ceiling is recommended to ensure stability of the ceiling and its composing elements.

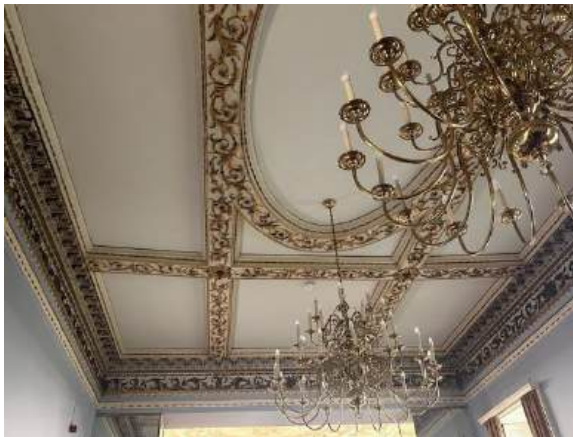
- The full ceiling exhibited evidence of displacement, observed as bowing from East to West along the full expanse of the ceiling (Figure 6).
- Bowing and displacement were noted on the West facing wall's cornice from North to South (Figure 7).

*Figure 6. Ceiling bowing from East to West, visible on the beam.*

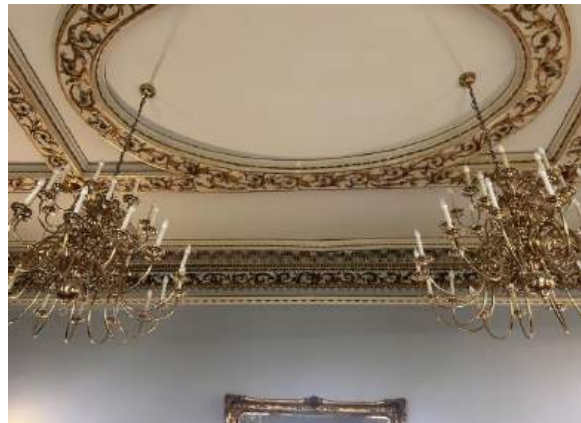
*Figure 7. Bowing noted on West wall cornice.*

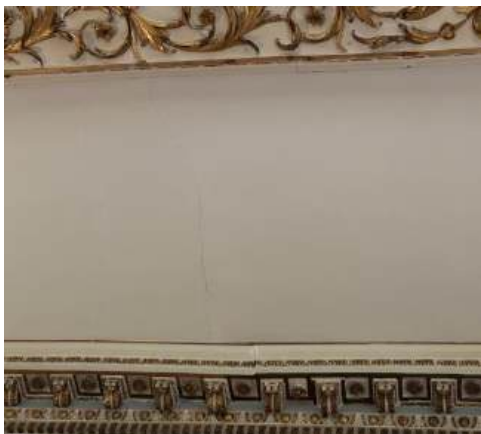
- Multiple hairline fractures were noted throughout the plaster, decorative elements, and cornice (Figure 8).
- Hairline fractures were noted on multiple enrichments; however, these may have been deliberate cuts created for the historic stabilization work on the upper ceiling (Figure 9).

*Figure 8. Hairline fractures noted throughout the ceiling.*

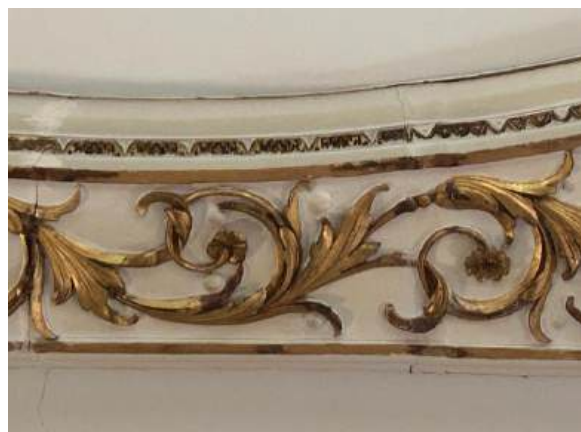
- Multiple hairline fractures were noted along the enriched decorative beams in equally spaced sequences. These also appeared to be deliberate cuts which could have been from the previous stabilization work to the upper side of the ceiling. Evidence supporting the insertion of deliberate cuts is aided by the visible presence of multiple bolts found between each fractured section. (Figure 11). These were found mirrored on both the East and West ends of the central decorative oval (Figure 12). These bolts match to the stabilization bolts viewed from the upper ceiling (Figure 13).

*Figure 11. Bolts visible give evidence on the underside ceiling of the stabilization methods which occurred on the upper side of the ceiling.*

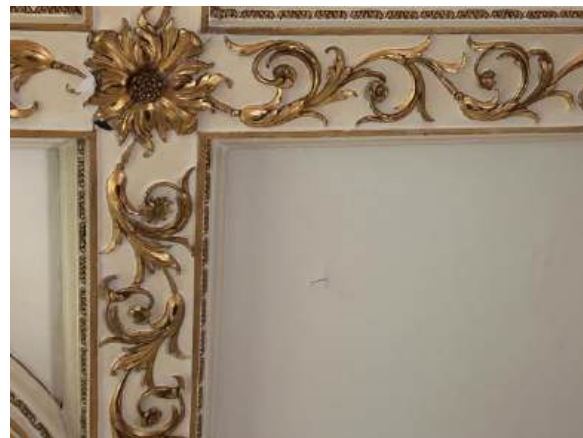
- Multiple minor areas of loss and minor cracking and flaking were noted throughout the ceiling (Figure 14).

*Figure 14. Minor delamination of skim coat and loss visible surrounding the enrichment.*

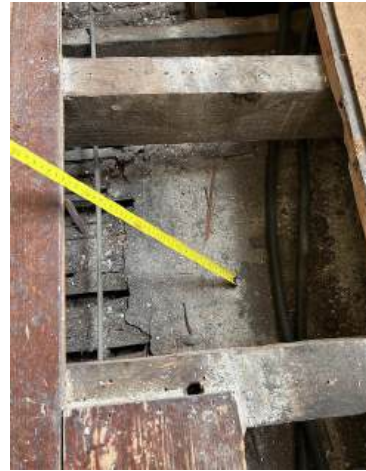
- Pugging was noted only around the perimeter of the upper ceiling corresponding with the cornice below. It is possible that the pugging only extended 750 – 800 mm from the wall (Figure 16).

*Figure 16. Pugging extending only partially over the edges of the ceiling.*

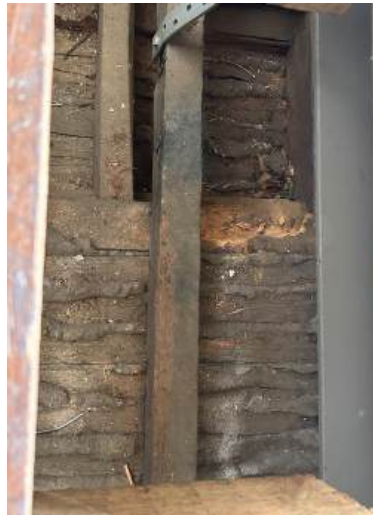
- Nibs and Laths were overall found to be in good condition (Figure 17).
- It appears that there were two major phases of renovation historically to the Blue Room ceiling. This is evidenced by red coloured inserted steel beams running East to West (Figure 17) and grey coated steel beams of a later manufacture found inserted running North to South (Figure 18). The later grey coated beams have bat straps attached which are fixed to the plaster ceiling below. Earlier steels were also found affixed in a support system for the remaining original timber beams (Figure 19).

*Figure 17. Close up of ribs and laths.*

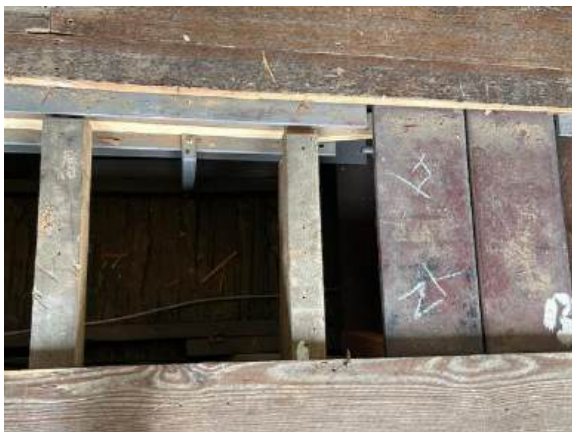
*Figure 17. Red coloured steel beams running East to West give evidence of the first major intervention to the ceiling's structural stability.*

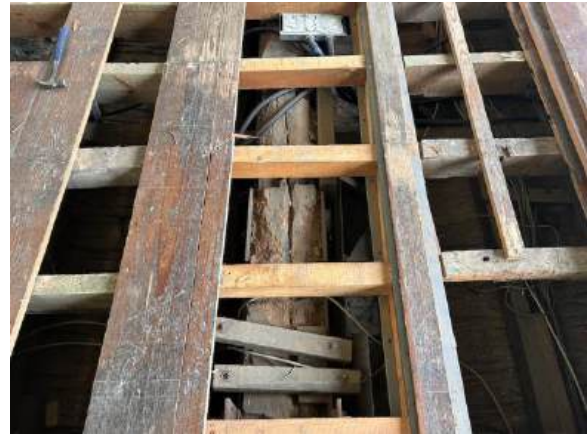
- The wooden beams and joists are original to the ceiling and it appears that the later steel beams were inserted to give additional structural support to the failing timber beams (Figures 20 & 21). Steel beams were also found where timber beams were missing (Figure 22). These inserted steels could have possibly replaced a rotten or failing original timber beam. The earliest inserted steel beams were found running above the timber beams (Figure 23).

*Figure 20. Timber beam supported by steels on either side.*

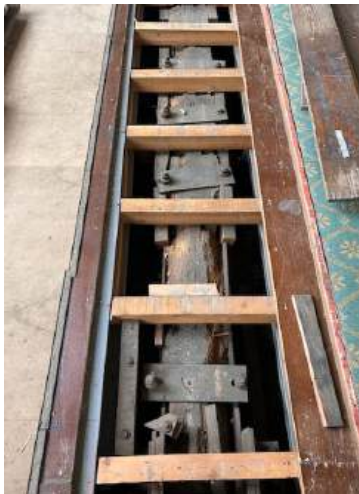
*Figure 21. Timber beams being aided by later added support system.*

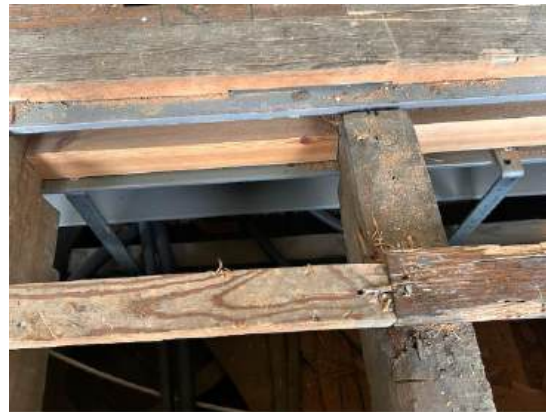
- The fractures and bolts which were visible from the underside of the ceiling give evidence that sections of plasterwork were removed to allow the fitting of the main steels, which run East to West. The plaster was then refixed and screwed in place using bolts. The deflection in the ceiling also therefore corresponds with the placement of the replaced beams above (Figure 22) and could have been caused by the loss and rotting of the original structural elements.

*Figure 22. Steel beams found where timber beam would have originally been.*

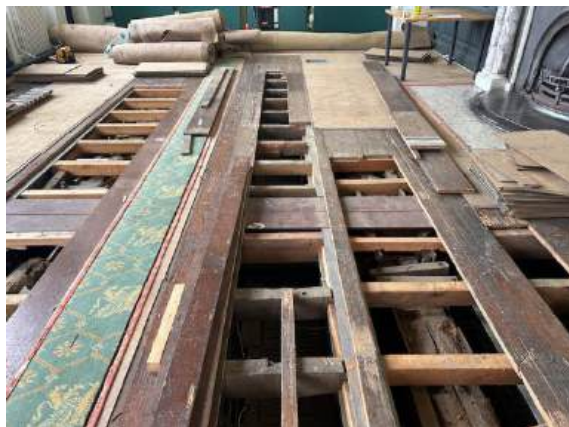
*Figure 23. Two red steel beams inserted East to West above timber beams.*

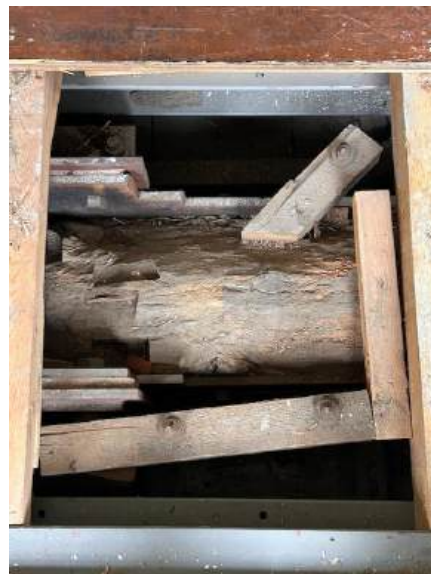
*Figure 24. Loose timber elements affixed with bolts requiring extra stabilization agreed upon with architect.*

- Extra support to the two timber joists which were found to be loose during the survey was recommended on site and a plan was devised with the architect for design and placement of the added support (Figure 24).

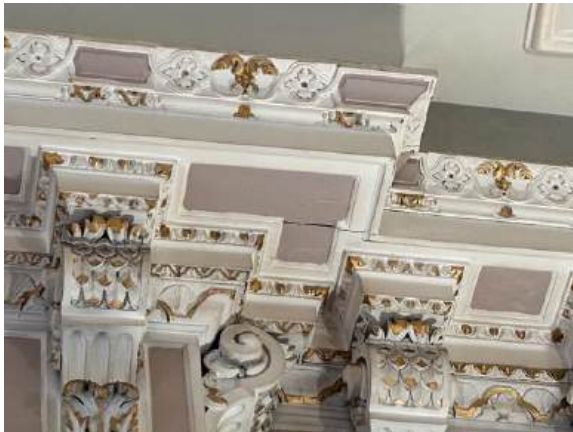
*Figure 27. Fracture visible on the cornice.*

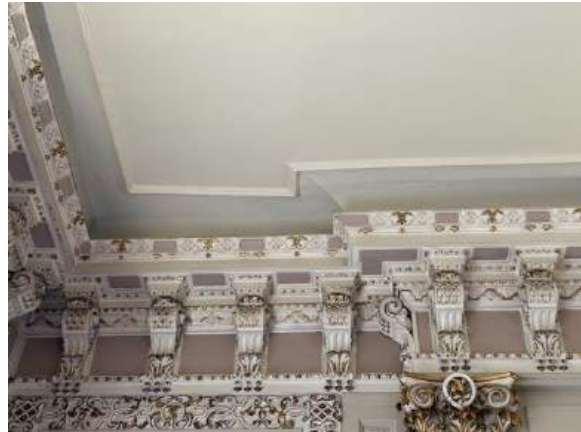
*Figure 28. Minor deflection and evidence of a previous repair over the South wall cornice.*

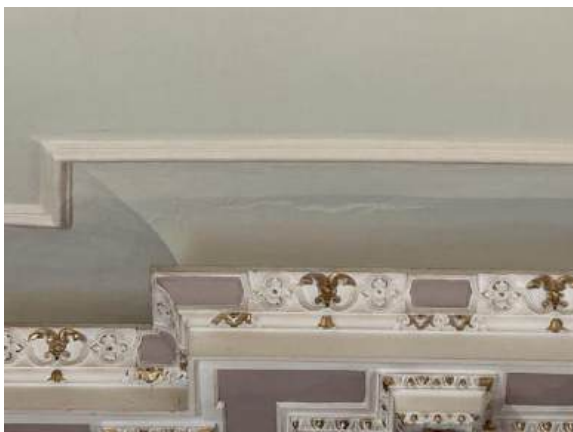
*Figure 29. Previous patch repair visible.*

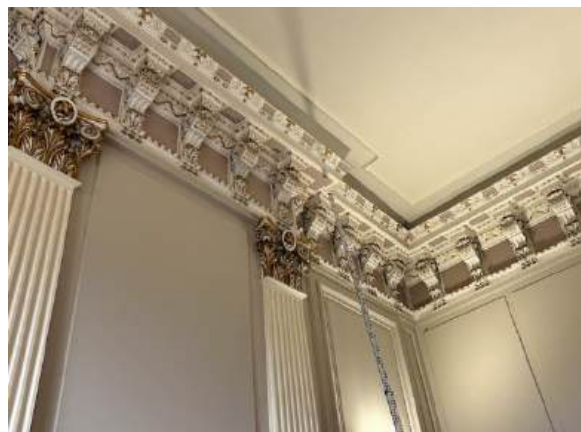
*Figure 30. Push test revealed the plaster ceiling to be stable.*

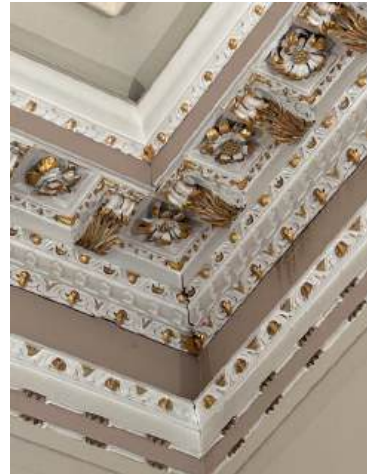
*Figure 34. Cracks visible in the mitres.*

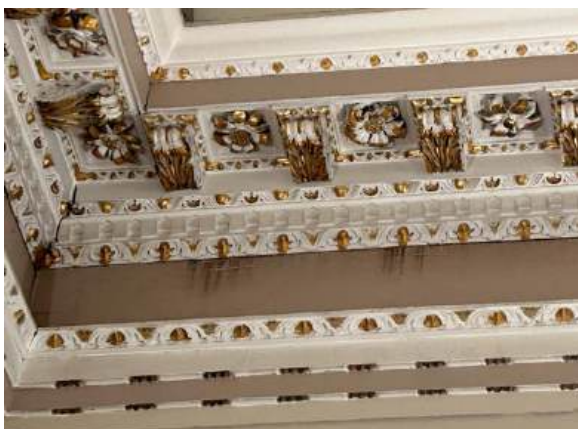
*Figure 35. Possible water ingress visible on the cornice.*

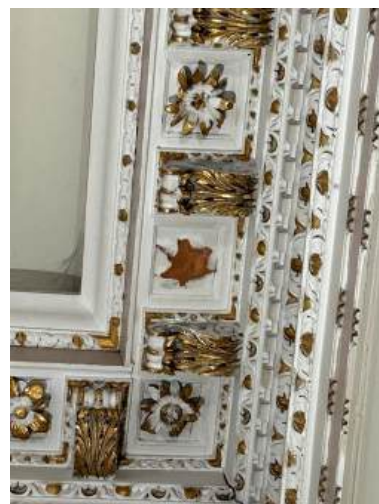
*Figure 36. Missing embellishments throughout the cornice.*

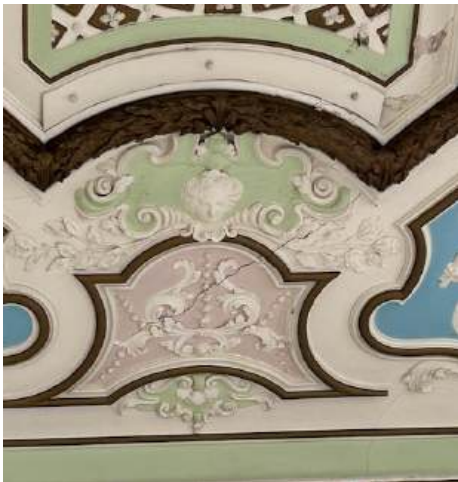
- The ceiling has multiple hairline cracks present throughout (Figure 47)
- There are some areas of loss present throughout the ceiling. An area of loss can be seen on the central rose, where there is a loss of paint and possible loss of plasterwork (Figure 48). Additionally on the central border (Figure 49). Closer inspection is needed to fully understand the type and level of damage.
- Five support straps attached with bolts were visible on the ceiling. (Figure 50).

*Figure 47. Hairline fractures visible throughout the ceiling.*

- A closer in-depth tactile survey is recommended to fully understand the level of damage and stability of the structure of the ceiling.
- If possible, it would be beneficial to access the upper side of the ceiling to fully understand the condition of the ceiling structure and support system.
- It is important to understand if there is any ingress which could be causing the areas of loss and damage.

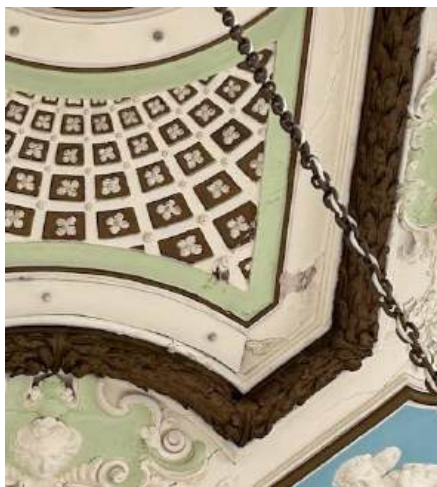
*Figure 49. Area of loss on central border.*

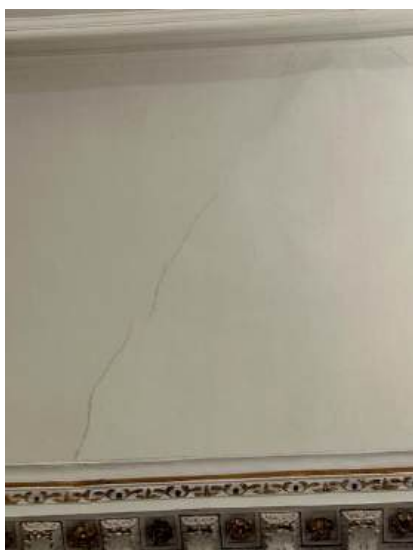
- Multiple hairline fractures were found throughout the expanse of the ceiling (Figure 53). Two repeating hairline fractures were found mirrored on the North and South coves (Figure 53).
- Markings which could potentially be water ingress marks or salts were observed on the North wall cornice (Figure 55).
- Fractures resulting in flaking paint were noted and some small areas of loss of the skim coat of plaster and delamination of the plaster skin were observed (Figure 55).
- Minor deflection was noted between the two South columns.

*Figure 53. Hairline fractures noted throughout the ceiling.*

- A closer in-depth tactile survey is recommended to confirm the ceilings stability and damage level.
- If possible, it would be beneficial to further access the upper side of the ceiling to fully understand the condition of the ceiling structure and support system.
- It is important to understand if the ingress is ongoing and requires intervention or is stable, inspection of the roof and lead flashing and tiles may further inform on this.

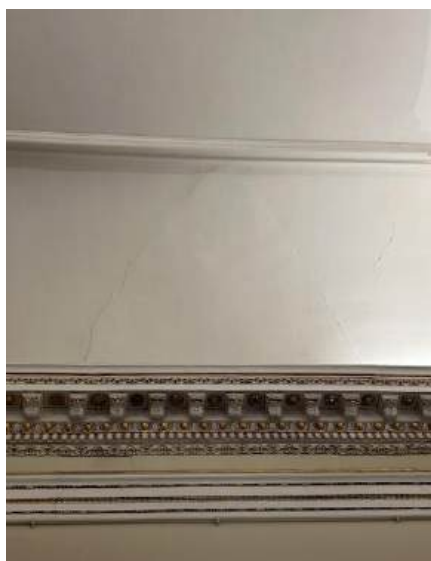
*Figure 54. Shape of hairline fractures on North and South wall coves.*

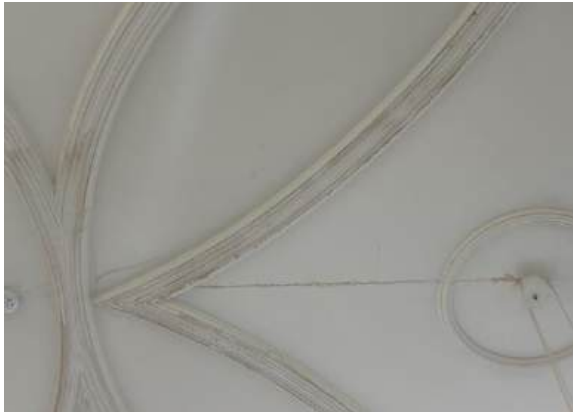
- Multiple hairline fractures were found running West to East along the ceiling expanse (Fig.84).
- Plasterboard was present in the ceiling and there is fracturing along the joint lines between plasterboards.
- There was potential water ingress visible (Fig.85).
- Push testing revealed the plaster ceiling to be solid and stable.

*Figure 84. Hairline fracture on centre rose of ceiling.*

- A closer in-depth tactile survey is recommended to fully understand the level of damage and stability of the structure of the ceiling.
- If possible, it would be beneficial to access the upper side of the ceiling to fully understand the condition of the ceiling structure and support system.
- It is important to understand if the ingress is ongoing and requires intervention or is stable.

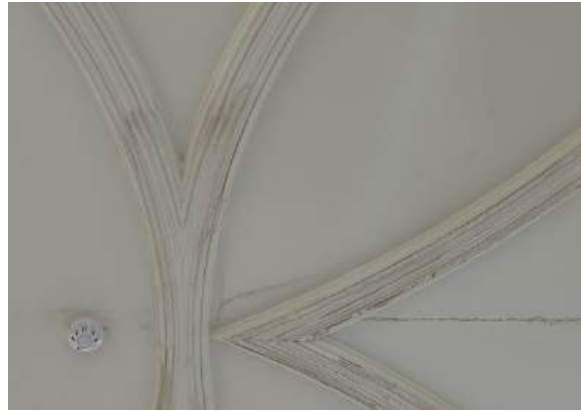
*Figure 85. Possible water ingress marks near fractures.*

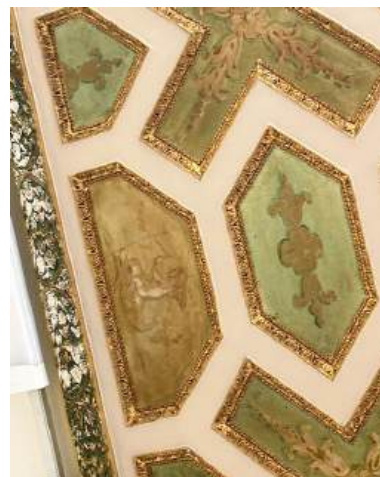
*Figure 91. Fading noted on the painted decorative plaster border. Hairline fractures visible throughout.*

- A closer in-depth tactile survey is recommended to fully understand the level of damage and stability of the structure of the ceiling.
- If possible, it would be beneficial to access the upper side of the ceiling to fully understand the condition of the ceiling structure and support system.
- It is important to understand if the ingress is ongoing and requires intervention or is stable.

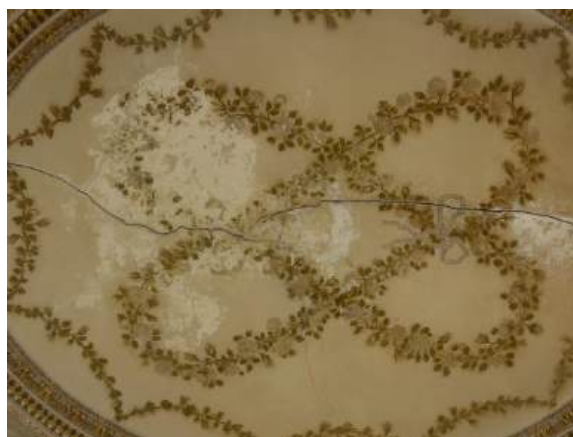
- Multiple fractures observed throughout the ceiling expanse with a significant fracture running through the central panel from East to West. Multiple hairline fractures form out of the larger significant crack (Fig.94).
- Possible water ingress was observed resulting in discolouration of the painted detail (Fig.95)
- Areas of paint loss, flaking, and fading were noted throughout the painted ceiling panel (Fig.96).
- The perimeter ceiling could be composed of a different material from the inner painted ceiling, however, this requires further assessment.

*Figure 94. Multiple fractures run from the central significant fracture.*

- A closer in-depth tactile survey is recommended to fully understand the level of damage and stability of the structure of the ceiling.
- If possible, it would be beneficial to access the upper side of the ceiling to fully understand the condition of the ceiling structure and support system.
- It is important to understand if the ingress is ongoing and requires intervention or is stable.

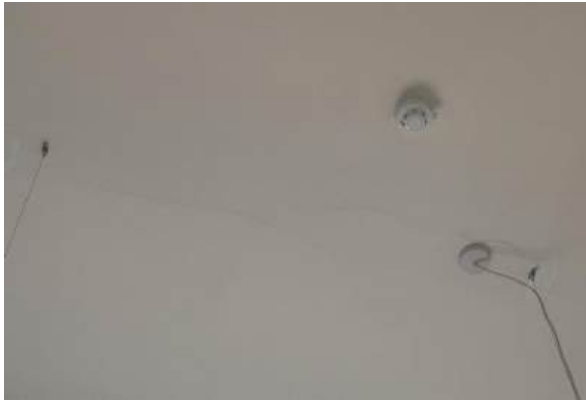
- Multiple fractures were observed throughout the ceiling expanse (Fig.99). Fractures were found on the mitred corners and along the cornice (Fig.100 and Fig.101).
- Deflection was noted along multiple fracture lines.
- Possible water ingress and staining was observed (Fig.102).
- Tactile push test revealed some movement was present in the ceiling.
- Previous repairs were found in the form of some localized areas which had been previously filled.

*Figure 99. Fractures found running along the ceiling expanse.*

- A closer in-depth tactile survey is recommended to fully understand the level of damage and stability of the structure of the ceiling.
- If possible, it would be beneficial to access the upper side of the ceiling to fully understand the condition of the ceiling structure and support system. Additionally, this would aid in pinpointing the possible cause of movement in the ceiling and inform the best course of action for stabilization, if required.
- It is important to understand if the ingress is ongoing and requires intervention or is stable.

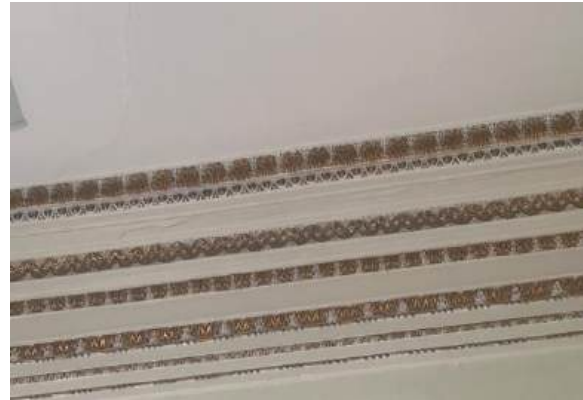
*Figure 100. Fractures found along the cornice.*

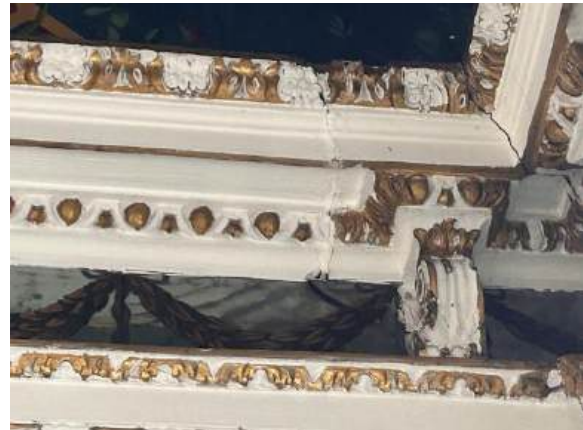
*Figure 106. Crack running through cornice and causing a break in the mirrored frieze panel.*

- A closer in-depth tactile survey is recommended to fully understand the level of damage and stability of the structure of the ceiling.
- If possible, it would be beneficial to access the upper side of the ceiling to fully understand the condition of the ceiling structure and support system.
- It is important to understand if the ingress is ongoing and requires intervention or is stable.
- For aesthetic considerations the hairline fractures can be filled and painted. Areas of loss and flaking can be consolidated and retouched.

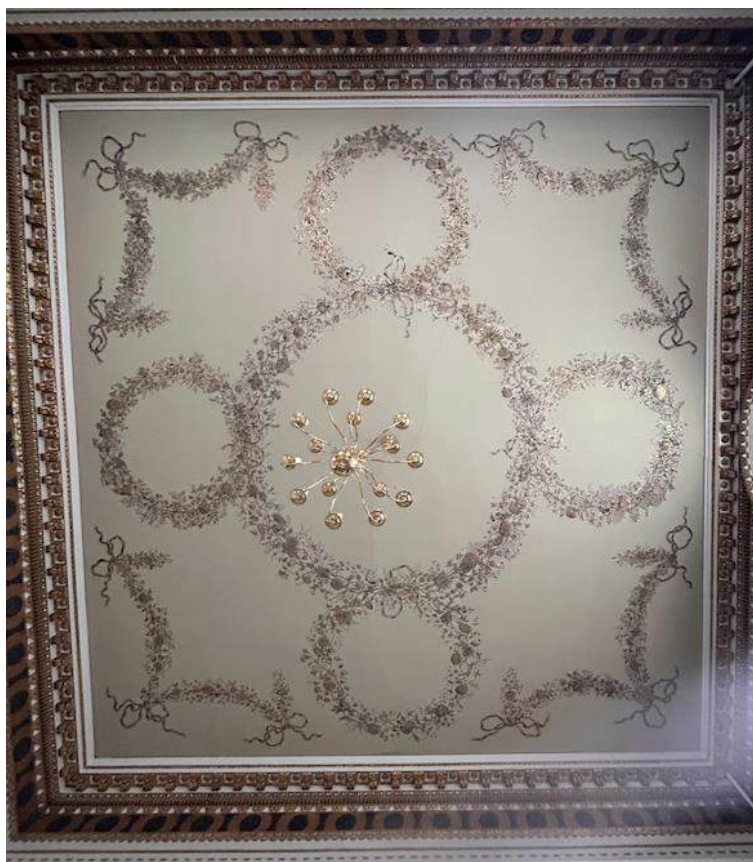
Figure 112. Principal's Office Ceiling.

- Multiple hairline fractures were observed throughout the ceiling (Figure 113 & 114). Fractures were found extending into the cornice (Figures 115 & 116).
- Possible water ingress or staining was observed.
- Paint loss was observed along many of the fracture lines. Paint loss, flaking, and fading was found throughout the ceiling. Areas of discolouration and possible overpainting were noted (Figure 117).

- Consolidation methods can be employed to ensure the stability of the ceiling due to the lack of solid nibs and laths.
- The boards found in the underside of the ceiling should be removed if found to have no securing purpose.

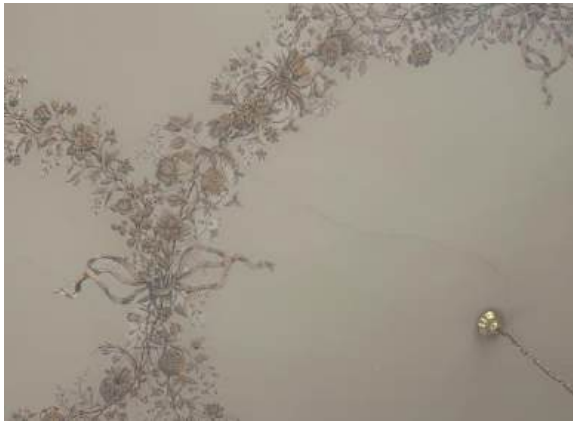
*Figure 113. fractures found along the ceiling expanse.*

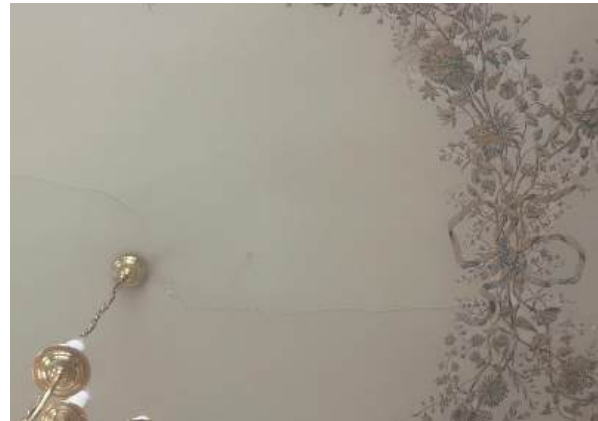
*Figure 114. Fractures found along the ceiling expanse.*

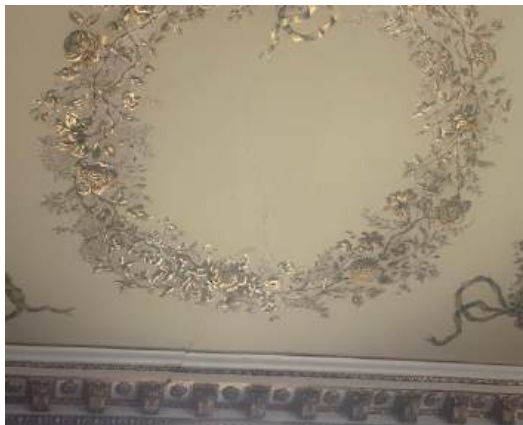
*Figure 115. Fractures running through cornice.*

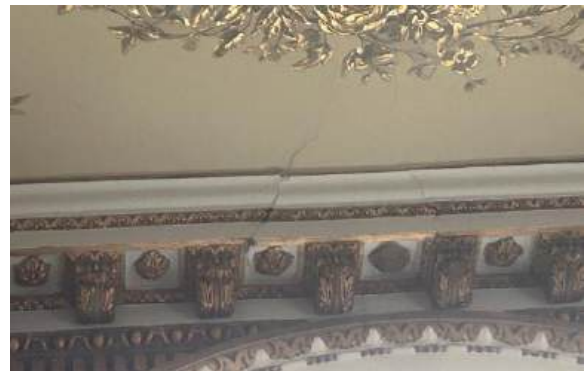
*Figure 116. Fractures running through cornice.*

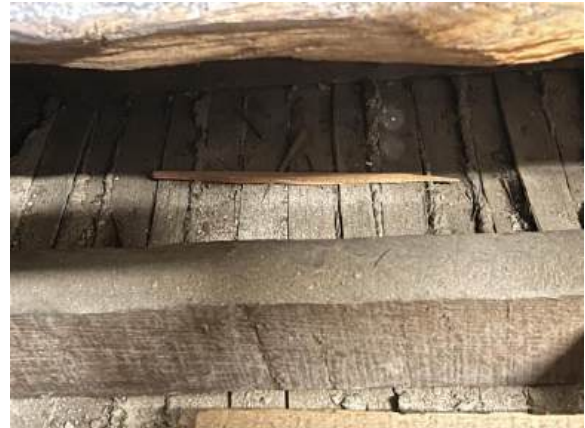
- Nibs were found to be present but were found to be in poor condition (Fig.118).
- Nibs were found to be intermittent with some missing (Fig.119).
- Laths were found to be tightly spaced but were not found to be springing.
- Timber boards were found resting directly on top of the plaster laths and nibs adjacent to the main beams, their purpose and reason for placement is unknown.

*Figure 120. View of laths and nibs, laths are tight and nibs are sparce.*
