# **STRUCTURAL APPRAISAL REPORT**

**Ivy House Farm  
Chapel Road  
Pilley  
Barnsley**

**REPORT NUMBER:** FC 2023.121

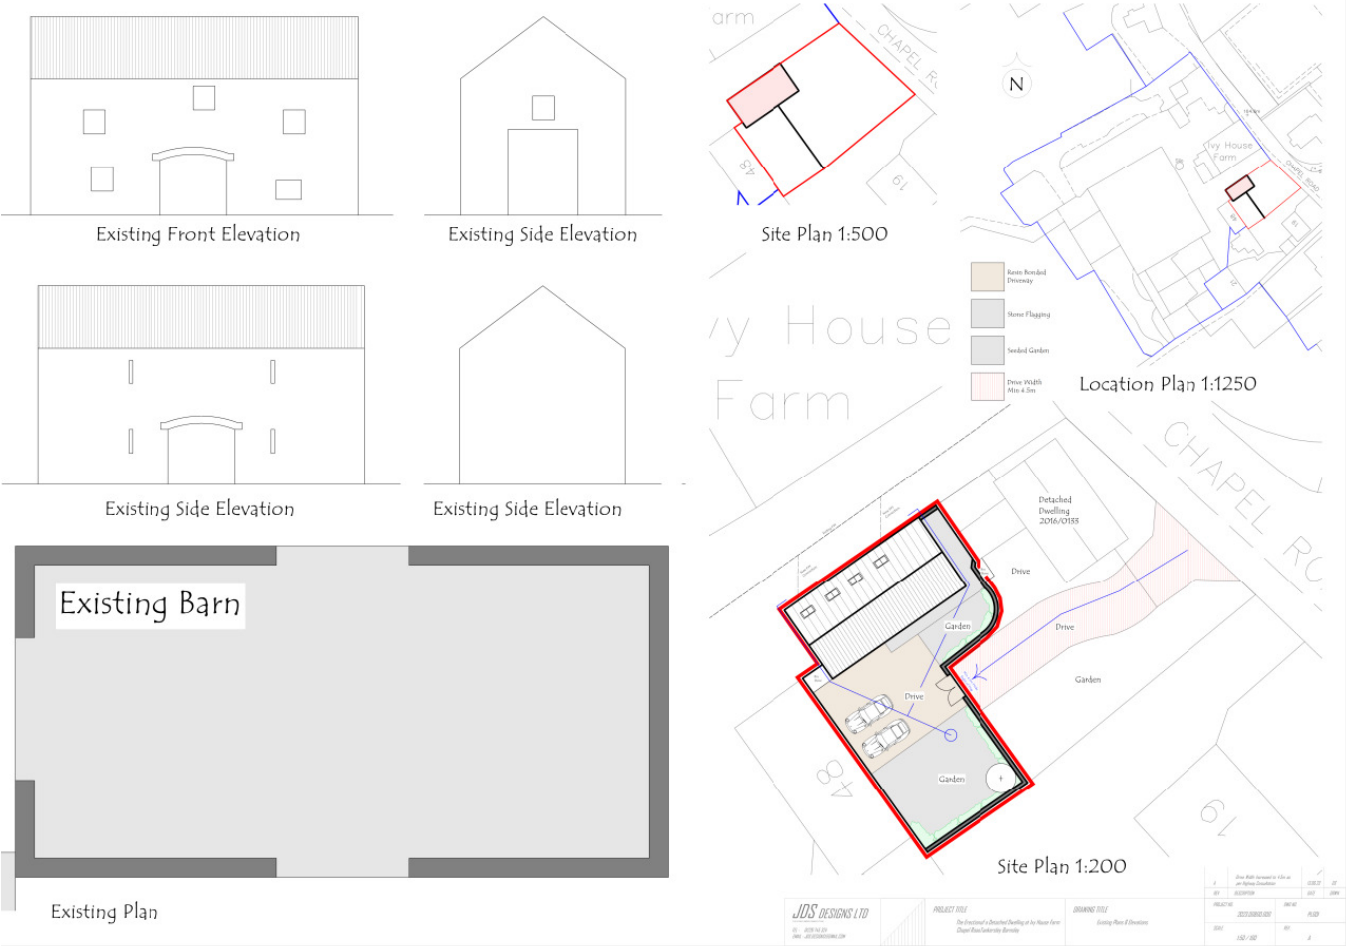
**Fig.1 Existing Plans**

The building surveyed is identified in Fig 1, having open plan layout and no first floor.

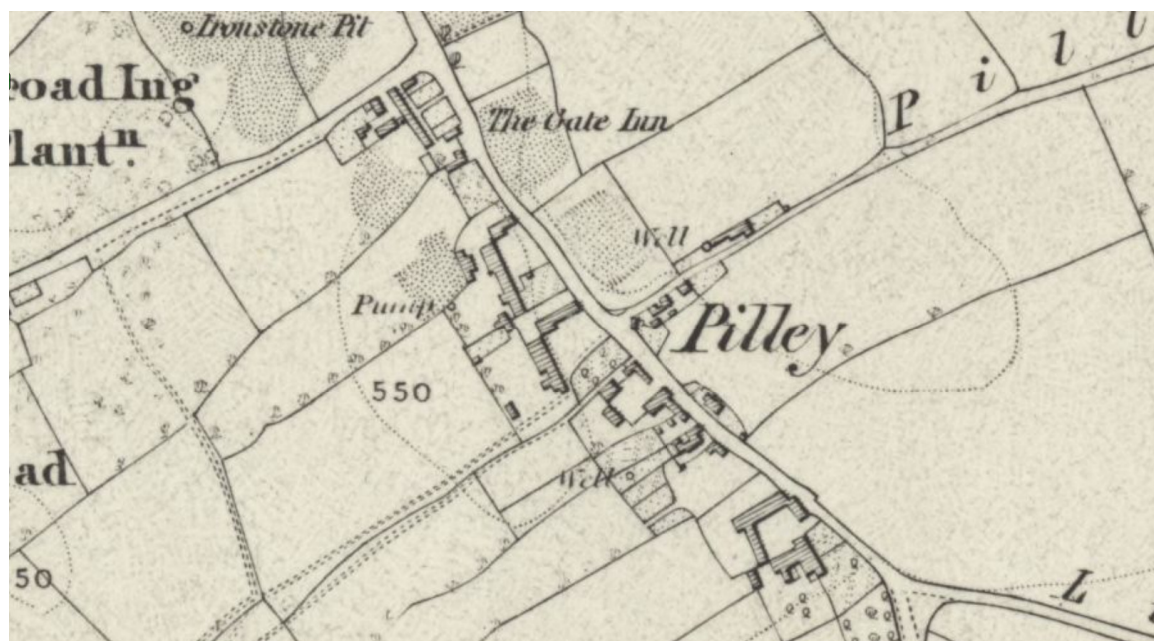
**Fig.3 1848 Surveyed Map**

The building is shown on the 1850s map with attached structure extending towards Chapel Road. This can be seen physically where it abutted against the remaining north facing gable. Fig.3.

We are of the opinion that the barn was perhaps constructed early 18<sup>th</sup> or late 17<sup>th</sup> century and reference to the 1850 Ordnance Survey map, originally surveyed in 1848 shows development on the site. Fig.3.
