**BARNSELY CIVIC HALL ,ELDON STREET , BARNSELY  
FAÇADE, ROOF , DRAINAGE AND TILED FLOORING CONDITION  
SURVEY**

**Date: 1st FEBRUARY 2022 rev 1**

**BARNSELY CIVIC HALL FAÇADE, ROOF, SURFACE DRAINAGE SYSTEM AND TILED FLOOR  
CONDITION SURVEY**

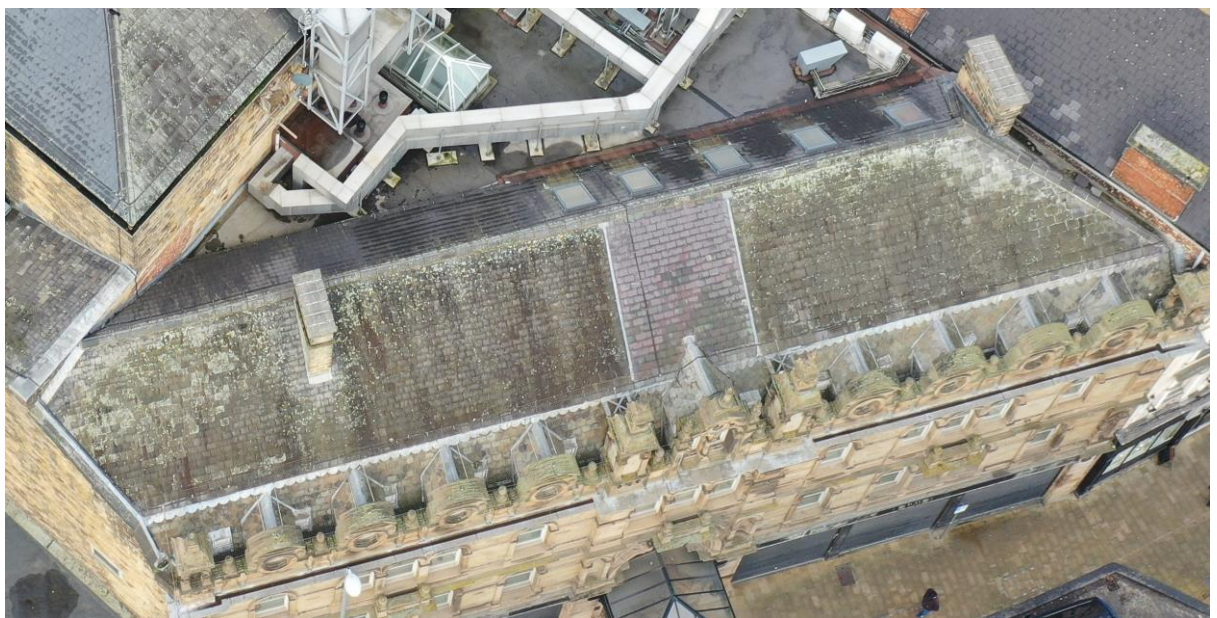
3.1.7

- 3.1.6 For the extent of the survey was to the front elevation pitched roof and dormers. A general overview was made of the remaining roof over the main hall without a detailed internal inspection.

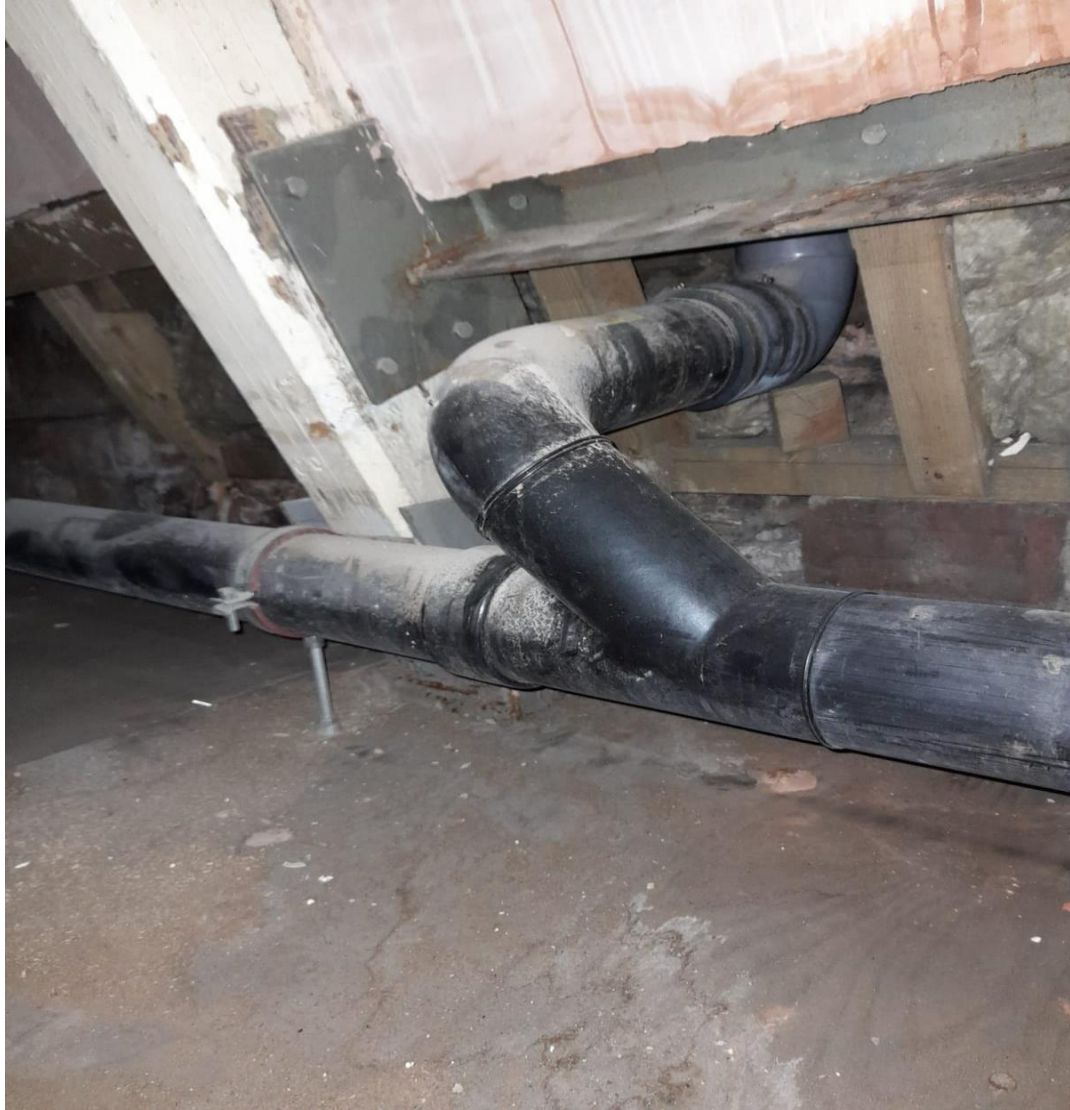
- 4.4.2 Pipe work is 100mm plastic. Each section between the roof dormers has a single outlet, with a hold drain through the box gutter into a pipe running to fall set internal above the 3<sup>rd</sup> floor.

- 4.4.3
- 4.4.4 The internal pipe work is continuous across the front elevation but has a 'break back' on the falls at centre point. I.E. the pipe falls in two directions. This obviously provides a benefit in that if one outlet from the building is blocked discharge water can back flow to the second discharge point.
- 4.4.5 Externally each box gutter between the dormers has a 'holed outlet'. All appeared clear and clean.

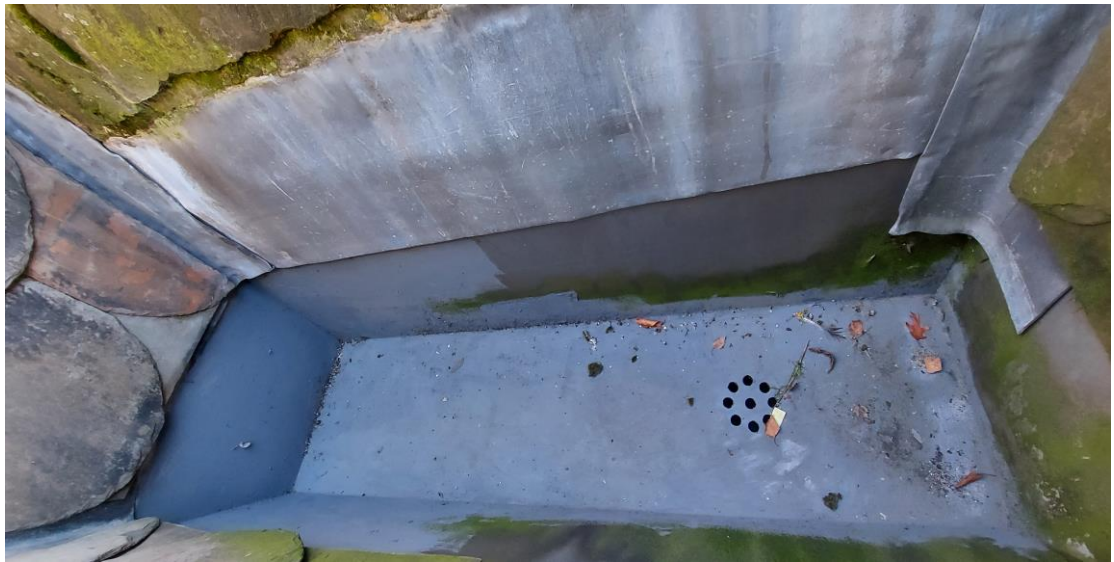
4.4.6

There are two discharge points at either corner of the Eldon Street elevation, each boxed into the full height. These pass into the basement area and out through the basement wall to Eldon Street assuming into the surface water drainage system.

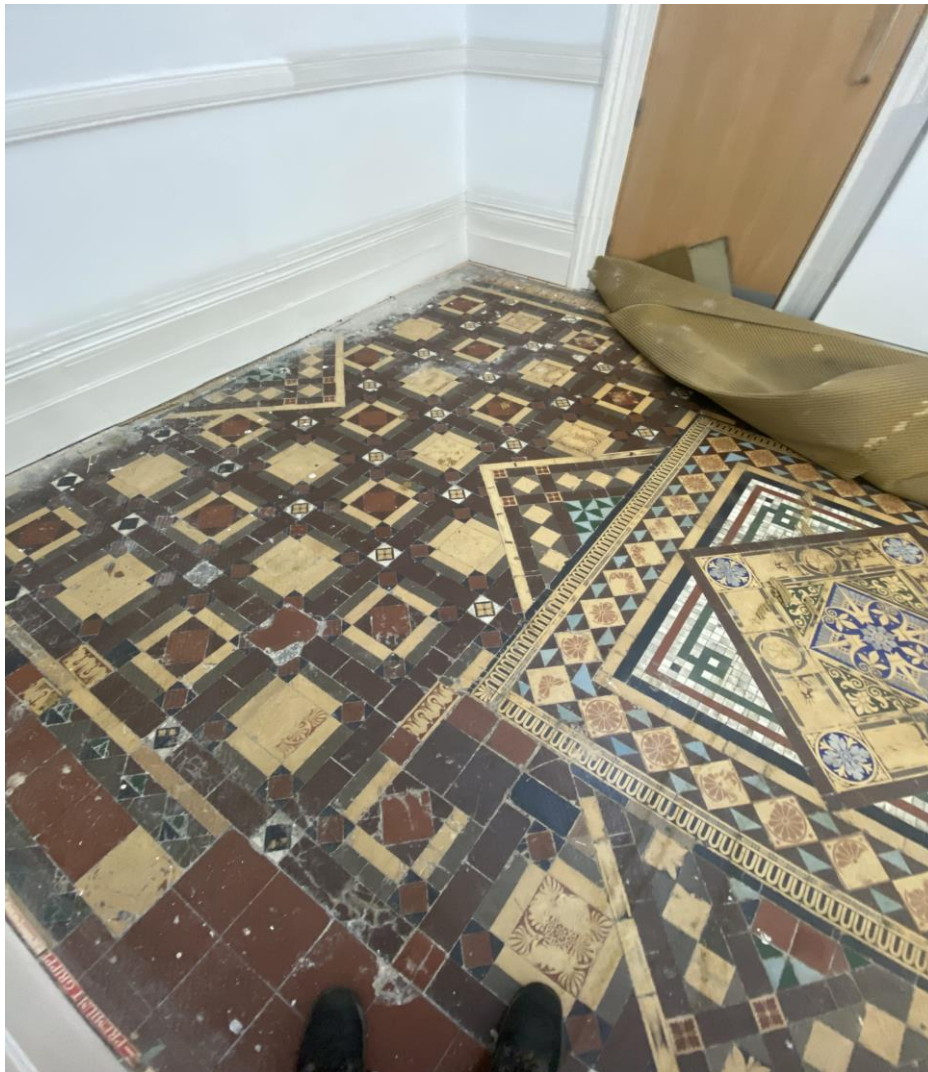
5.1.2

- 5.1.1 The survey was requested to record current defects to the Encaustic tiling at the ground floor level below the main staircase and Mosaic tiling to the main entrance lobby area.

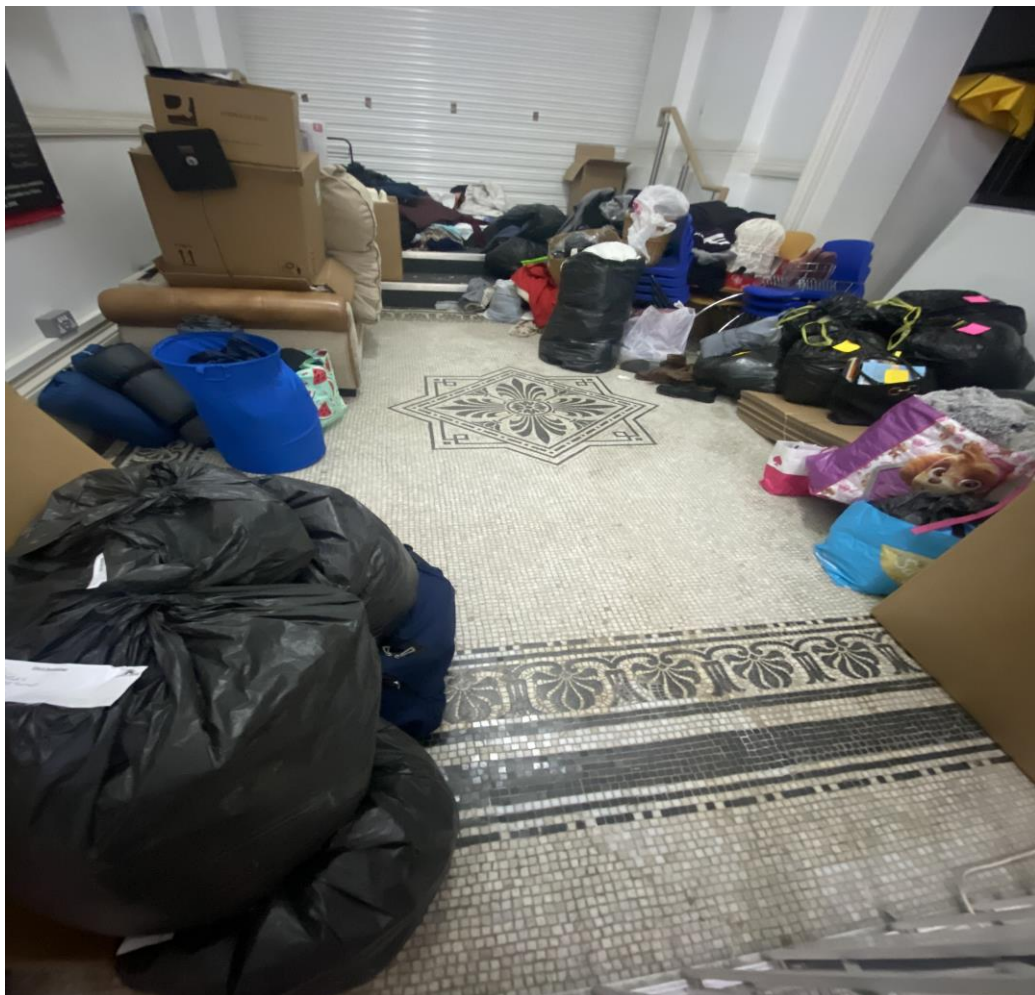
5.2.1.2

- 5.2.1.1 Access for visual inspection to sections of the mosaic at the main entrance and lobby were hindered by an area being used as a storage room. A further area at the entrance door is covered with a large entrance mat which it was not possible to remove as the entrance was in constant use.
