# STRUCTURAL BUILDING SURVEY

## PROPOSED CLASS Q RESIDENTIAL CONVERSION

Bothy on land off Hartcliffe Lane, Hillside, Thurlstone, Sheffield, S36 9QJ

**Report Ref:** TH/Ridge/Bothy/Struct/01/July 2019/v01

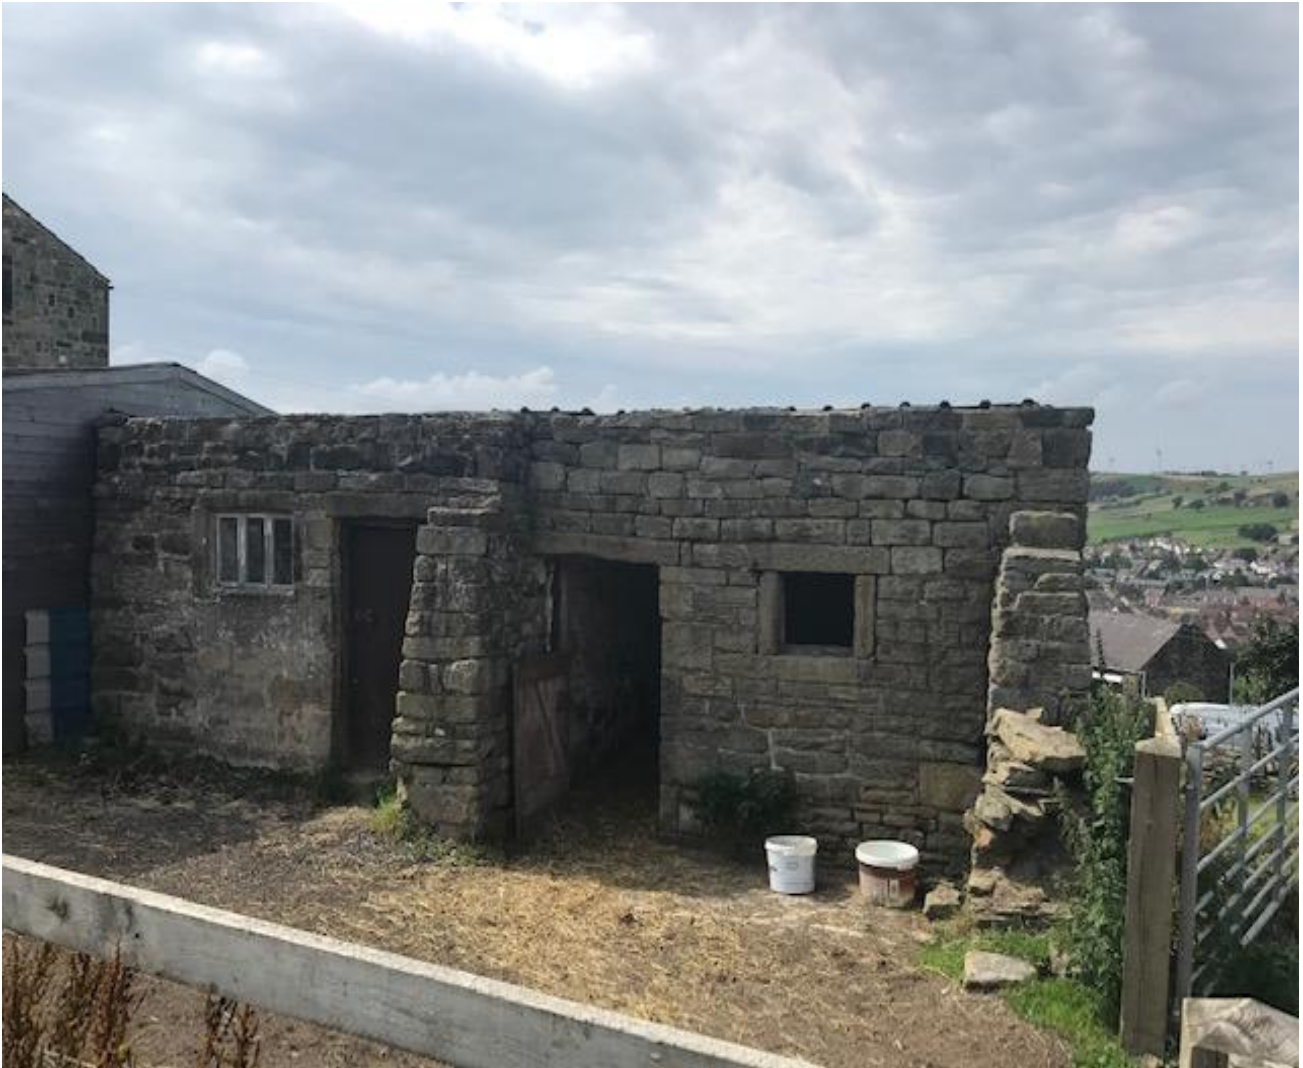
Fig 3 - Front elevation of the existing stone barn (bothy), off Hartcliffe Lane, Hillside, Thurstone, S36 9QJ

The south east elevation (front) facing Hartcliffe Lane is generally plumb and exhibits no signs of significant historical movement and no significant signs of extensive damage.
