# **ARBORICULTURAL REPORT & Impact Assessment to BS 5837:2012 at:**

***Plumpton Lodge,  
Manchester Road,  
Thurlstone,  
Barnsley,  
S36 9QW***

Prepared for: *Coda Studios*

Reference: *AWA6846*

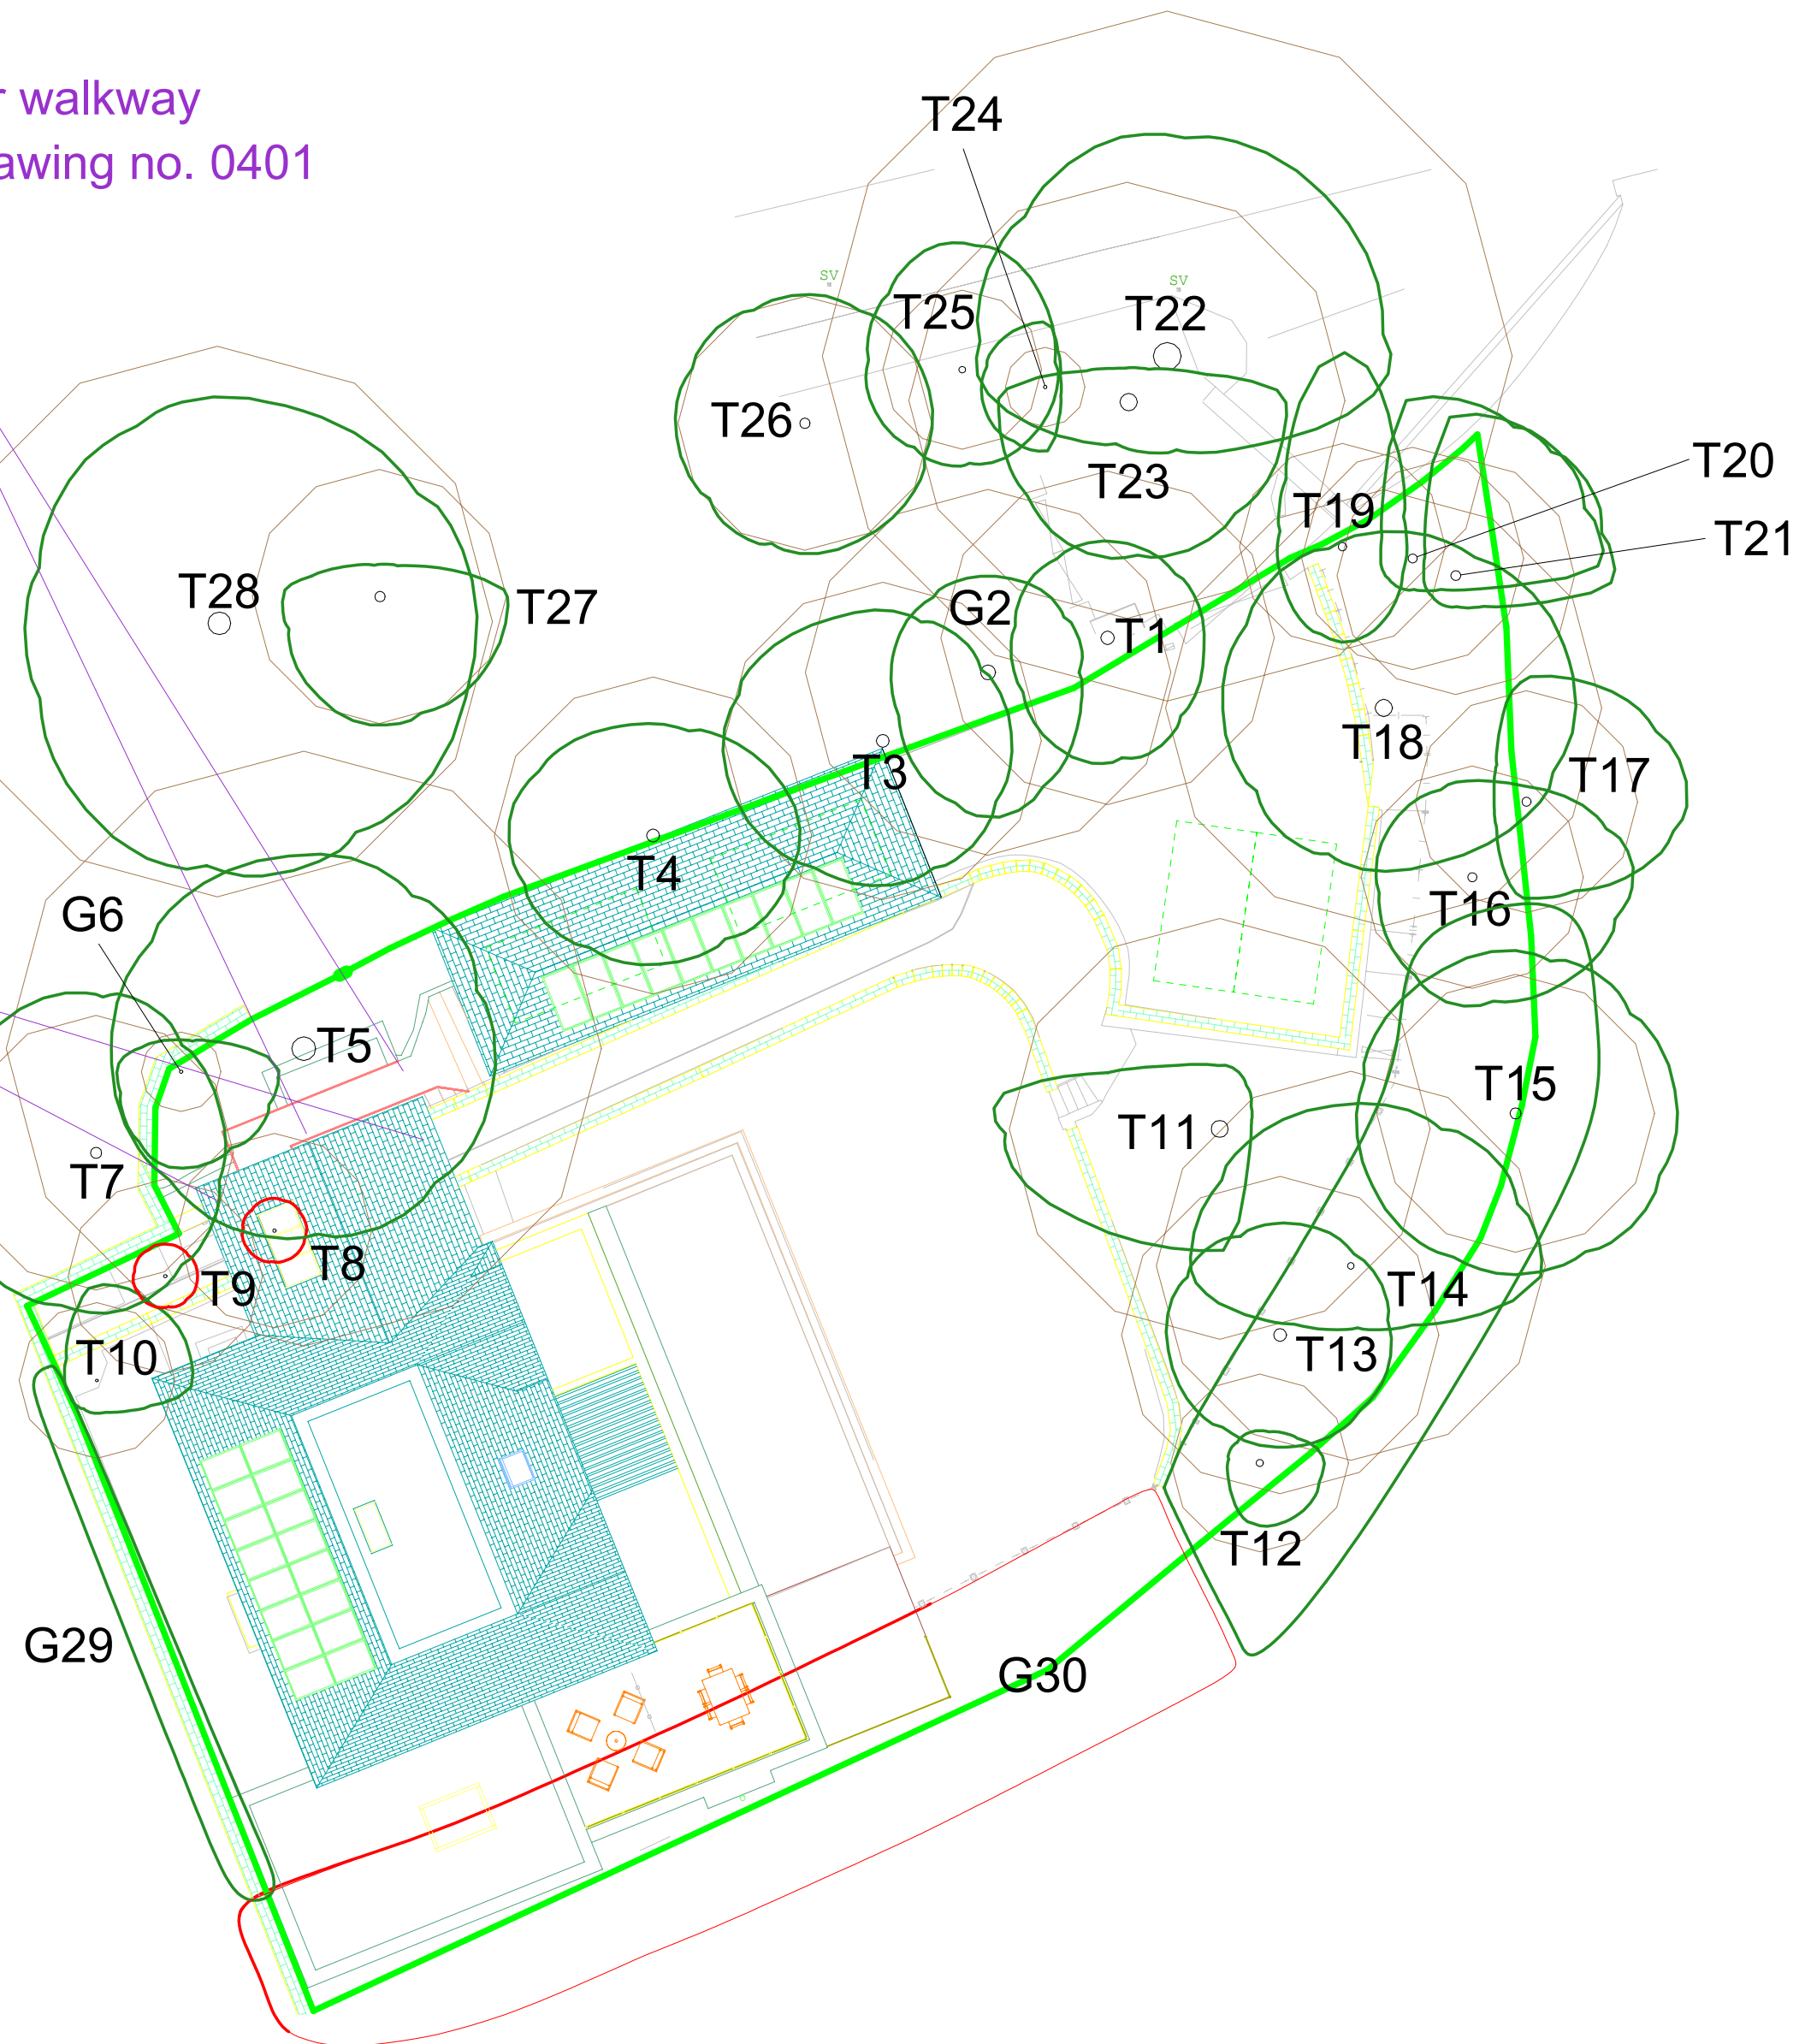
## Appendix 6: Tree Impacts Plan

Mini screw piles for walkway  
as detailed on CODA drawing no. 0401

Columns to south of retaining wall  
as detailed on CODA drawing no. 0401
