# **ADOPTED HIGHWAY DELAPIDATION SURVEY REPORT**

Development Name: Land off Calver Close, Dodworth and Smithywood Lane, Dodworth

Date of Survey: 2<sup>nd</sup> October 2024

Report Completed 10<sup>th</sup> October 2024

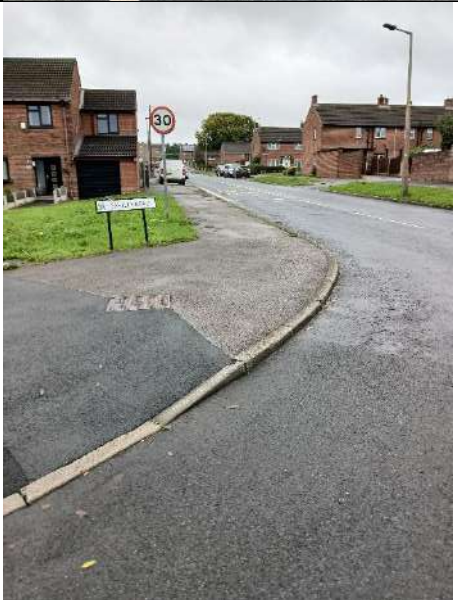
Photo 5  
Saville  
Road /  
Gilroyd  
Lane

Kerb damage. Carriageway surface deterioration.

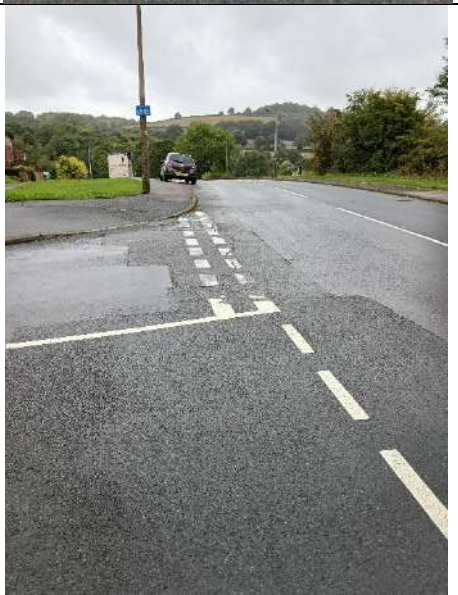
Photo 6  
Saville  
Road /  
Gilroyd  
Lane

Scarring. Surface course deterioration.

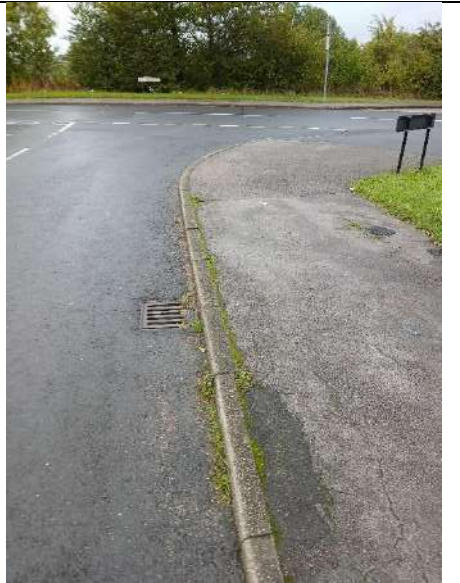
Photo 9  
Saville  
Road /  
Gilroyd  
Lane

Footway cracking and scarring.

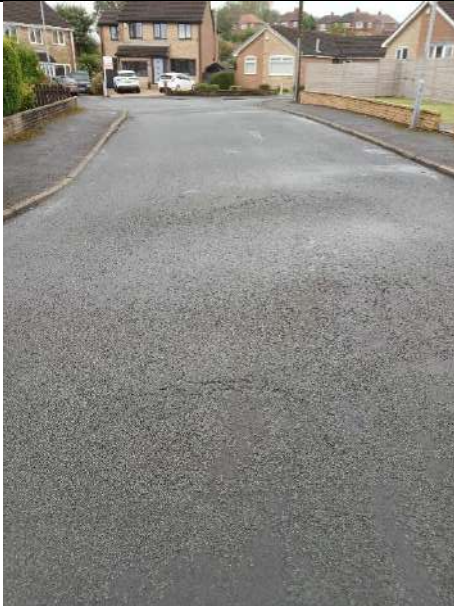
Photo 22  
Calver  
Close

Surface course cracking. Uneven levels.

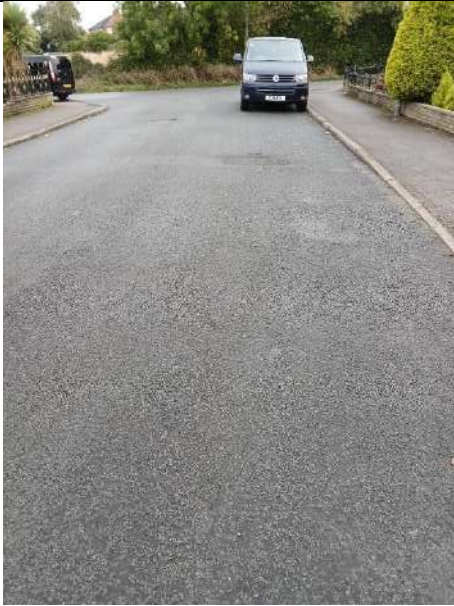
Photo 40  
Bradwell  
Avenue

Minor carriageway damage.

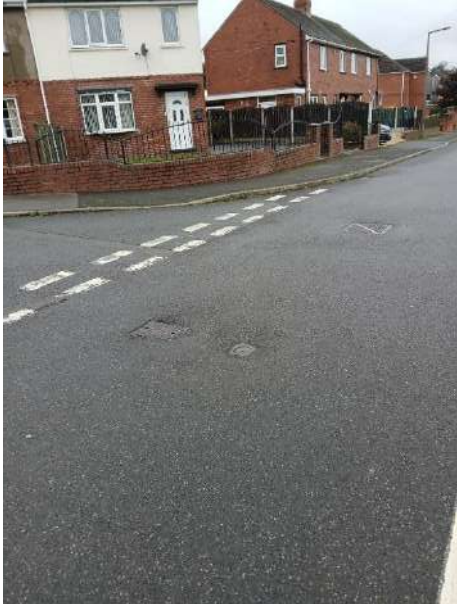
Photo 74  
Smithy  
Wood  
Lane

Carriageway surface course damage.

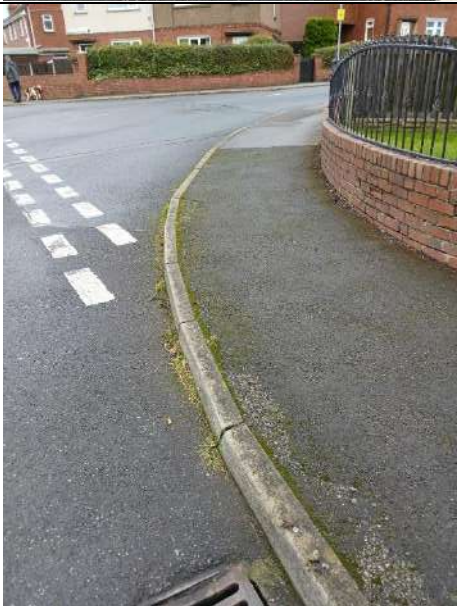
Photo 75  
Smithy  
Wood  
Lane

Carriageway scarring. Footway scarring. Footway minor surface course damage.

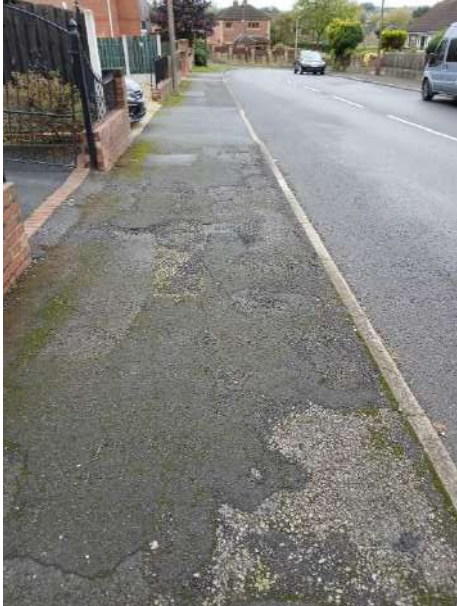
Photo 76  
Smithy  
Wood  
Lane

Footway surface course deterioration.
