Berrywell, Springvale

Bat Survey Report

3rd November 2025

Document ref: MBE/BAT/2025/106/01				
Purpose and Description	Originated	Checked	Reviewed	Date
For Planning	G Slack MCIEEM <i>Greg Slack</i>	P Middleton MCIEEM <i>P Middleton</i>	G Slack MCIEEM <i>Greg Slack</i>	03/11/2025

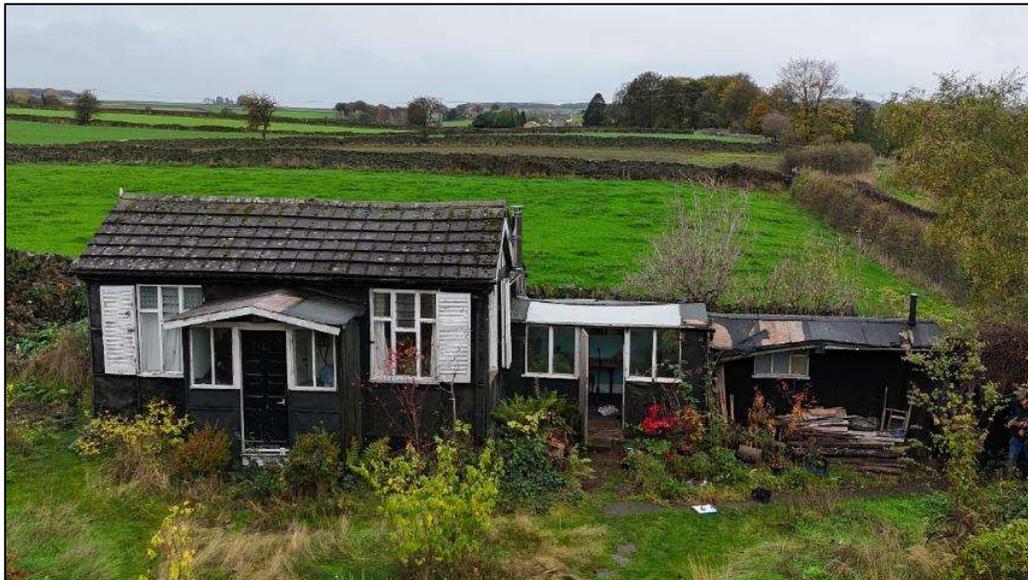
Plate 3. The building viewed from the northeast

- 5.2.1 The building comprised a detached bungalow with a porch on the northeast aspect (Plate 3). The building was located on the south edge of the plot. The original building had been extended to the southwest by the addition of a full length rear extension with a shallow pitched roof extending up to the original ridge (Plate 4), and a series of three extensions to the northwest.
- 5.2.2 The extensions to the northwest comprised a single storey entrance porch and dining area with a two-pitched roof, and bathroom with a separate, lower two pitched roof. A storage area was present at the end of this series of extensions.
