Belle Green Court Care Home, Cudworth

Bat Survey Report

24th January 2024

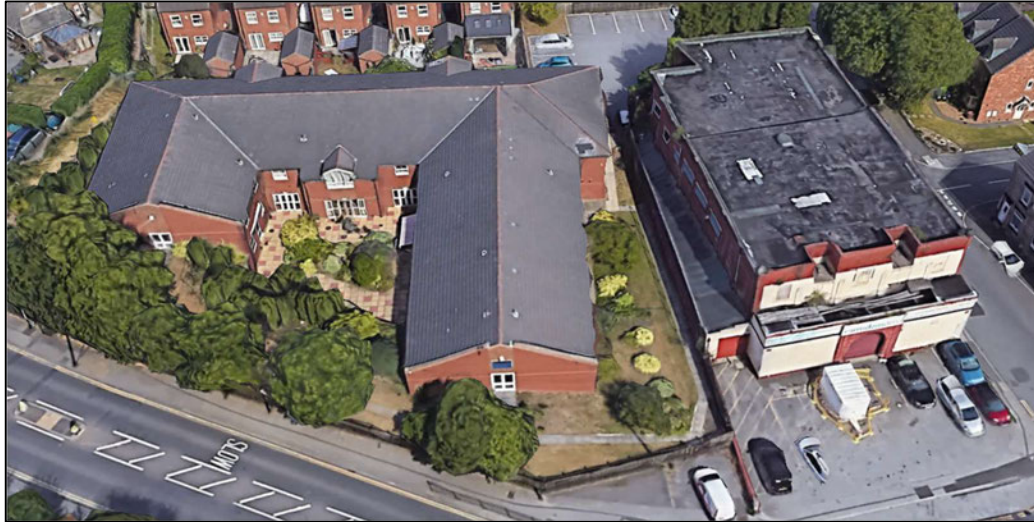
Plate 1. Google Earth birds eye view of the care home (left) and cinema (right) viewed from the west

- 5.2.6 The care home was a brick-built building with a multi-pitched roof. The building was built in a 'J' shape with a hipped roof at the southeast, and northeast corners and gables present at the two western ends (Plate 1). The gables had a small parapet covering most of the end of the roof with a gap at the apex where the mortared verge could be seen (Plate 2). The roof was covered with interlocking concrete tiles. Valleys were lined with lead. Soffit boxes were present, they included a ventilation strip along the outer edge of the base which was lined with insect mesh.
