## Tree

| Tag Number: | T3 |
| Common Name: | Lombardy poplar |

| Location | |
|---|---|
| Address: | 51 High Street |

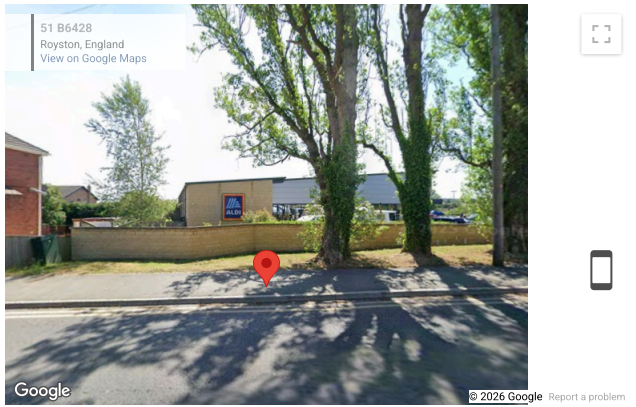
## Street View

| Structural Condition: | Poor |

| Observations | |
|---|---|
| Root Comments: | Sounding suggested significant decay to buttress root closest to pavementLikely from Aldi carpark construction and wall approx 3m from edge of stem |

| Tree Comments: | Recommend Felling and Stump Grinding due to poor condition of tree crown and roots and its co-dominant neighbours, resulting in high exposure if some trees are removed and not others, combined with extremely high target high street location between busy public highway and supermarket carpark and in falling distance of housing, telegraph lines, street lighting, carpark and store. |
