# ARBORICULTURAL REPORT & Impact Assessment to BS 5837:2012 at:

*Land off Lee Lane,  
Royston,  
Mapplewell,  
Barnsley  
S71 4RT*

Report Date: *January 2026*

Reference: *AWA7126*

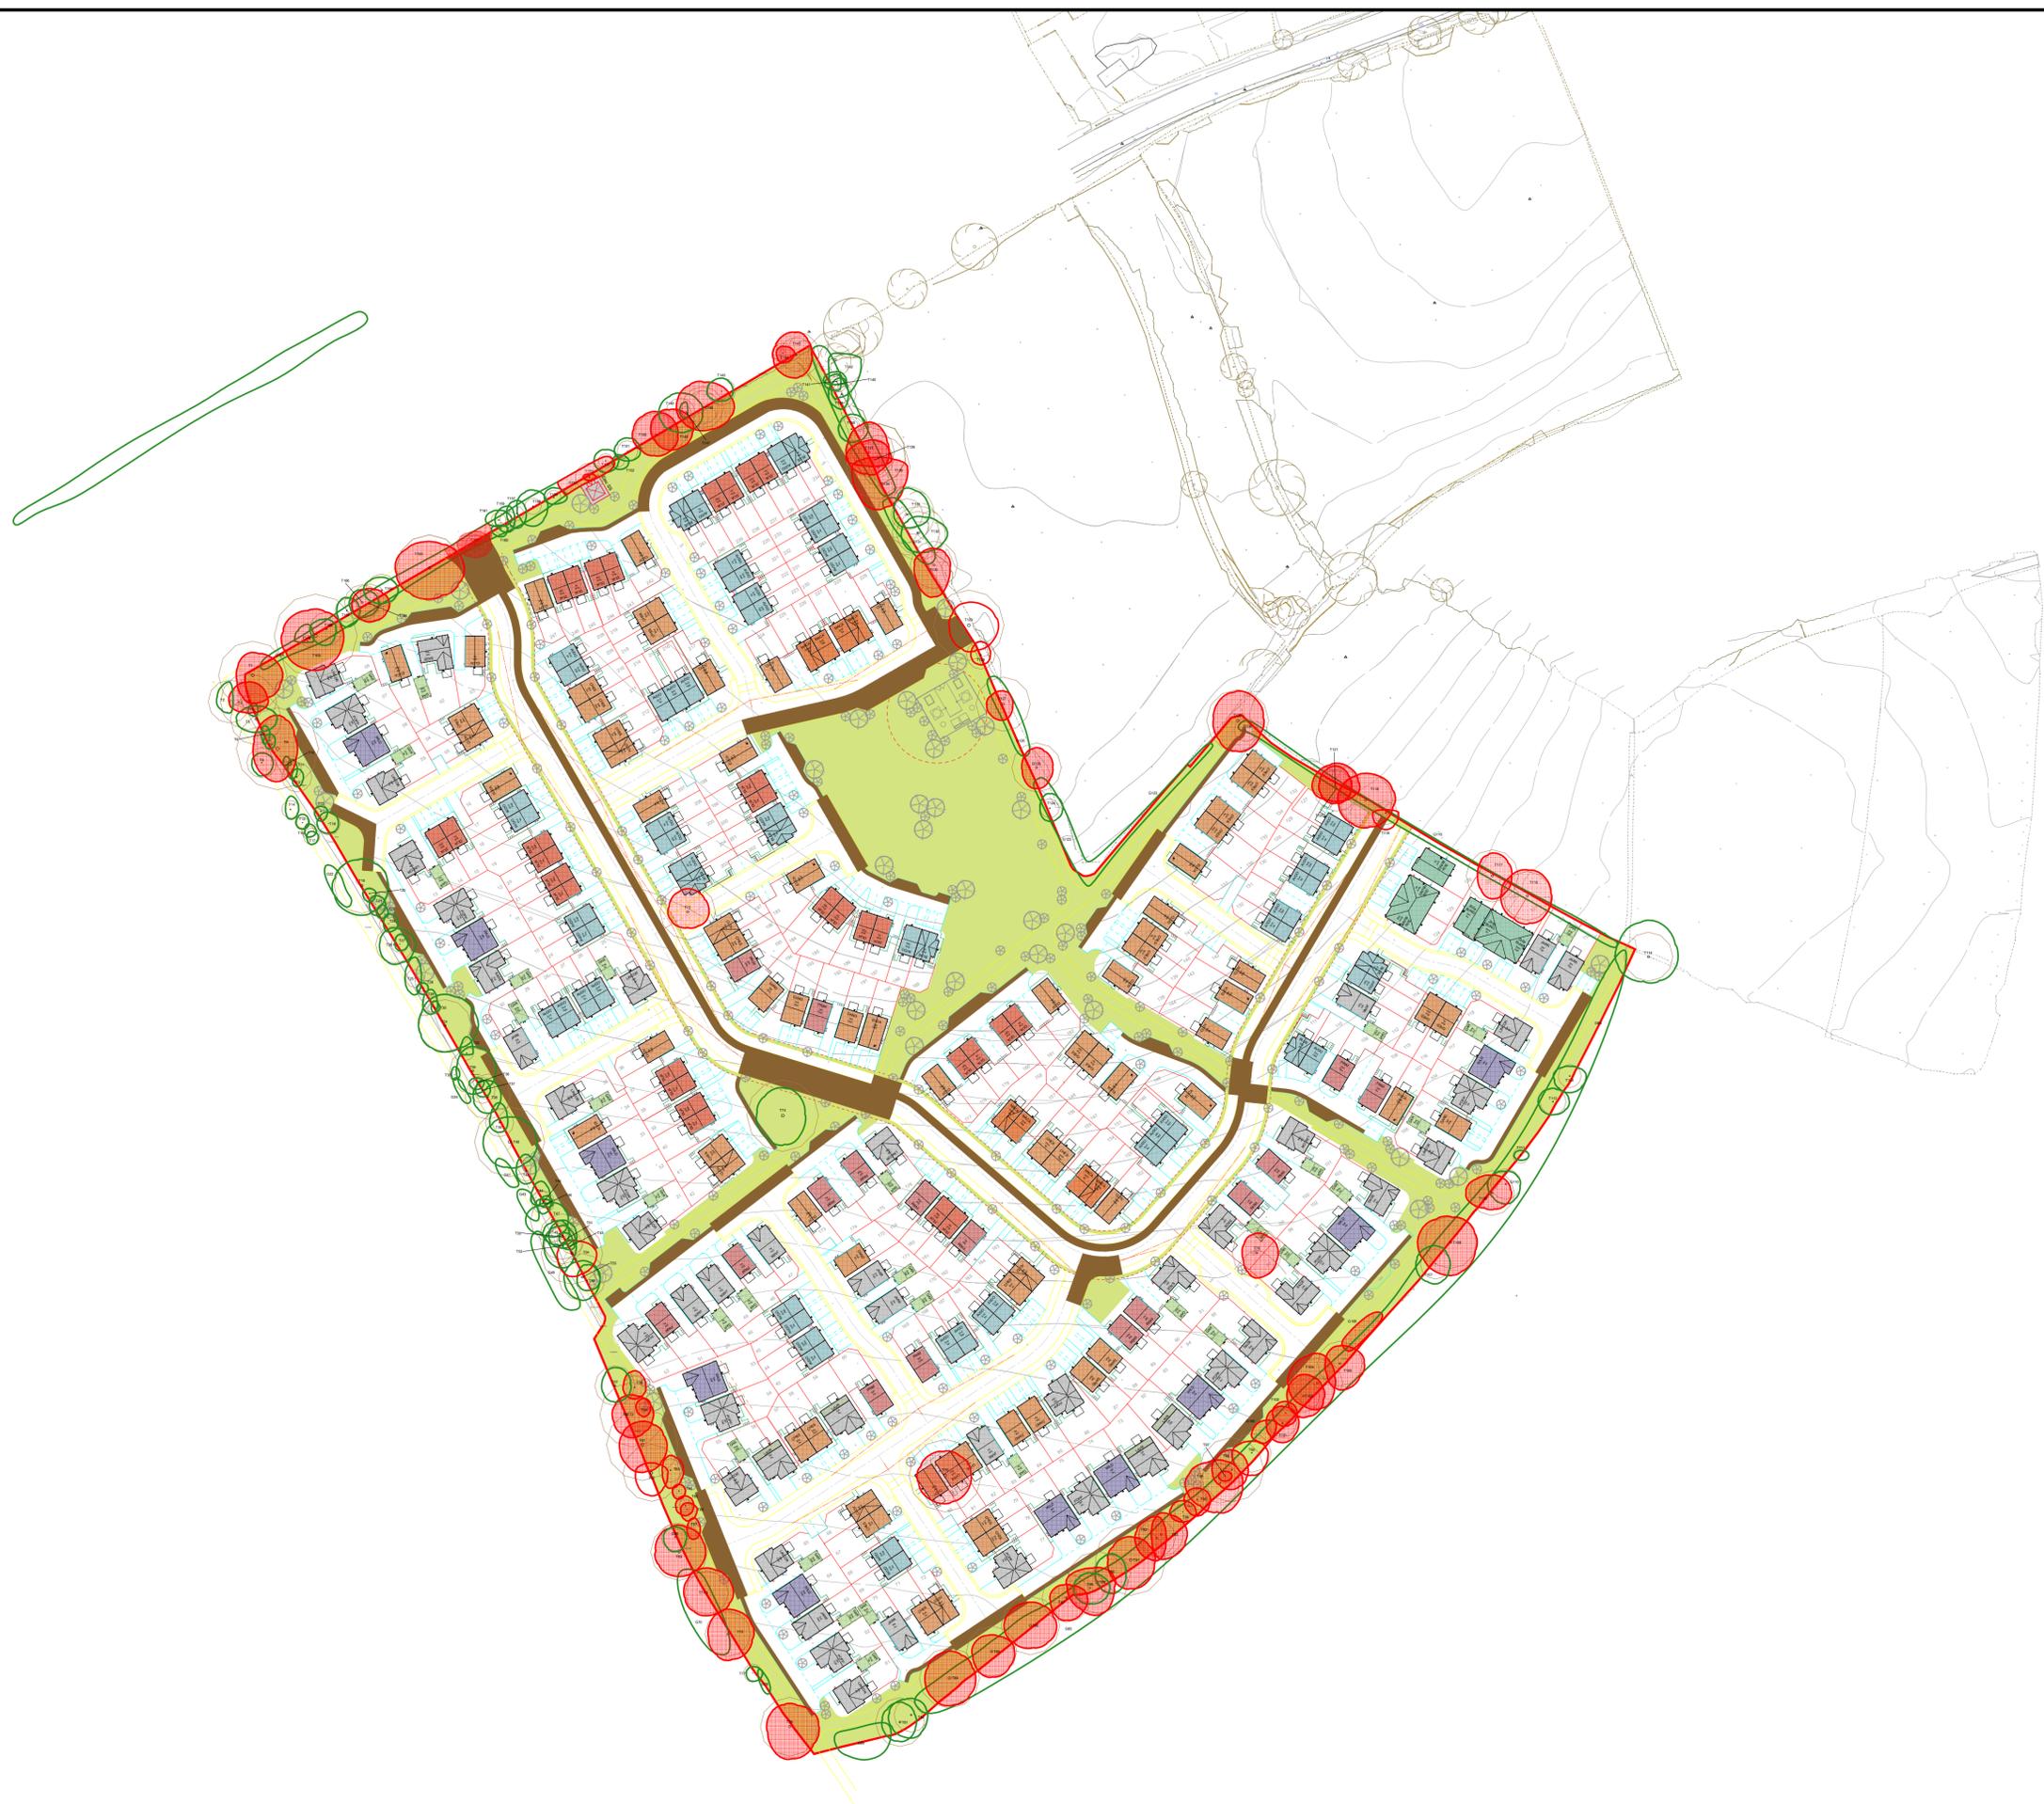
**Appendix 6:  
Tree Impacts Plan**

The proposed development will require the removal of 31 low value trees, 2 low value groups and part of 1 hedge. 8 high and 22 moderate value trees are also proposed for removal. This will result in a major negative arboricultural impact.

The layout of the development has been designed to minimise encroachment into Root Protection Areas (RPAs), with only minor incursions into a trees' RPAs, which are not expected to significantly affect tree health. Mitigation measures, including protective fencing and 'no-dig' construction methods, are recommended where necessary.
