# BS 5837: 2012 Arboricultural Survey & Impact Assessment

Site Address:	103 High Street, Penistone, S36 6BR	Client:	John Mahoney
Report Ref:	HSP01-24	Report Date & Revision:	12th March 2024 1
Author:	Laurence Smith BSc (Hons) Arb, M Arbor A	Signed:	<i>Laurence Smith</i>

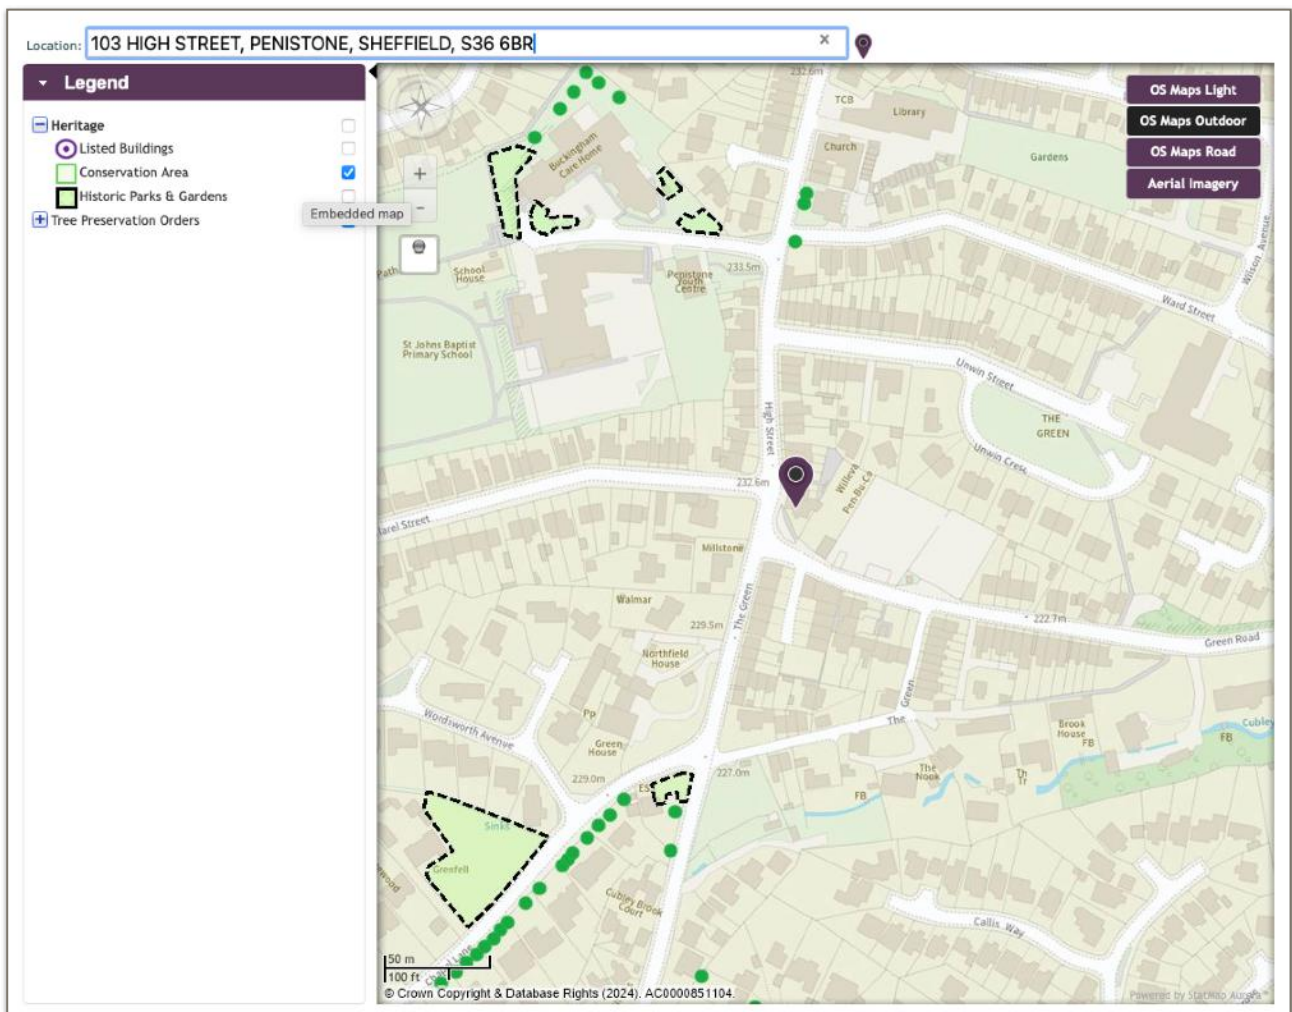
**Screenshot 1.** An image lifted from the Barnsley Council website visited on the 12th of March 2024 showing the site (purple arrow) with no Tree Preservation Order designations within 15m of the site boundary.
