**Carlton Road**

**Barnsley**

**– BS 5837 (2012) Tree Survey**

Report Title: **Carlton Road, Barnsley  
BS 5837 (2012) Tree Survey**

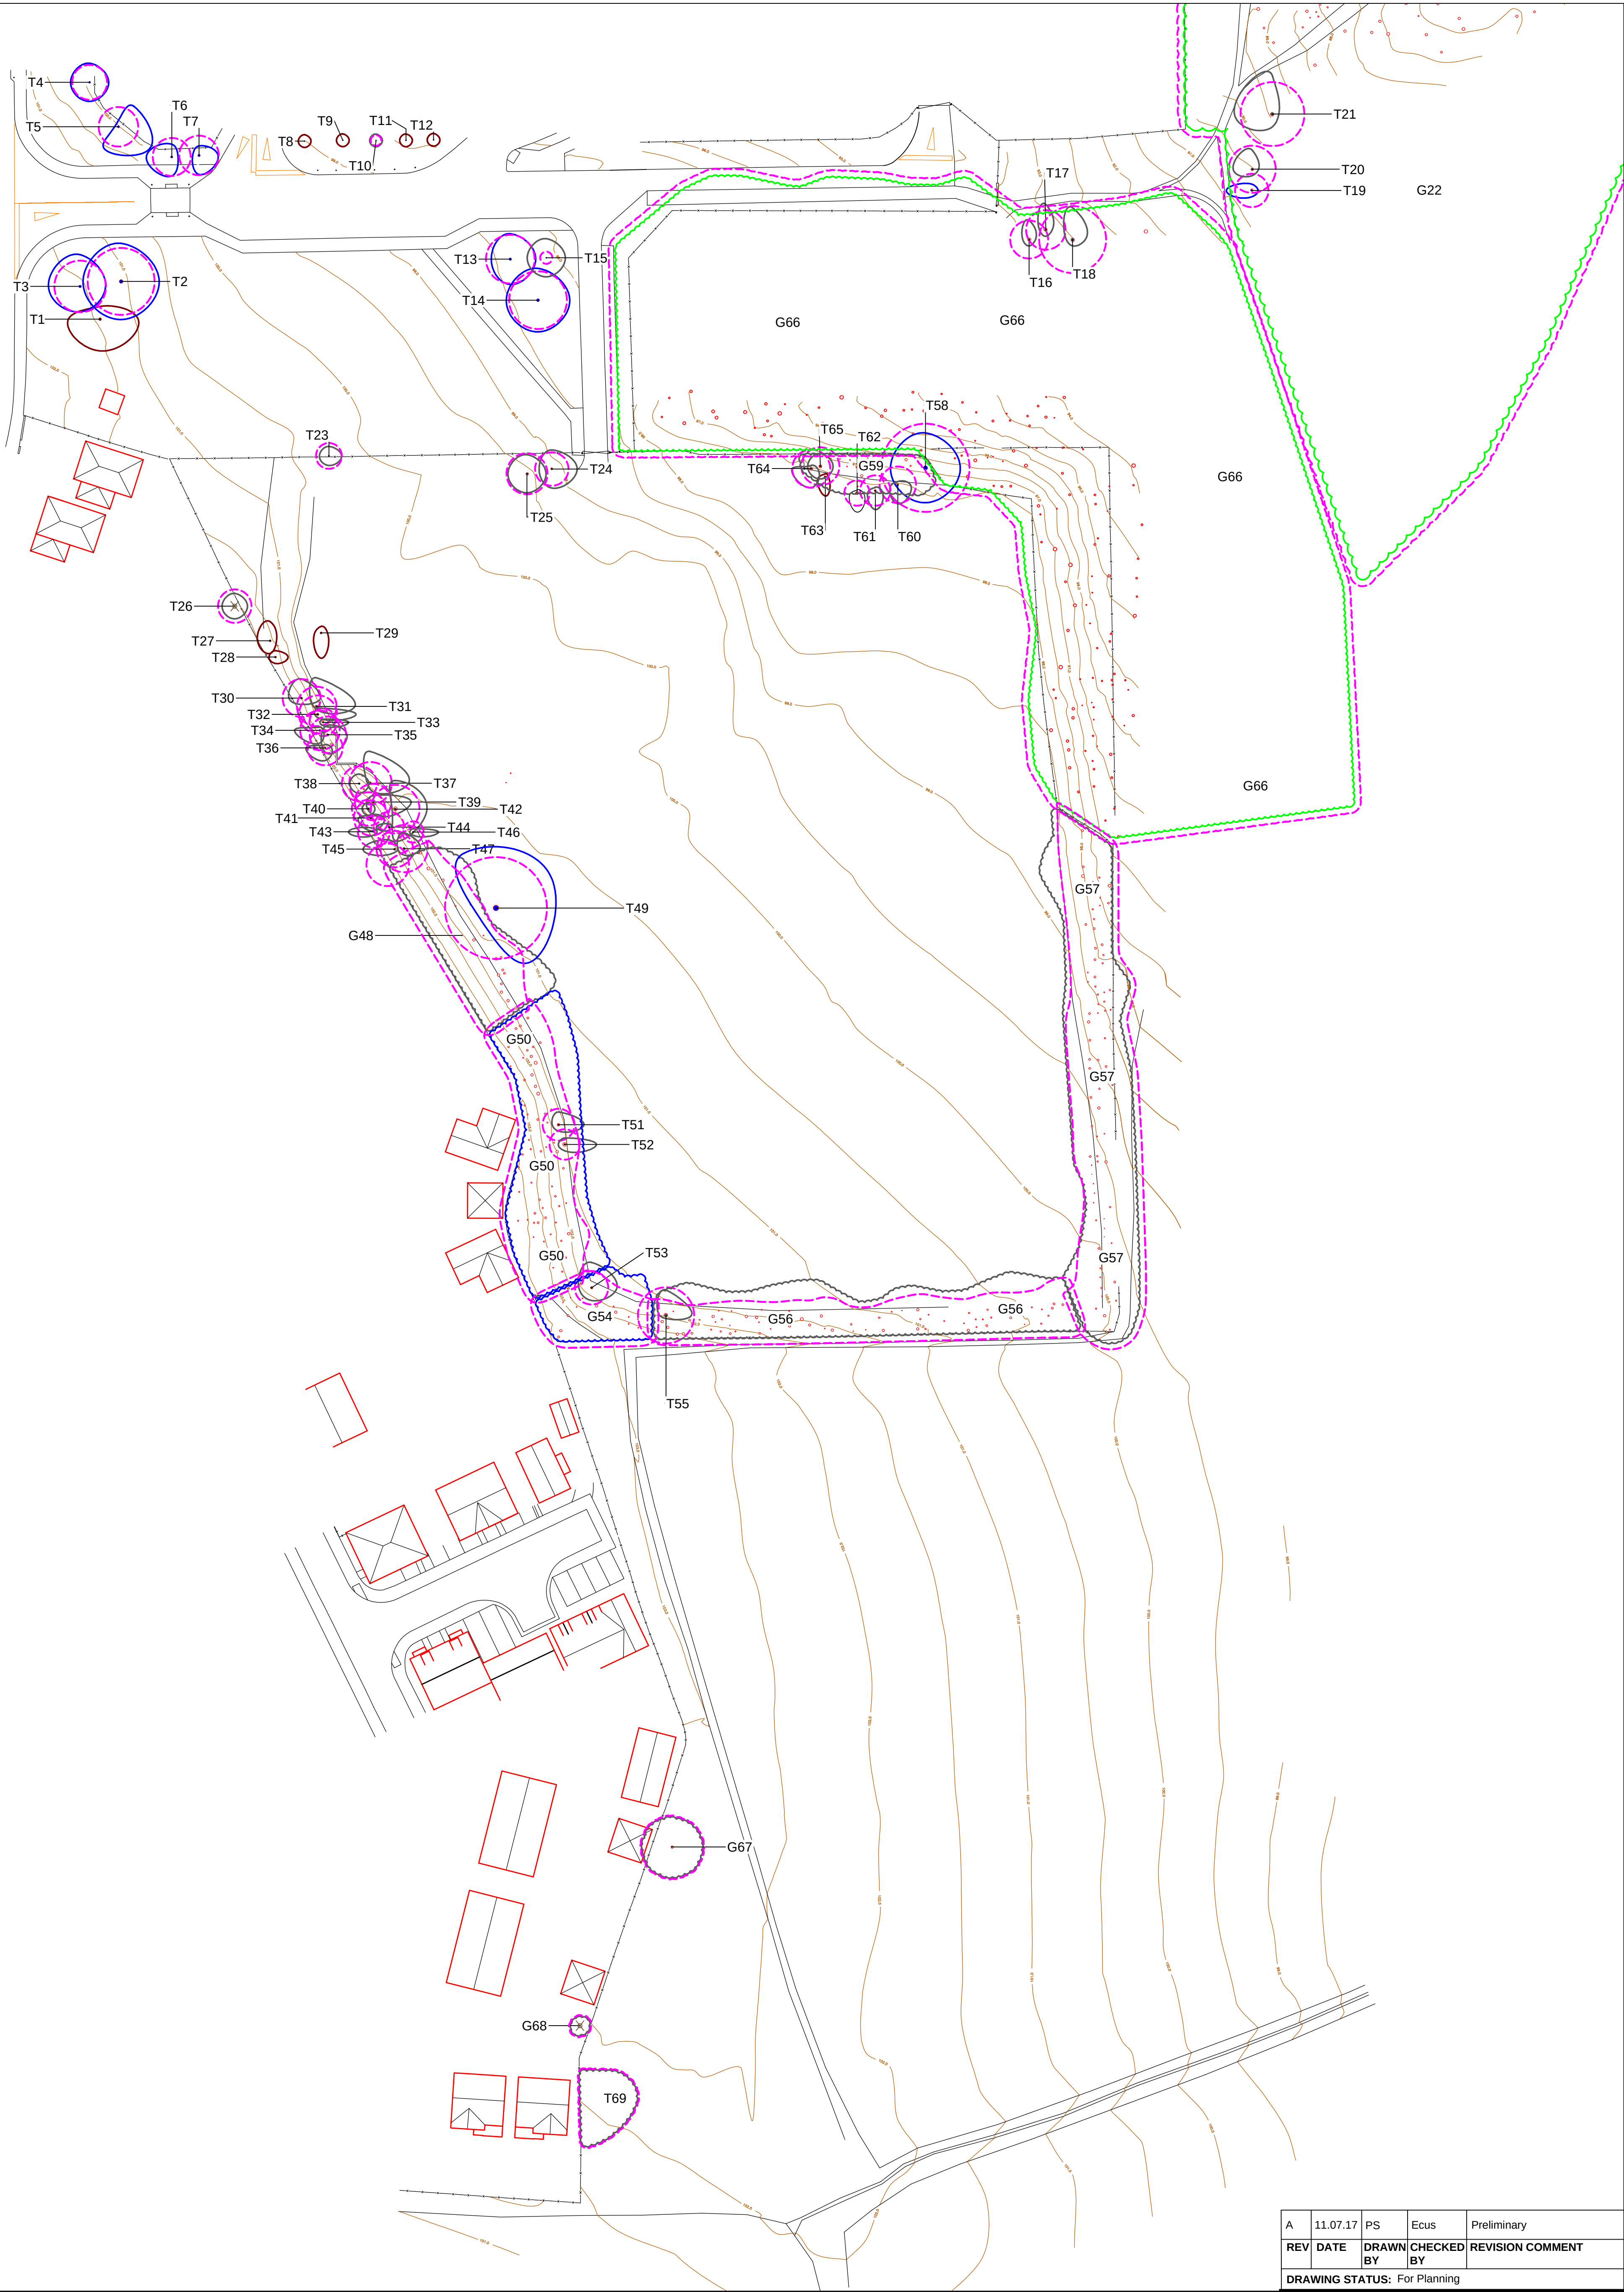
## **Appendix 3 – Tree Survey and Tree Constraints Plan**

- 3.3.1 The Tree Survey Schedule in Table 1, Appendix 1 describes the results of the tree survey and includes preliminary management recommendations. The table should be read in conjunction with Figure 2 Tree Survey and Tree Constraints Plan. This drawing illustrates the location of the trees surveyed, the extent of their canopies as well as the Root Protection Areas (RPA) of each tree and tree group.
- 3.3.2 Ten tree groups and 59 individual trees have been recorded during the survey. A full
