PEAR TREE FARM

BRIERLEY, BARNSELY

Preliminary Bat Roost Assessment

August 2016

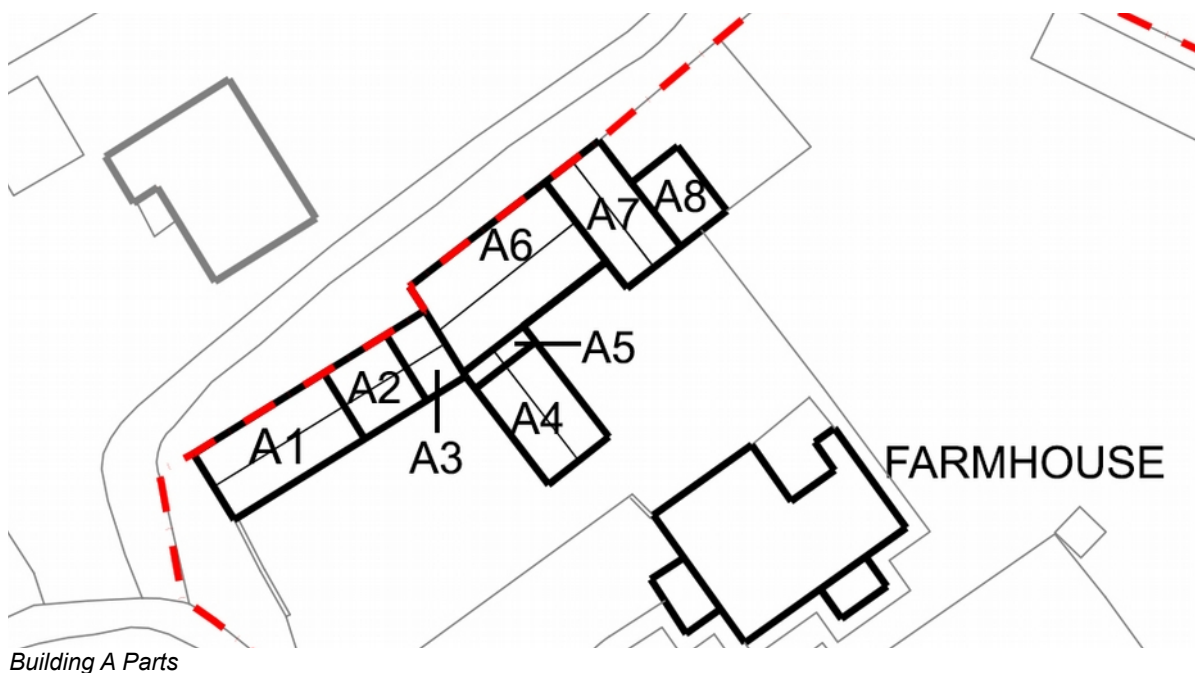
A1, A2 and A3

This is a single storey stone and brick built barn and is split into 3 sections by solid internal walls. The windows and doors are well sealed on A1 and A2. The door to A3 is loosely fitted. The stone, brickwork and pointing are generally in a good condition.

All have a corrugated cement sheet roof featuring a continuous vent along the length of the ridge and potential access points beneath the sheeting. One broken roof sheet was found on the north side of A1 allowing bats to potentially access the interior of the barn.

The internal inspection found there was not a separate roof void, no insulation or lining and a timber roof structure.

On closer inspection very few suitable roosting locations were found and no direct evidence such as droppings, feeding remains, stains or scratching was seen. No squeaking or chattering was recorded.
