Bat Survey to  
Burntwood Hall Farm  
Brierley Common

Barnsley  
S72 9HB

# 1. Summary

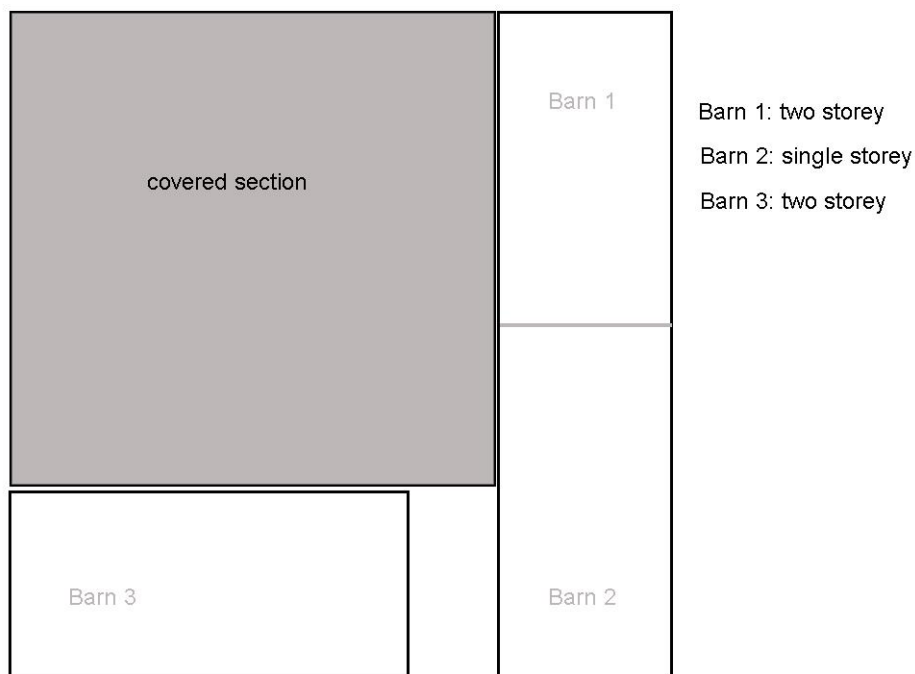
Figure 1: Layout of the site

**Barn 1:** This barn is a two storey building adjoining an existing residential dwelling. The walls are stone and are very well pointed and do not have gaps or cavities. All walls have been extensively repointed and all verges sealed and the single gable has stone capping which appears well bedded. The roof is sound and has been modified and recovered at some stage and the original York stone tiles have been replaced with a thin, cement fibre tile. Internally, the roof is unlined and the tile structure can be easily seen to be a criss-crossed diamond effect that has no gaps or cavities the would enable bats to roost or entre the barn via the roof. The ridges appear sound and have a heavy build-up of dust webs and dirt and do not show signs of bats. The floor in this section is very clean and inspection did not reveal any droppings or scattered prey remains. There are some stored good that have clearly not been moved in a good while and these did not show any signs of droppings. Both internal walls were inspected for

droppings that may have adhered to the stonework but none were found. There did not appear to be any evidence of bats using this section of the barn and the building is considered to be of **negligible** interest to bats.

**Barn 2:** A single storey extension to barn 1 and again, the building has been extensively renovated and repointed resulting in no external cracks or cavities that may be of interest to bats. The roof has also been replaced with Marley tiles and does not have cavities. The ridges are sound apart from one small section that has some pointing missing and the single gable wall has sound heavy stone capping. Internally the roof is lined with traditional hessian and bitumen felt which is sound and has no light ingress. The ridges show a big build-up of cobwebs and do not show signs of bats using the ridges. There was no evidence internally of bats using the building with no droppings to be found on the stored goods. There are no fascia or soffits that would offer potential roosting sites and the dry verge is sound. Overall, the building is considered to be of **low-negligible** interest to bats.

**Barn 3:** This is a large two storey stone barn which is one big open space internally having no first floor. The roof has been replaced with a Marley tile which has a tight interlocking pattern and has no access gaps. Internal inspection shows the roof to be lined with traditional felt and in a good condition with no light ingress from the ridges. Although the ridge section is clean internally, there was no evidence to suggest use by bats. There were no droppings adhered to the internal gable walls and no droppings on the large wheat drying device installed inside the barn. The barn has several windows and is therefore subject to a good deal of daylight which would discourage the use by some species of void dwelling bats. All walls have been extensively repointed both internally and externally and all dry verges are sound and very well cemented. There are no fascia or soffits that would allow access to the wall tops and internally, the walls tops have all been heavily cemented to the underside of the roof tiles so it is unlikely there are suitable areas for bats. All windows and doors are wooden but well sealed into the openings. The building is considered to be of **low-negligible** roost potential.

The two ranges of barns are connected by a large covered area at the rear which has a roof of cement fibre sheeting on top of a steel roofing frame. This roof is considered to be totally unsuited to use by bats.
