**WENTWORTH CASTLE, STAINBOROUGH, BARNSELEY:  
PROPOSED REPAIR OF STRUCTURE AND CEILING AT  
EAST END OF SOUTH ('PALLADIAN') WING**

**LISTED BUILDING STATEMENT (as submitted December 2011)**

This Statement has subsequently been superseded with regard to the extent of the defective structure revealed in March 2012 when the cracked ceiling was demolished and the floor structure fully examined from below.

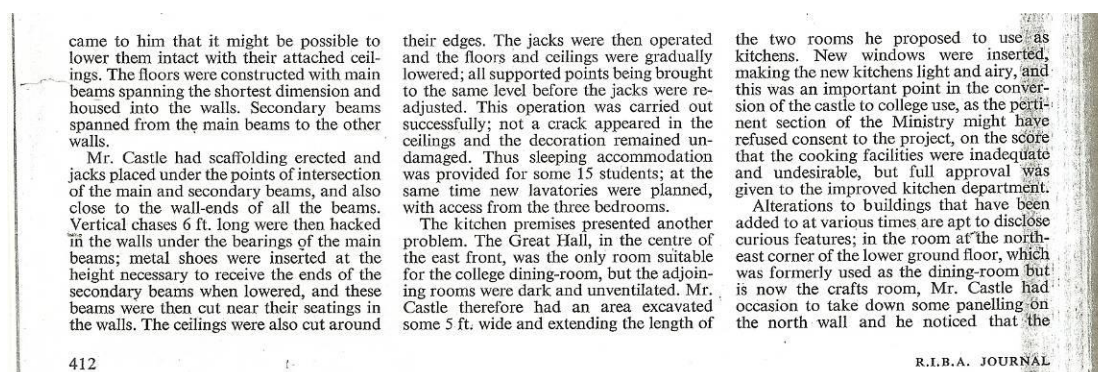
- 1.3 In 1950 when Barnsley Corporation had acquired the building it was in poor condition. The building was repaired and converted to be used as a teacher training college. The ceilings of the four first floor rooms at the east of the south range were lowered by approximately 1450mm to give better headroom at second floor level and to put the second floor windows into a better relationship with the floor. Shown below is an excerpt of text from an article in the RIBA Journal of September 1950 which described this building alteration, a copy of the article is at **Appendix H** of the supporting documents.

2 Extract from RIBA Journal Sept 1950

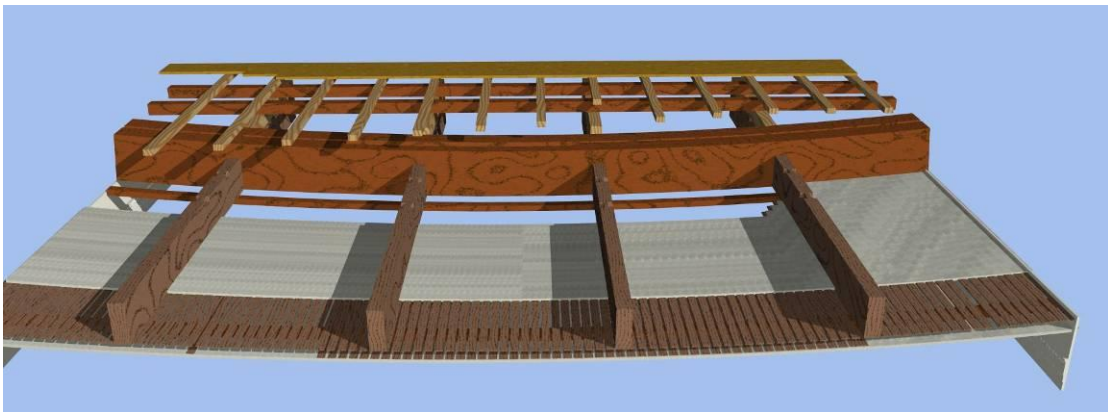
**4** *Model of the floor structure from above*

The structure of the floor is as follows and as shown on the following drawings. Two large oak principal beams span from north to south. These beams approximately 400mm square support oak secondary beams approximately 275mm x 100mm at approximately 1500mm centres. The secondary beams are morticed into the principal beams. The secondary beams support light ceiling joists approximately 100mm square at approximately 450mm centres. All these members are oak and appear to be original. The floor joists bear on the secondary beams. It is apparent that work was done in 1950 to level the floor. This was necessary since the original structure shows considerable deflection – as much as 225mm.

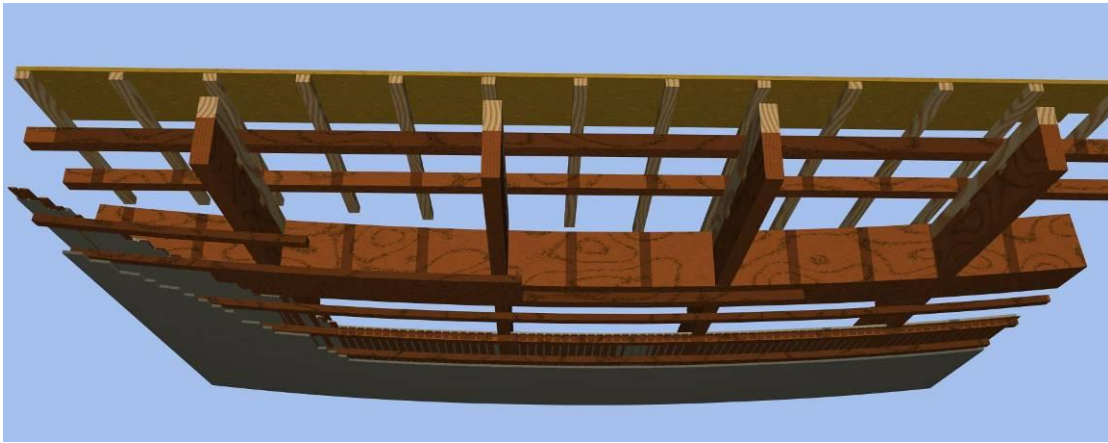
**5** *Model of the floor structure from below*

Modern softwood firing pieces have been provided on top of the secondary beams. The floor joists bear on these and have been wedged level. It would appear that some of the joists are original whilst others are modern softwood. The secondary beams are notched and it appears that these mortices originally received the ends of the floor joists. It would appear that the original floorboards finished flush with the top surface of the principal beams as would have been normal practice in the mid-eighteenth century.

An additional tier of structure has been added, seemingly in the 1950 alteration; 75mm wide x 50mm deep softwood joists span east west and support a floor of narrow north American hardwood boards.

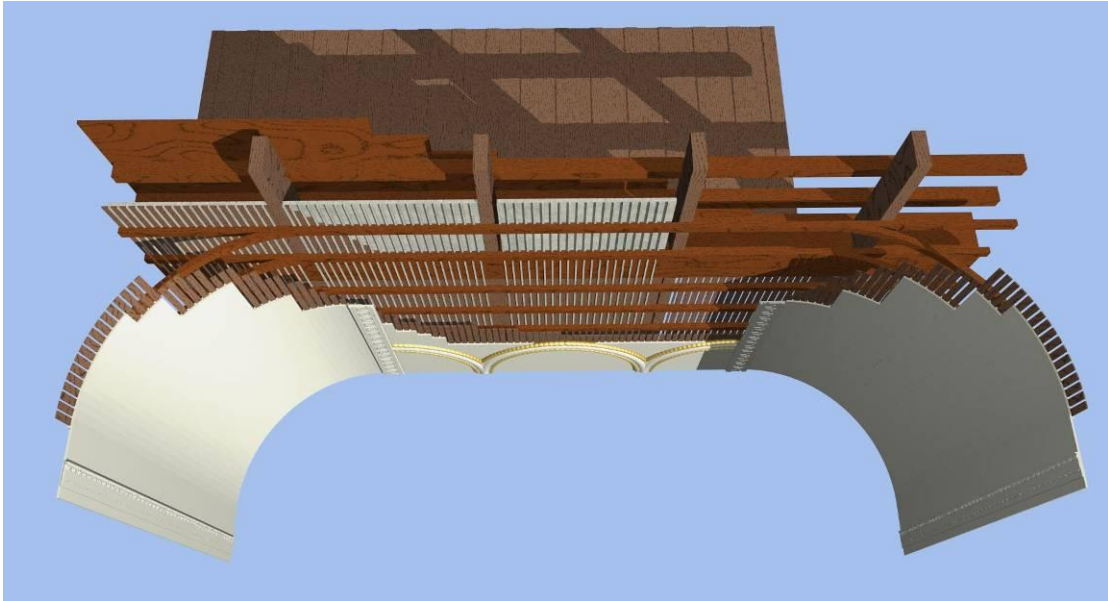
**10** *Conjectured original construction.*

The central panel, enclosed by an enriched band decorated and probably painted in a similar manner to the ceiling shown on photo 11. A large radiused cove or vault extending towards the frieze. At second floor level there was probably a stud partition on the line of the principal beam – evidenced by the slot mortice that is present in the top of both beams.

The central decorative plaster was probably lost when the beam was repaired and made good in the 19<sup>th</sup> C with less expensive work. The 'cornice' was probably lost in 1950 when the ceiling was lowered. The frieze remains intact.

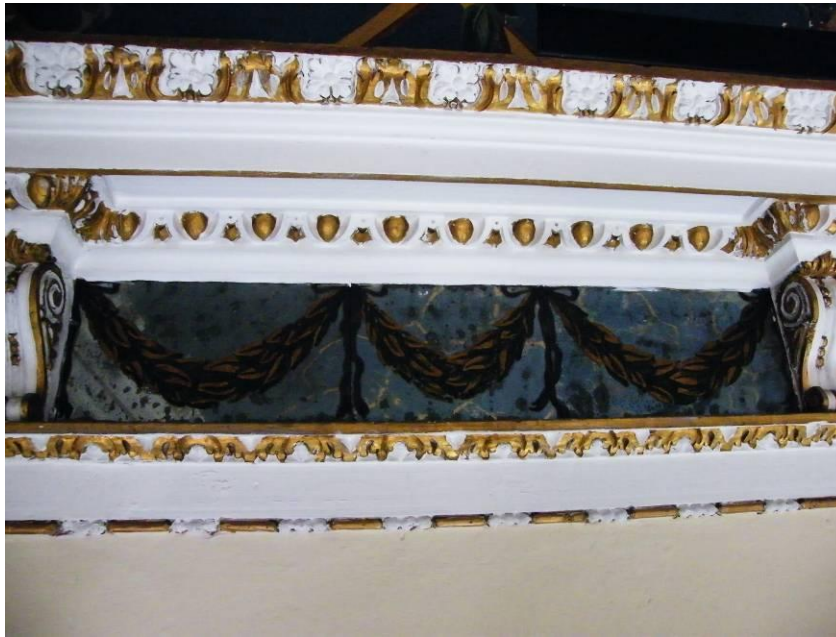
**23** Existing cornice and frieze in the Aviary Room of the South Palladian Wing

**22** Indicative design for a cornice with hand painted panels above the existing frieze inspired by the existing in the Aviary room as shown below
