**Residential & Commercial Development
Land at Midland Road, Royston**

Existing Highway Condition Survey

**For
Kier Property Developments Limited
&
Persimmon Homes West Yorkshire**

Report Ref	Issue	Prepared by	Reviewed by	Date
11120	2	J Mitchell	A Liddell	August 2013

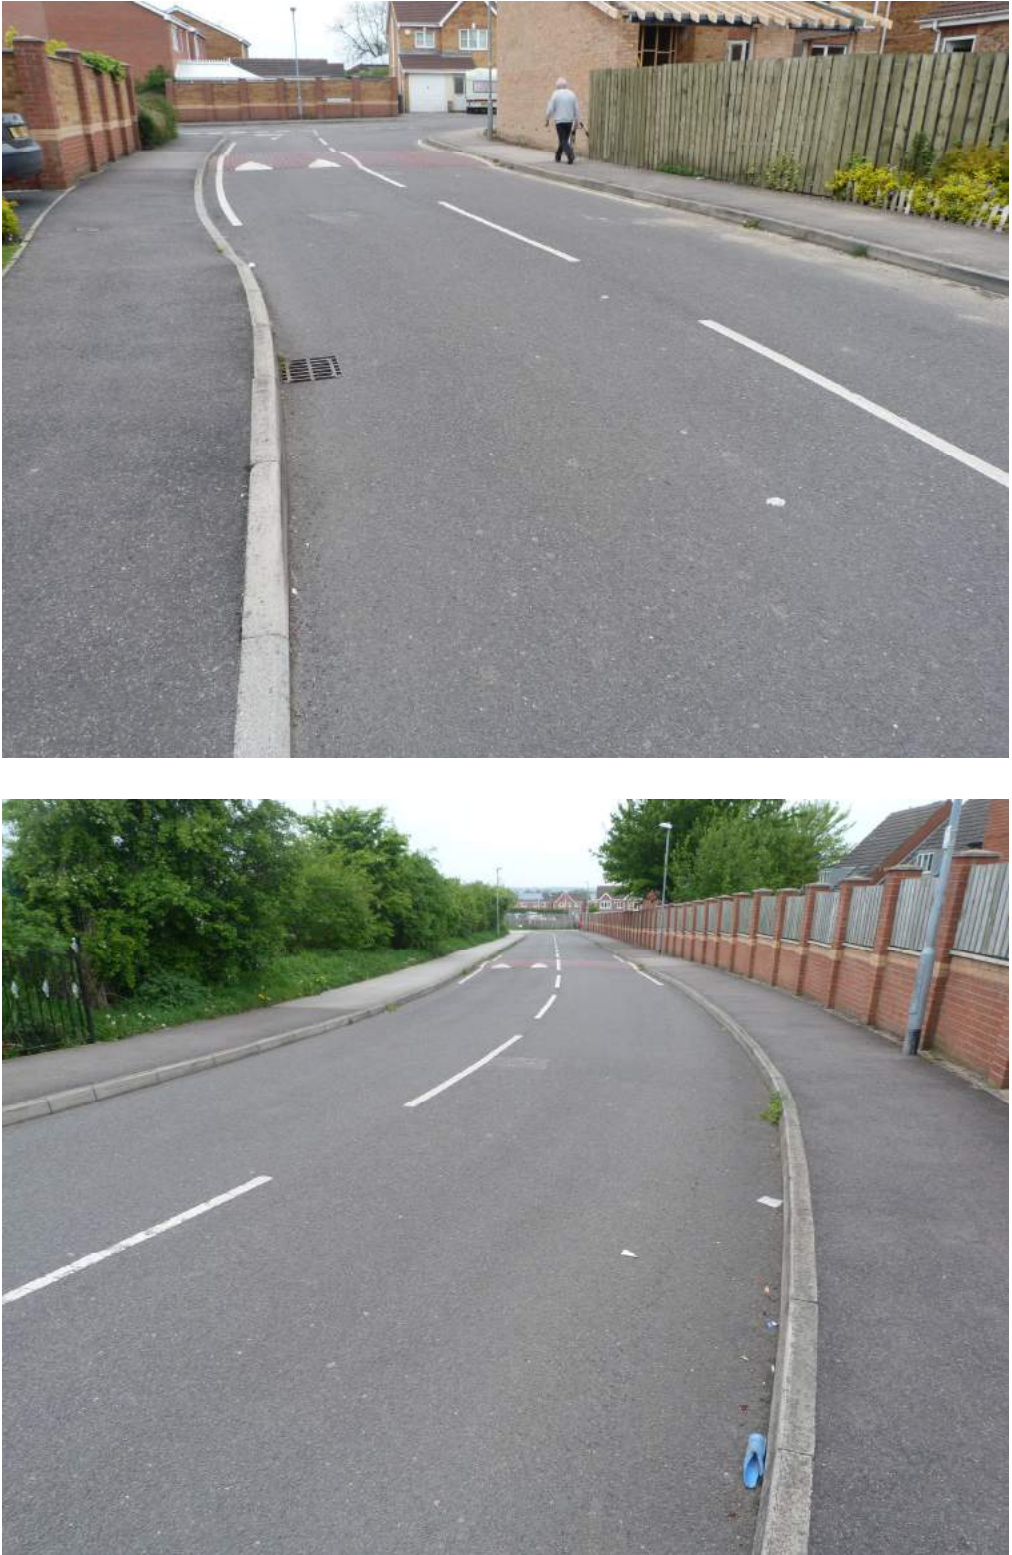
<p>Sunken manhole cover and frame located at the junction of Galway Close and Ruston Drive.</p> <p>No other defects noted. Carriageway in good condition overall.</p>
Footway/verge	Minor surface cracking to rear of footway on LHS adjacent red imprint detail.
Kerbs & edgins	Kerbing & edgings in good condition throughout.
Covers, gratings and stats boxes	All gullies on RHS of carriageway require jet vac to remove silt and debris. All gullies to LHS of carriageway in good working order.
Road markings	All road markings are in reasonable condition. Red imprint in good condition.
Other	None.

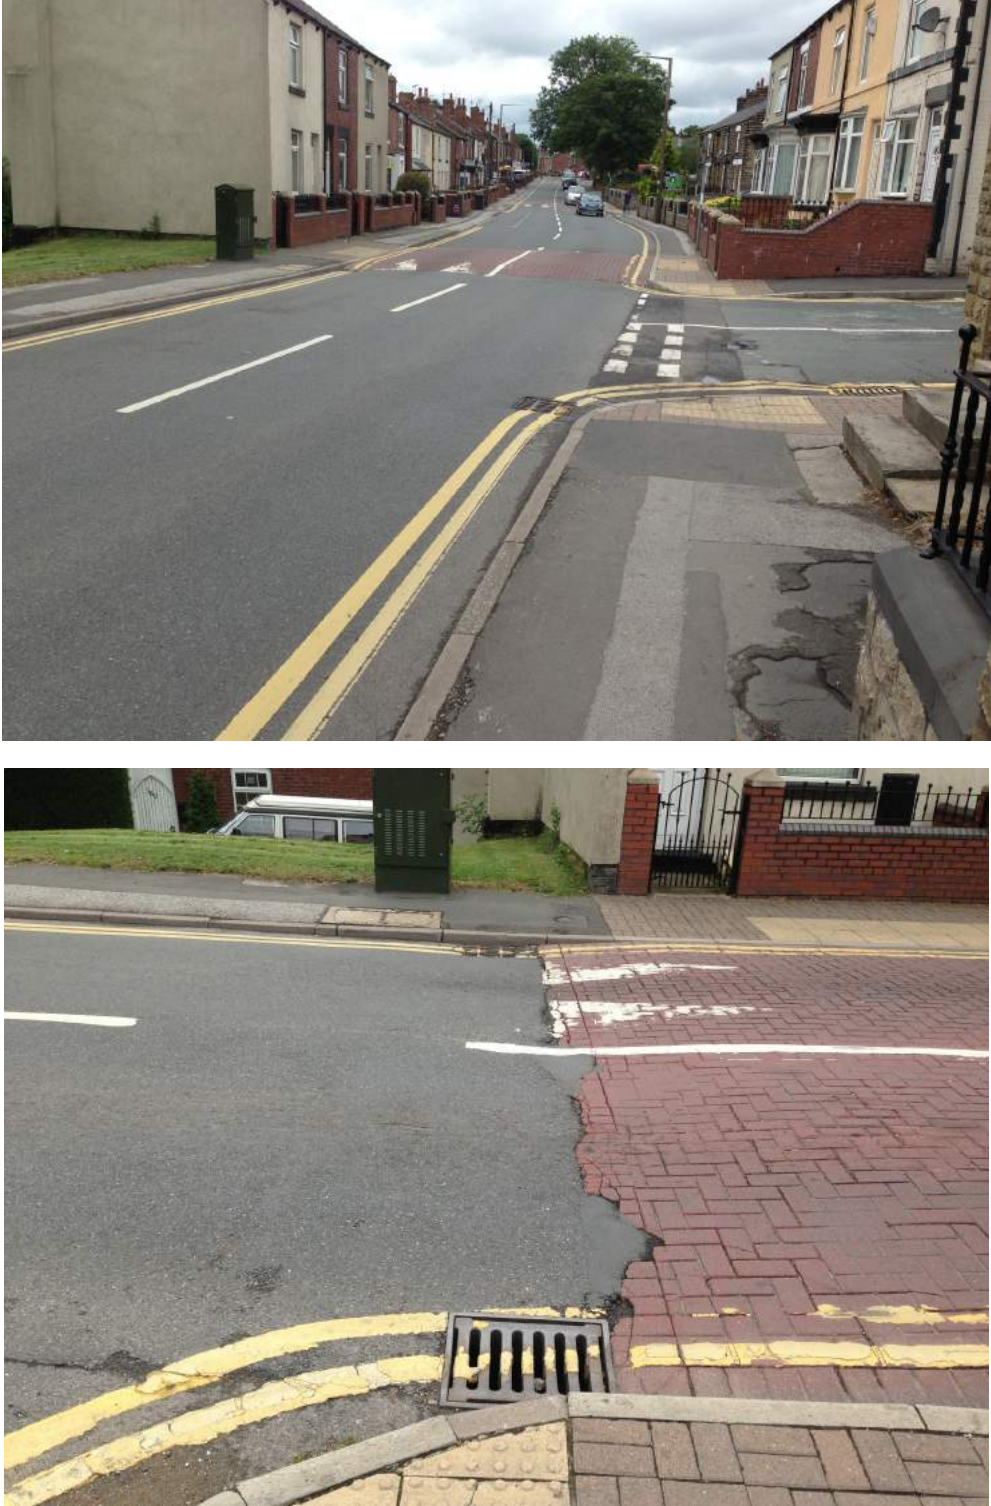
Inspection Items	Defects Identified
Carriageway	<p data-bbox="437 360 1485 432">An additional photo survey was undertaken on the 31st July 2013. A selection of the site photo's showing the existing carriageway defects are presented below:</p>
