Oak Tree Development  
Wath Road, Elsecar  
Project Address

Sheet Name: Ambulance Store Schedule

Drawing No: H4005-BOW-ZZ-ZZ-ZZ-A-0006

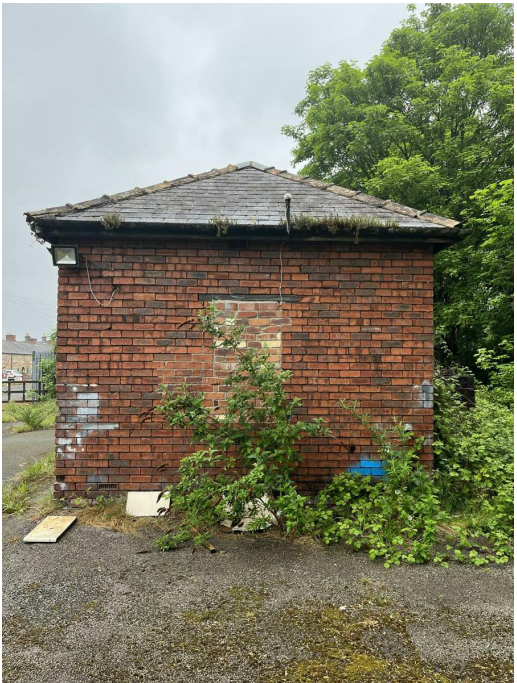
2) Side elevation A - Existing

Condition: Overall satisfactory, discolouration with age and minor cracking. Some sections of brick(s) absent with damage occurred due to alterations such as the sill &/or general wear and tear. Mortar condition is weathered extensively in areas with a large number of open joints especially to front elevation.

-Brickwork to be retained unless stated, such as individual bricks.  
-Brickwork to be cleaned, including extensive graffiti removal, and joint brushed to remove debris and review condition.  
-Mortar to be carefully raked out by hand and repointed with a lime mortar, allow for a raked or recessed joint, depth to match joint to clear brick edge shape. Colour to match existing (dark grey).

Repair / Replace brickwork: Carefully remove bricks in location indicated.

A1 Sections &/or individual brickwork to be replaced.  
A2 Gas valves to be carefully disconnected, capped and removed. Once removed, wall to rear made good.
