Project Name: High Street Royston D39325
Project Description: CCTV Survey
Project Number: D39325
Project Status: Complete
Project Date: 13/03/2026
Inspection Standard: MSCC5 Sewers & Drainage GB (SRM5 Scoring)

Section Inspection - 01/12/2025 - MH1X

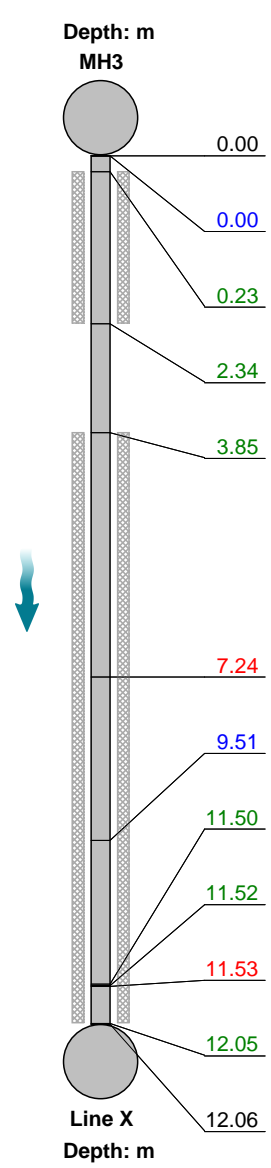
<table><tr> <td style="text-align: right;">0.00</td> <td>MH</td> <td>Start node, manhole, reference: MH3</td> <td>00:00:00</td> <td></td> <td></td> </tr><tr> <td style="text-align: right;">7.24</td> <td>FC</td> <td>Fracture, circumferential from 3 o'clock to 9 o'clock</td> <td>00:00:24</td> <td>MH3X_3a 311c70-73 28-4fe9-a9</td> <td>3 / 2</td> </tr></table>
