**PROPERTY ADDRESS:** 25 & 27 Millhouses Street, Hoyland, Barnsley S74 9BQ

**REPORT TYPE:** Asbestos Refurbishment/Demolition Survey

**REPORT NUMBER:** B-21809

**REPORT DATE:** 25/07/2024

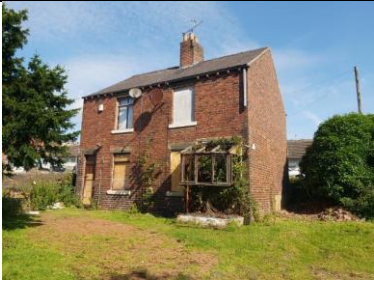
| 25 & 27 Millhouses Street, Hoyland, Barnsley S74 9BQ | | | | |
|---|---|---|---|---|
| External | R001 | External | Rainwater goods: Plastic / No Suspect Material<br>Roof: Slate / No Suspect Material<br>Walls: Brick / No Suspect Material<br>Window & Doors: Timber / No Suspect Material | |

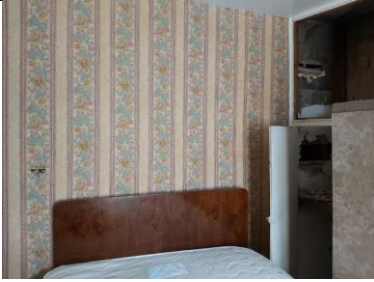
| 25 & 27 Millhouses Street, Hoyland, Barnsley S74 9BQ | | | | |
|---|---|---|---|---|
| 1st Floor | R002 | Bedroom | Ceiling void: Lath and plaster ceiling / No Suspect Material<br>Doors: Timber / No Suspect Material<br>Floor: Carpet / No Suspect Material<br>Walls: Plastered masonry and lath and plaster partitions / No Suspect Material | |

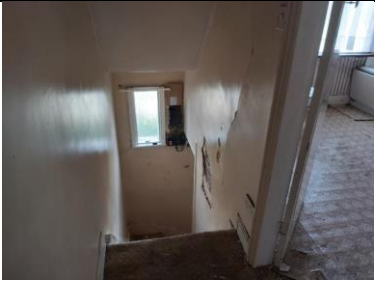
| 1st Floor | R003 | Landing | Ceiling void: Lath and plaster ceiling / No Suspect Material<br>Doors: Timber / No Suspect Material<br>Electrics / No Suspect Material<br>Floor: Carpet / No Suspect Material<br>Walls: Plastered masonry and lath and plaster partitions / No Suspect Material | |

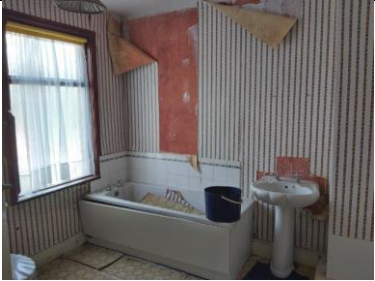
| 1st Floor | R004 | Bathroom | Ceiling void: Lath and plaster ceiling / No Suspect Material<br>Doors: Timber / No Suspect Material<br>Floor void / No Suspect Material<br>Floor: Carpet / No Suspect Material<br>Sanitaryware / No Suspect Material<br>Walls: Plastered masonry and lath and plaster partitions / No Suspect Material | |

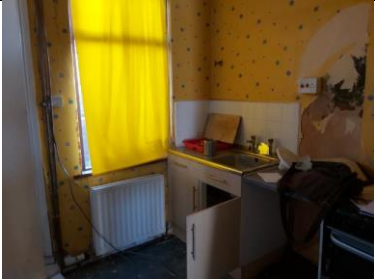
| Ground Floor | R005 | Kitchen | <p>Ceiling void: Lath and plaster ceiling / No Suspect Material</p> <p>Doors: Timber / No Suspect Material</p> <p>Floor: Carpet / No Suspect Material</p> <p>Modern sink / No Suspect Material</p> <p>Walls: Plastered masonry / No Suspect Material</p> <p>Walls: Plastered masonry and lath and plaster partitions / No Suspect Material</p> | |

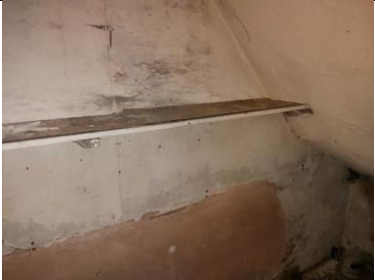
| Ground Floor | R006 | Pantry | <p>Ceiling void: Lath and plaster ceiling / No Suspect Material</p> <p>Door: Timber / No Suspect Material</p> <p>Doors: Timber / No Suspect Material</p> <p>Floor: Carpet / No Suspect Material</p> <p>Walls: Plastered masonry / No Suspect Material</p> <p>Walls: Plastered masonry and lath and plaster partitions / No Suspect Material</p> | |

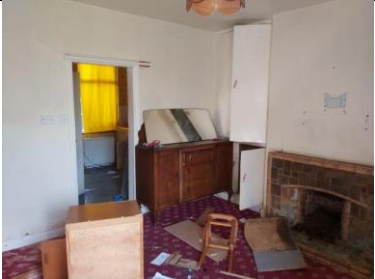
| Ground Floor | R007 | Living room | Ceiling void: Lath and plaster ceiling / No Suspect Material<br>Chimney / No Suspect Material<br>Door: Timber / No Suspect Material<br>Floor: Carpet on concrete / No Suspect Material<br>Walls: Plastered masonry / No Suspect Material | |

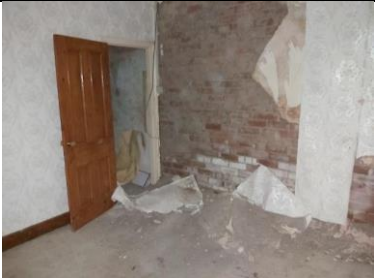
| 1st Floor | R008 | Bedroom | Ceiling void: Lath and plaster ceiling / No Suspect Material<br>Doors: Timber / No Suspect Material<br>Floor void / No Suspect Material<br>Floor: Carpet on timber / No Suspect Material<br>Walls: Plastered masonry and lath and plaster partitions / No Suspect Material | |

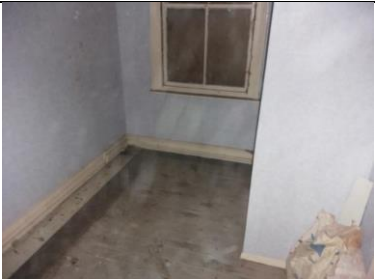
| 1st Floor | R009 | Bedroom | Ceiling void: Lath and plaster ceiling / No Suspect Material<br>Doors: Timber / No Suspect Material<br>Floor void / No Suspect Material<br>Floor: Timber / No Suspect Material<br>Walls: Plastered masonry and lath and plaster partitions / No Suspect Material | |

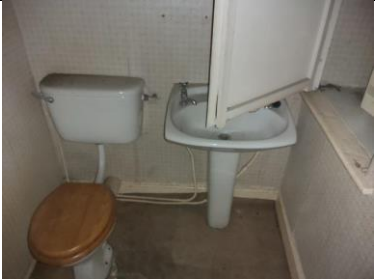
| 1st Floor | R010 | Bathroom | Ceiling void: Lath and plaster ceiling / No Suspect Material<br>Floor: Carpet on timber / No Suspect Material<br>Sanitaryware / No Suspect Material<br>Walls: Plastered masonry, lath and plaster and hardboard partitions / No Suspect Material | |

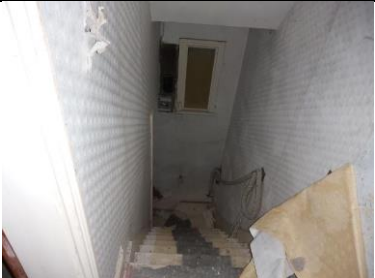
| 1st Floor | R011 | Landing | Ceiling void: Lath and plaster ceiling / No Suspect Material<br>Doors: Timber / No Suspect Material<br>Electrics / No Suspect Material<br>Floor: Timber / No Suspect Material<br>Walls: Plastered masonry and lath and plaster partitions / No Suspect Material | |

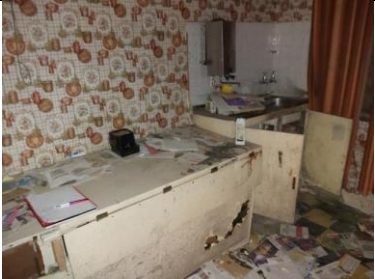
| Ground Floor | R012 | Kitchen | Bath and panel / No Suspect Material<br>Ceiling void: Lath and plaster ceiling / No Suspect Material<br>Doors: Timber / No Suspect Material<br>Floor: Carpet / No Suspect Material<br>Modern sink / No Suspect Material<br>Walls: Plastered masonry / No Suspect Material<br>Walls: Plastered masonry and lath and plaster partitions / No Suspect Material | |

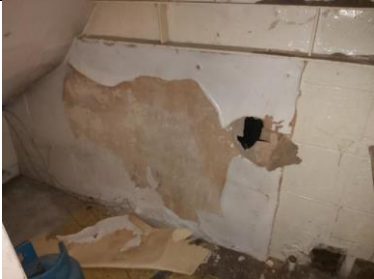
| Ground Floor | R013 | Pantry | Ceiling void: Lath and plaster ceiling / No Suspect Material<br>Door: Timber / No Suspect Material<br>Doors: Timber / No Suspect Material<br>Floor: Carpet / No Suspect Material<br>Walls: Plastered masonry / No Suspect Material<br>Walls: Plastered masonry and lath and plaster partitions / No Suspect Material | |

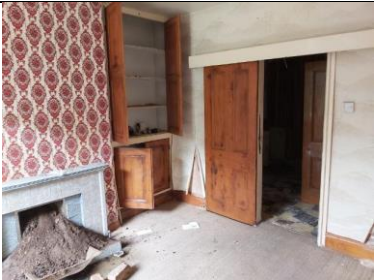
| Ground Floor | R014 | Living room | Ceiling void: Lath and plaster ceiling / No Suspect Material<br>Chimney / No Suspect Material<br>Door: Timber / No Suspect Material<br>Floor: Carpet on concrete / No Suspect Material<br>Walls: Plastered masonry / No Suspect Material | |
