**INGLEFIELD FARM BARN NEW ROW LANE INGBIRCHWORTH**

**1.0 Introduction**

- 1.1 We are instructed by Mrs D Knowles care of JR Planning Consultants, 40 Northern Common, Dronfield, S18 8XJ to undertake a survey of the buildings associated with Inglefield Farm and report on the suitability for conversion to residential property.

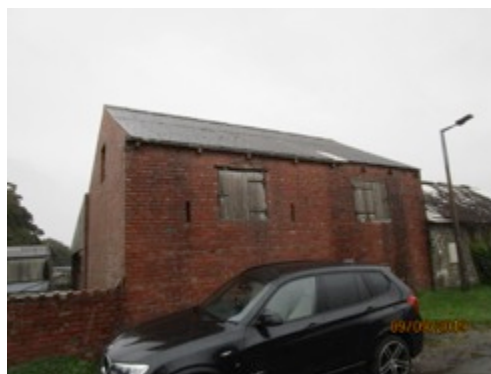
- 2.4 The property is located on the outskirts of the village of Ingbirchworth in a rural location. The building is accessed from New Row Lane. The property comprises of a two-storey high barn, lean-to open canopy and single storey open store.

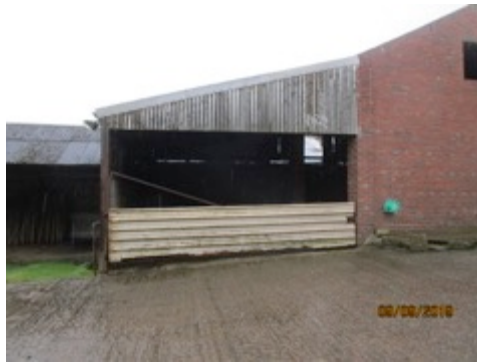
## 7.0 Lean-To Store

- 7.1.1 A lean-to construction comprising of a profiled metal sheet supported by six timber purlins and a metal frame. No significant issues were identified in the construction or condition of the metalwork.

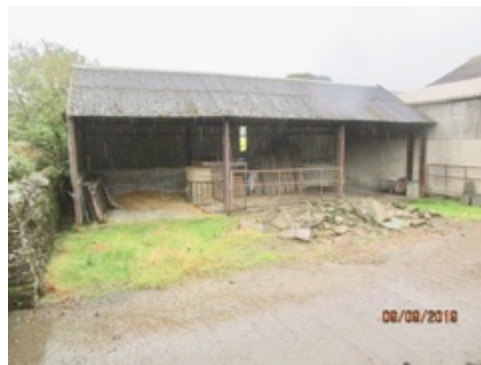
### 8.0 Open Store

- 8.1 This is a typical farm open store constructed with a steel frame and corrugated sheet and block with timber slat claddings.

- 8.2.1 The roof has a steel truss supporting framework with a covering of profiled sheets. The structural frame has a degree of surface corrosion typical of unprotected steel. The corrosion is not to such an extent that renewal of structural members is required.
