Tree Survey Mount Vernon Hospital - Ward 3, Barnsley

REPORT TITLE: **TREE SURVEY**

Mount Vernon Hospital, Barnsley

DATE: October 2009

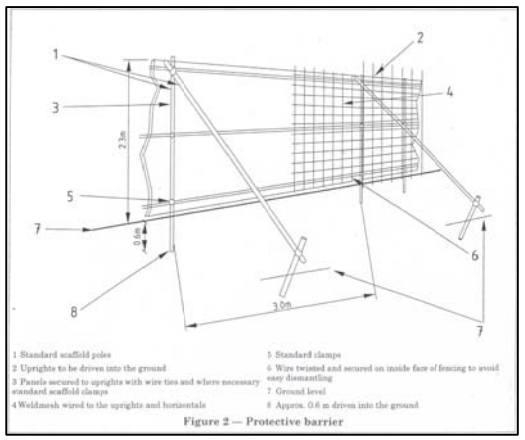
Endcliffe Holt 343 Fulwood Road Sheffield S10 3BQ Tel. (0114) 2669292 Fax. (0114) 2667707 www.shef.ac.uk/~ecus/	
Job Mount Vernon Hospital - Ward 3, Barnsley			
Title Tree Constraints Plan			
Drawn by KM	Date Oct 09	Scale 1:250@A3	Drg. no. Figure 3

4.2.1 The effect of the development on the existing trees is described below and shown on the Tree Constraints Plan. The Tree Constraints Plan has been produced in accordance with *BS5837:2005 Trees in relation to construction* and is shown in Figure 3.

4.2.3 The proposed footpath to the south west of the site conflicts with the Root Protection Area of T6. The use of porous paving for the construction of the footpath should be considered and disturbance to ground levels should be minimised to prevent potential damage to the tree roots.

4.3.3 Care should be taken to protect trees during the preparation for construction works (site clearance) and during the construction works themselves to minimise the potential for damage to the trees during construction from site machinery and inappropriate storage of materials. To limit the likelihood of damage occurring during construction, we recommend that locations for the site compound and storage of materials should be specified away from retained trees. In addition, protective fencing should be erected outside the root protection area prior to construction commencing and retained throughout the construction period to physically separate the trees from the development works. The protected area should not be used for the storage of building materials and vehicles should be prevented from running over this area. The location of the protective fencing is shown on Figure 3.
