# St Barnabas Hall, Barnsley

## Bat Survey Report

7<sup>th</sup> June 2024

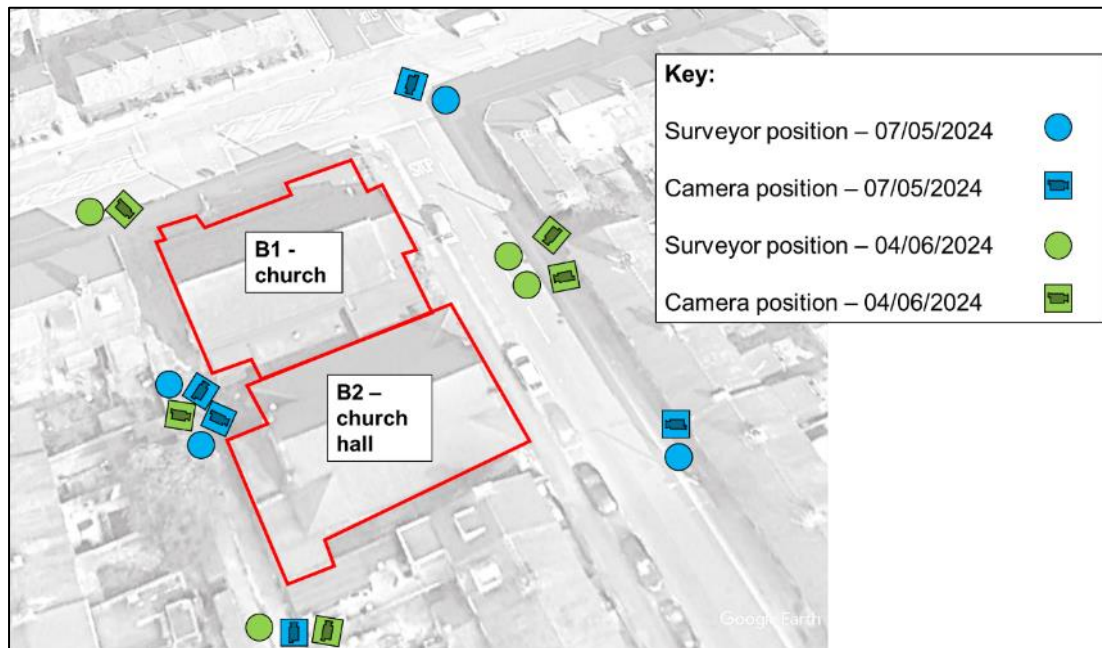
**Figure 2. Nocturnal survey plan**

4.3.1 A roof void present above the curved vaulted ceiling in B1 (the church in Figure 2) was not accessible due to the lack of an access hatch. In addition, the original roof void, present in the upper section of the roof within B2 (see church hall in Figure 2) was not accessible, due to lack of a safe means of access from the void beneath.

- 5.2.1 No signs of bat presence were recorded from St Barnabas Hall, with the two component buildings (Figure 2) considered to display a moderate level of bat roost suitability.

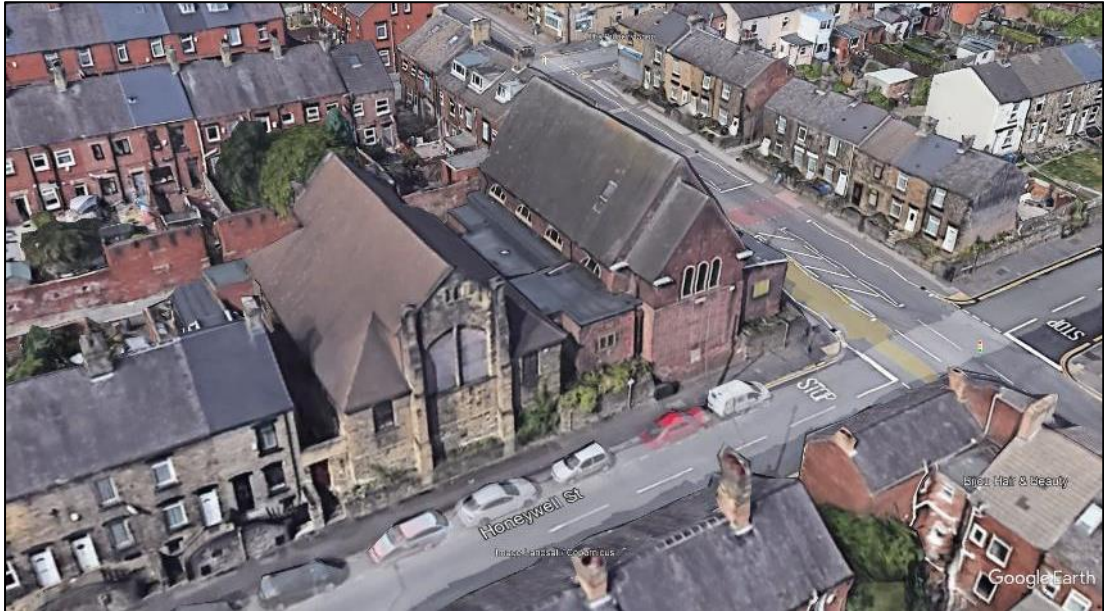
**Plate 1. Google Earth 3D image of St Barnabas Hall**

- 5.2.2 St Barnabas Hall comprised two individual but connected buildings originally functioning as a church (B1 in Figure 2; Plate 1) and church hall (B2 in Figure 2; Plate 1) and used as a Women's Freemason lodge at the time of survey. Both the key buildings had single-storey flat roofed extensions, some of which formed the connecting linkage between these buildings.

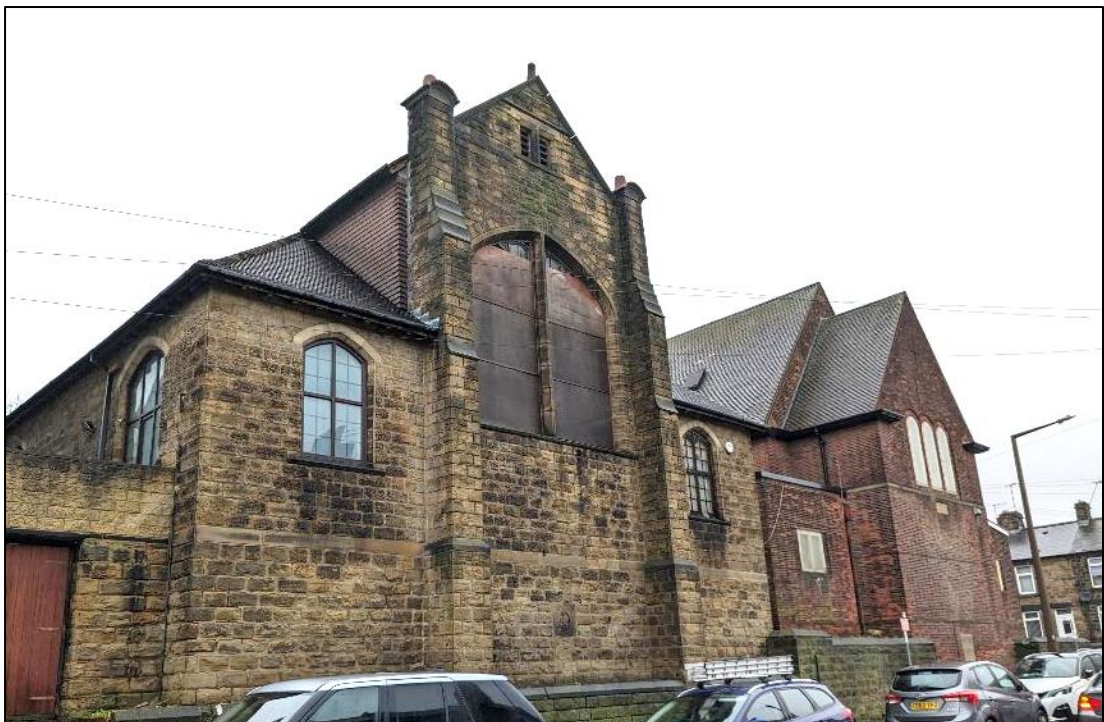
**Plate 2. Eastern corner of site**

- 5.2.3 The northern former church building (B1, Figure 2) comprised a 1930s brick-built chapel with a dual-pitched plain-tile covered roof (Plates 1, 2, 3 & 5). The ridge line stepped down towards Honeywell Street and the roof had mortar-filled gable verges. Windows were single paned with protective screens present in places. A wooden soffit was present.

shuttering. Wooden louvre openings were present towards the apex on both gables (Plate 2). The remaining windows comprised a mix of single-pane wood-framed units with double-glazed plastic framed units on the southeast elevation. Plastic guttering was present.

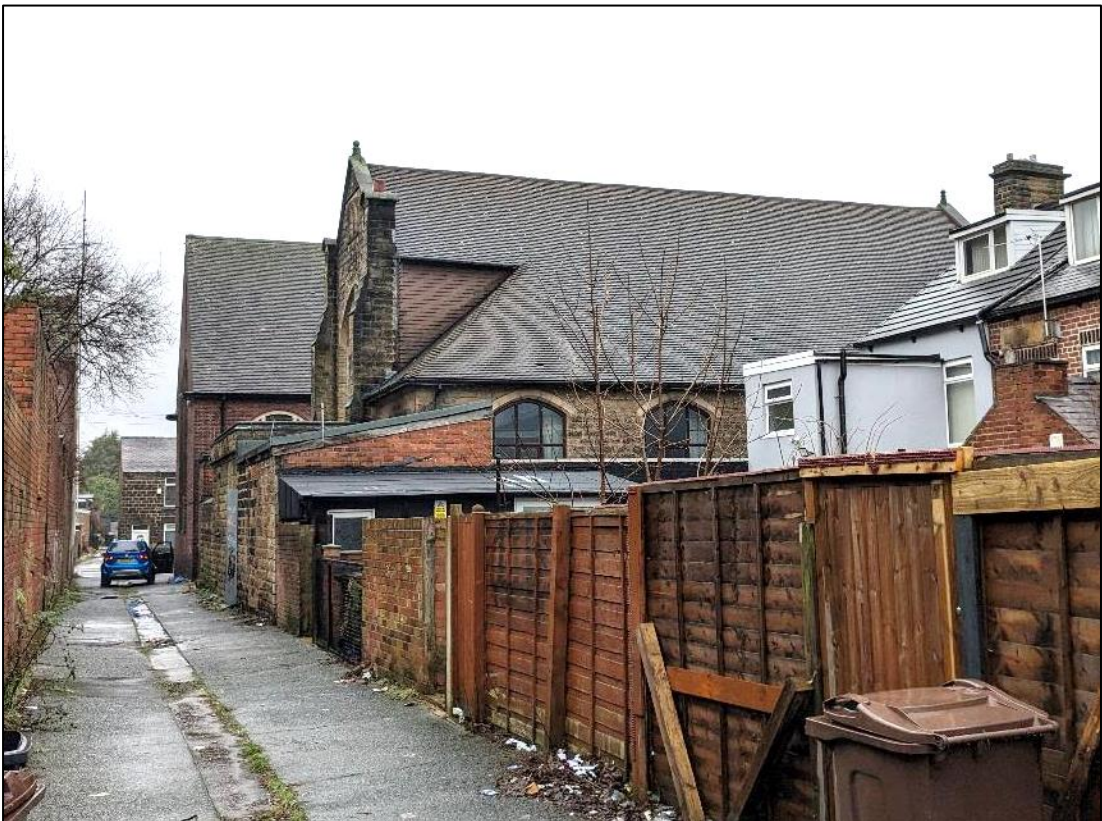
**Plate 4. Southern corner of site**

- 5.2.4 The southern former church hall (B2, Figure 2) comprised a C19th stone built structure which appeared likely to have comprised the original church (Plates 1-4). The building had a dual pitched plain tile covered roof with stone coping at the gables, The roof extended down over single-storey wings to the northwest and southeast, with hip ends present at the corners of the lower sections of the roof. Hanging tiles were present along sections of the northwest and southeast elevations (i.e. Plate 2), with deep eaves present in places. The building had large wood-framed single-paned windows associated with both gables, however, these had been mainly covered with wooden

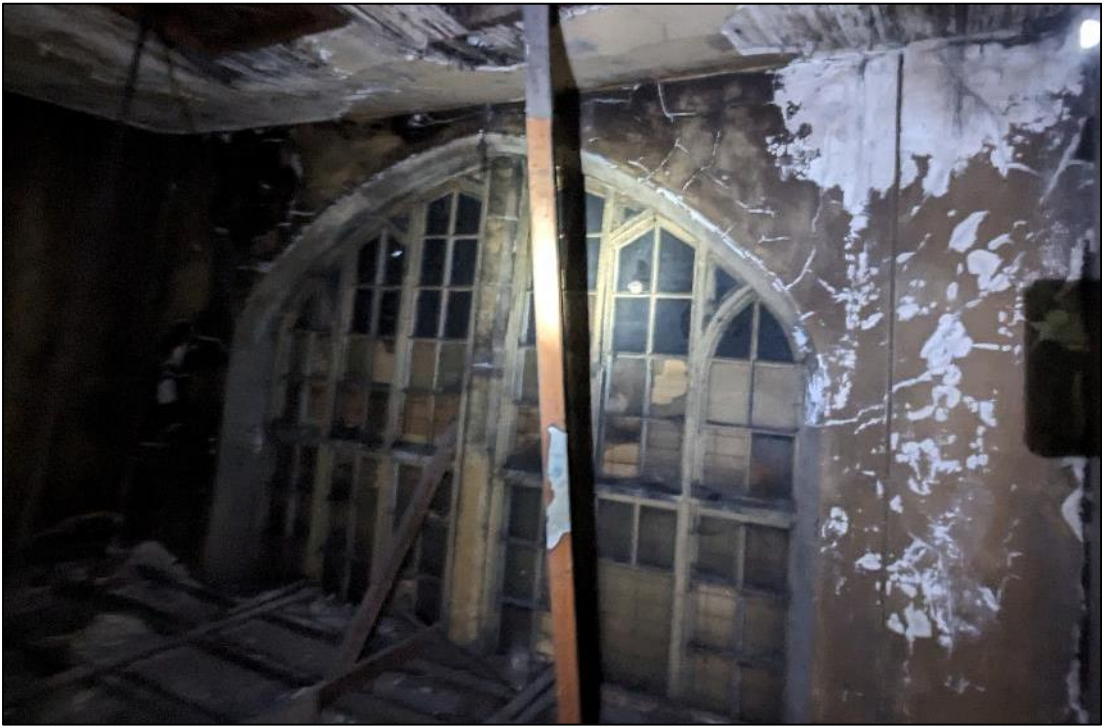
**Plate 10. Rear of boarded window on southwest gable of B2**
