Barn at Liley Farm, Millhouse Green

Bat Survey Report

3rd July 2025

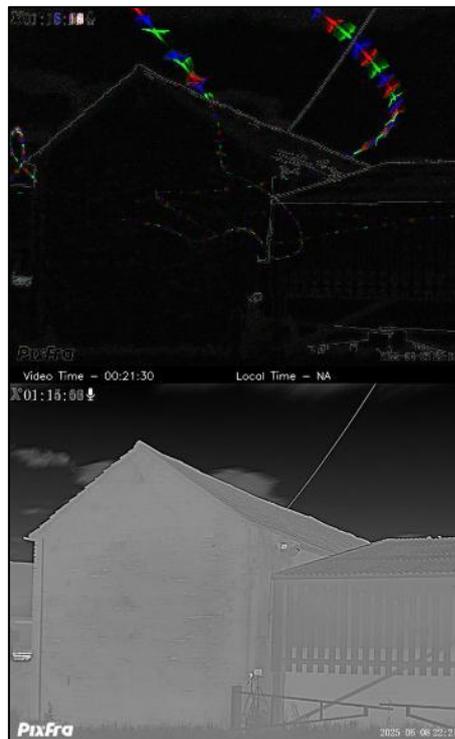
Plate 1. Example 30 second summary image from camera position on 8th June 2025, with the bat indicated by dotted red-green-blue line on upper image

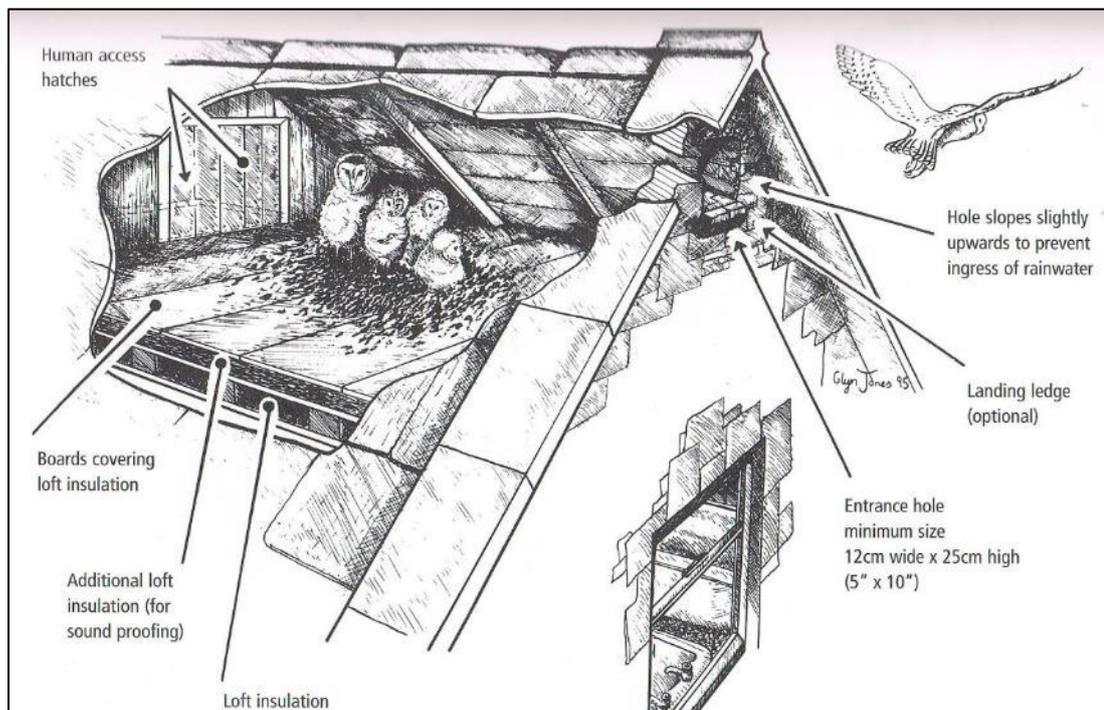
Figure 4. Proposed design for built-in barn owl provision

- 6.4.5 A barn owl perch will be lost during the development with four disused swallow nests also recorded from the building. Recommendations have however been provided in relation to inclusion of new bat, barn owl and swift nest/roost provision.

6.3.4 To mitigate for the lost barn owl perch a replacement roost site should be created on Liley Farm. This replacement roost site may comprise either a barn owl loft (Figure 4) to be included in the renovated barn, or a purpose made barn owl box, which could be attached to either the inside or outside of one of the modern barns on the site. A barn owl loft could be created within the former dove cote in the southeast gable of the barn (Plate 3). Were a barn owl box to be fixed to an existing modern barn then a suitable design of box would comprise the [Eco Barn Owl Nest Box](#) and Middleton Bell Ecology would be happy to advise further on suitable locations.
