# **Woolley Colliery Road, Darton, Barnsley**

## **Visual Condition Survey**

PROPOSED RESIDENTIAL DEVELOPMENT  
WOOLLEY COLLIERY ROAD, DARTON, BARNSELY

Ref: 24-256-006.01

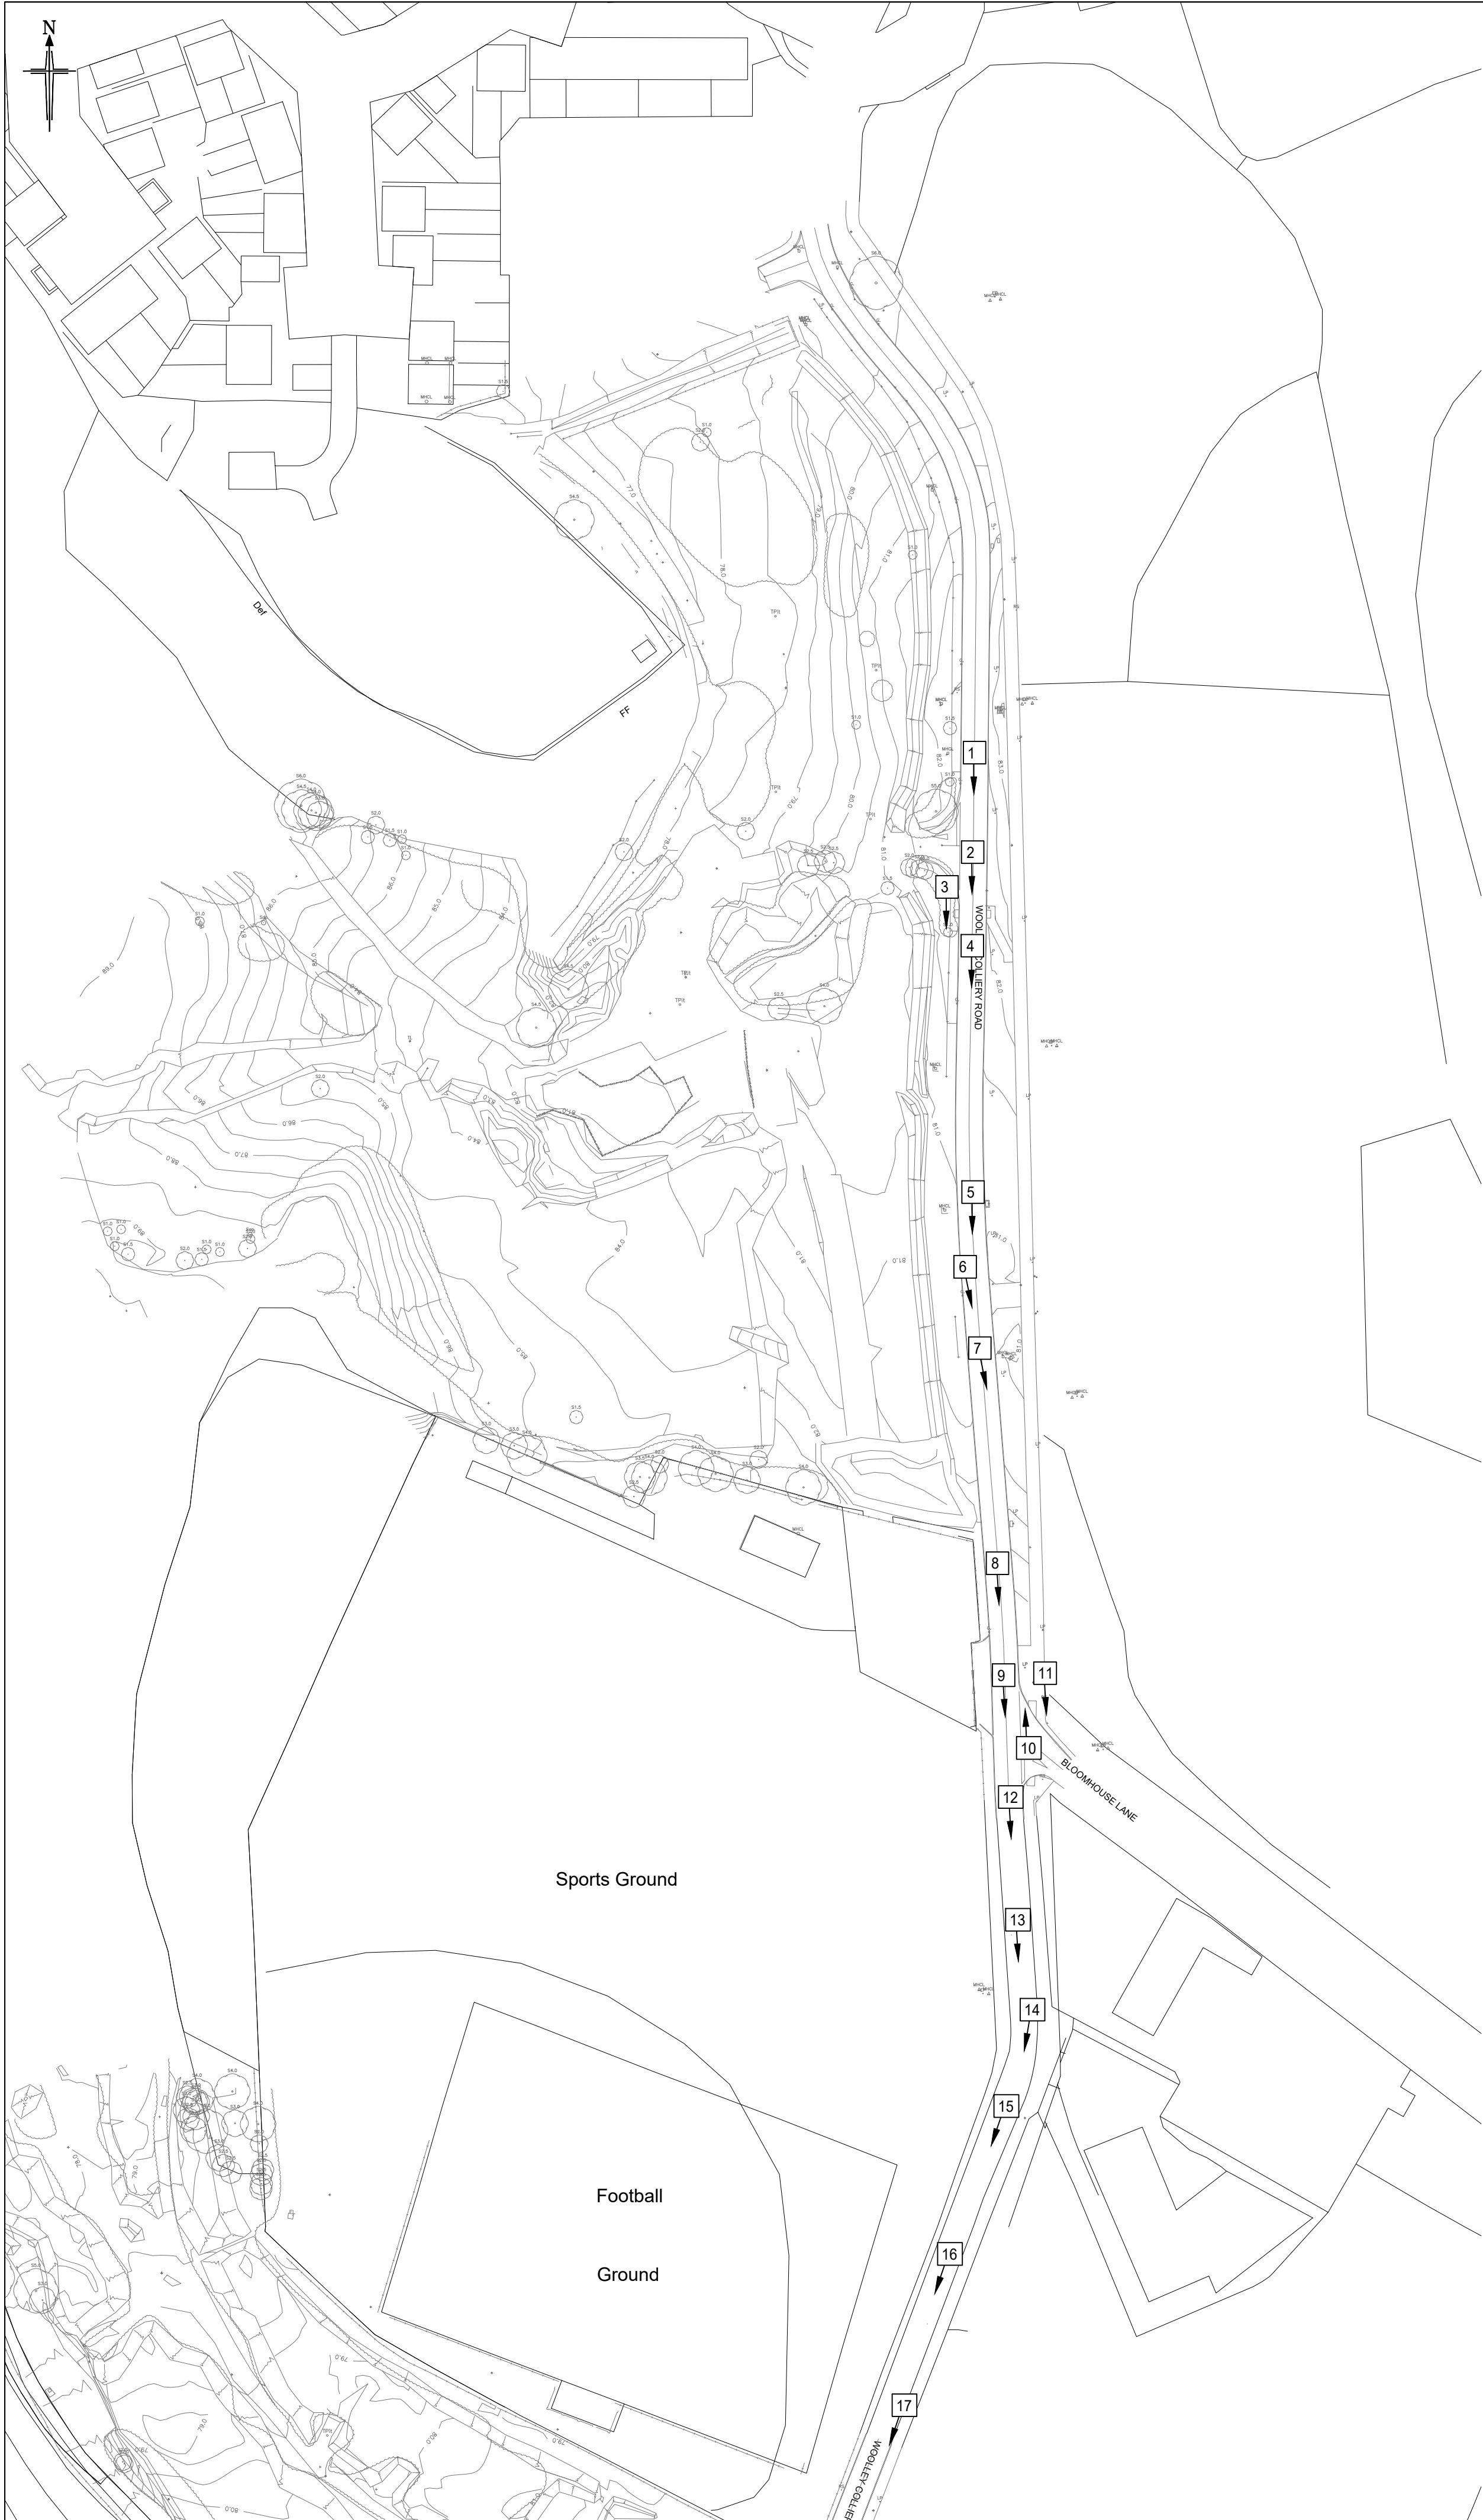
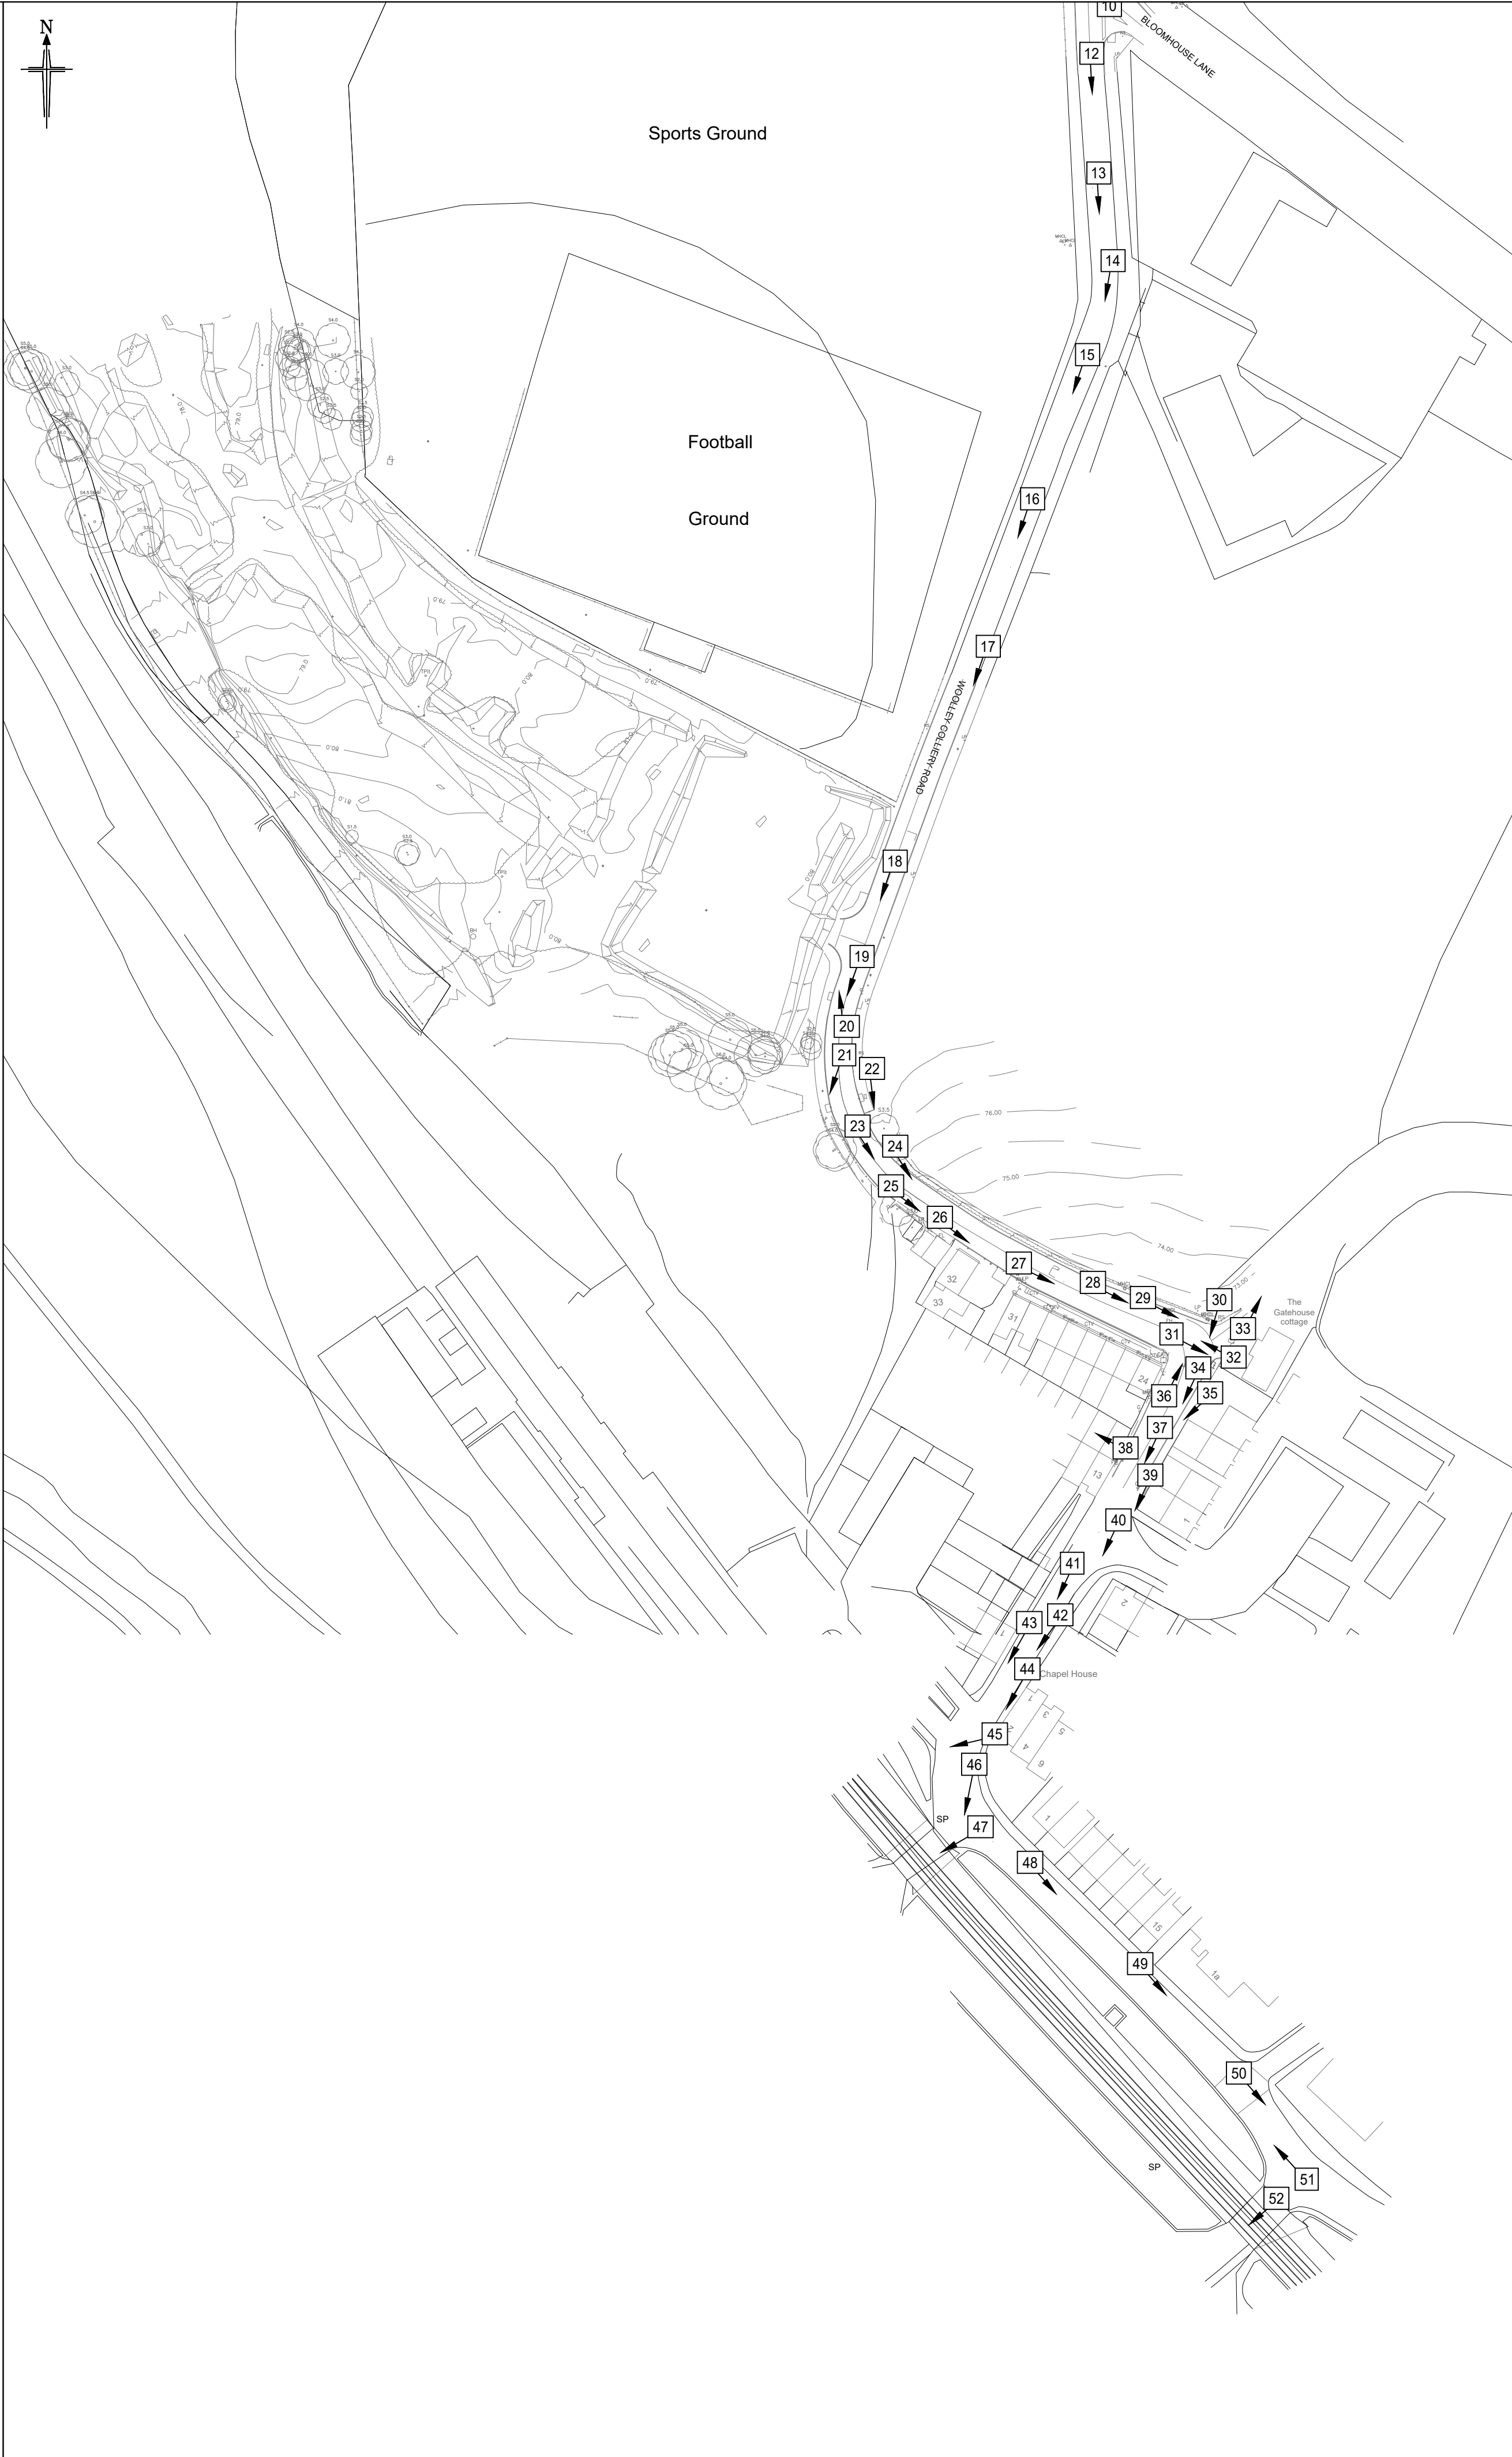
# **Appendix BGH 2**

- 2.2 A plan showing the location of significant defects identified at the time of the survey can be found in **Appendix BGH2**. A number of additional photographs were also taken along Woolley Colliery Road and Station Road that can be provided upon request.

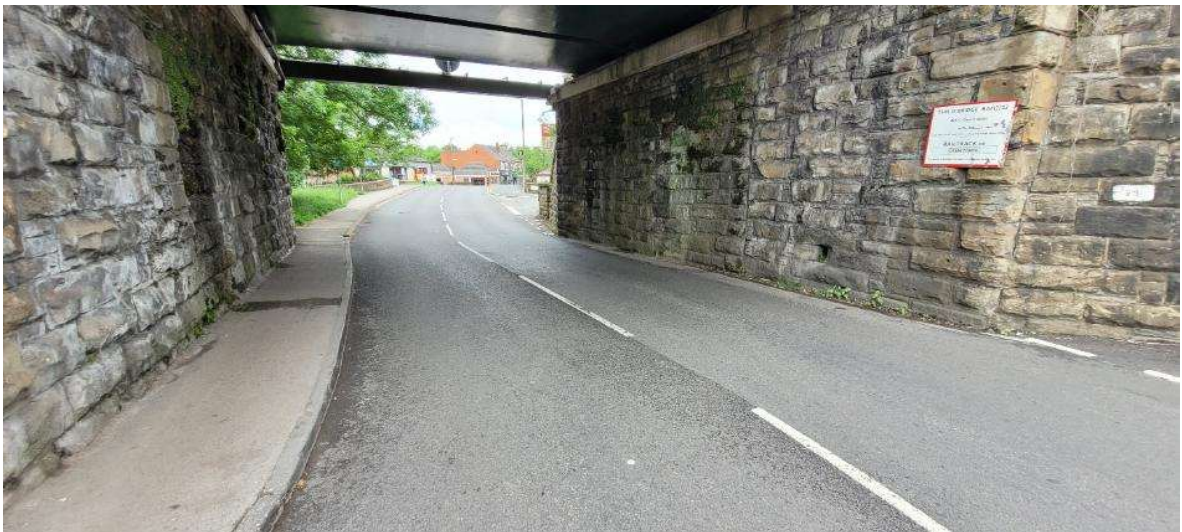
**Photo 52**

Church Street looking South under railway line
