Structural Solutions Ltd

Ref: NYP/16/104

REF: Land to Plot 2 `Delf Garth', High Street, Dodworth – Boundary Wall Remedial Works

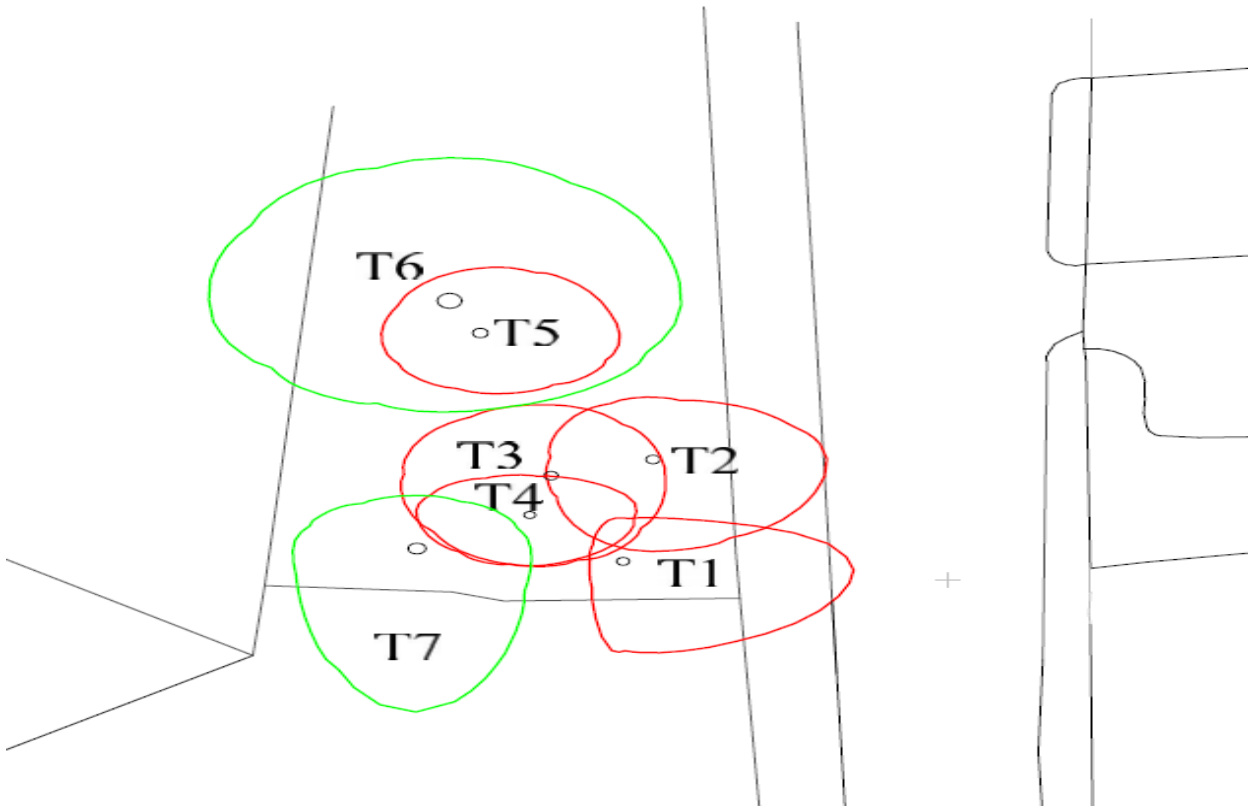
Existing Tree Plan

The arboricultural report states that it is likely the root growth of trees T1 & T2, as well as extended roots of T3, T4 & T5, are causing structural damage to the existing stone boundary wall. The report concludes that these 5 trees are not viable, or of value, to retain and could be removed.

We would suggest that if the trees are removed this will remove surcharge pressure off the back of the upper section of the wall. In this regard, appropriate remedial works would be to take down rebuild and realign the upper section of the wall. To be able to undertake rebuilding remedial works to the wall, and to maintain the structural integrity following repairs it will be necessary to remove trees T1 – T5, as noted in AWA's report.
