# Soakaway and Foul Drainage Testing Report

**Woodbine Cottage, Doncaster Road, Billingley**

Issued: September 2019

Delta-Simons Project No. 19-1049.01

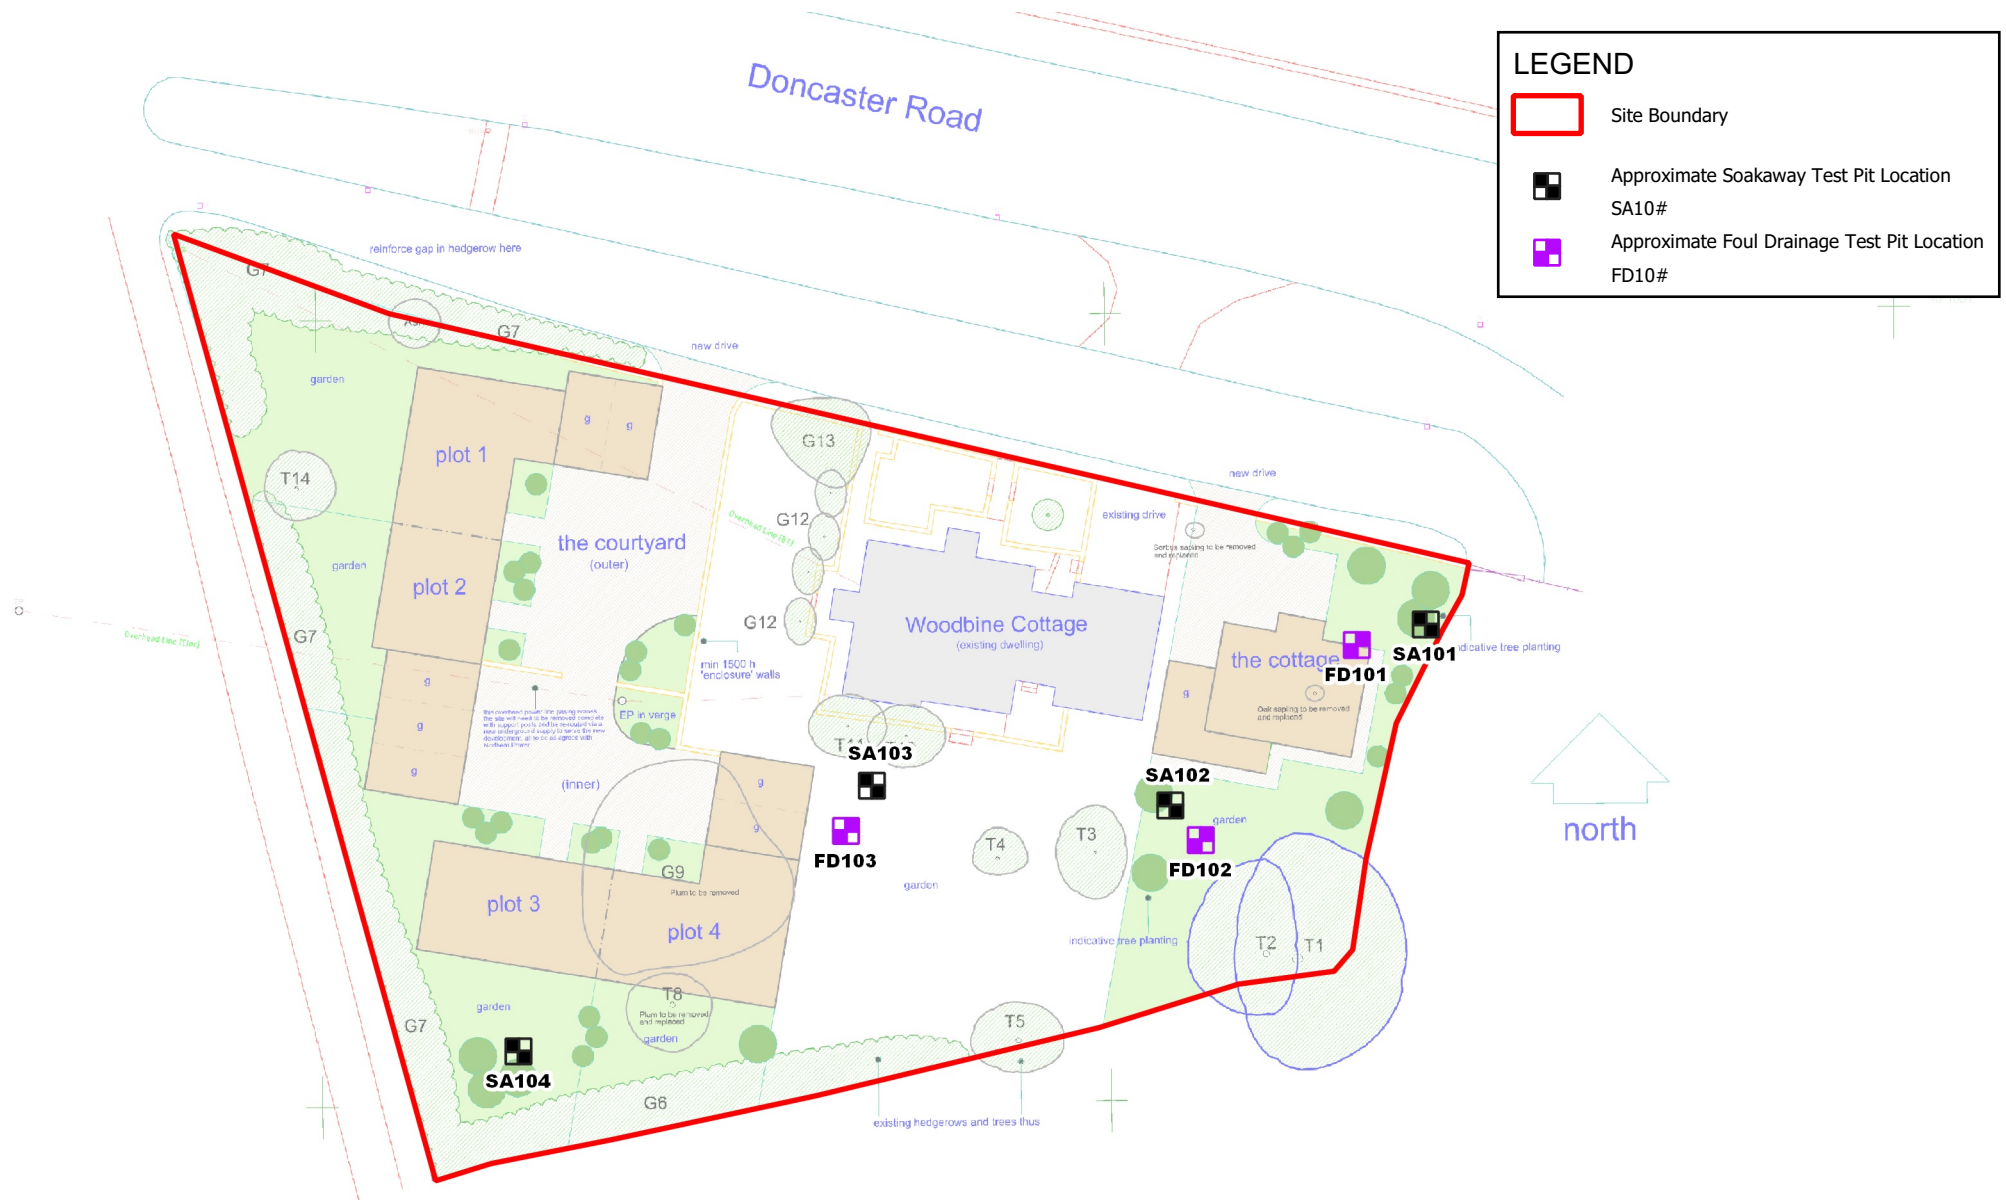
## Figure 3 – Exploratory Hole Location Plan

A total of seven pits were formed, SA101-SA104 and FD101-FD103 (see Figure 3 for approximate locations).
