Ref: AWA1482
21st December 2015

Arboricultural Report

27 DARTON STREET, BARNLSLEY, S70 3PN

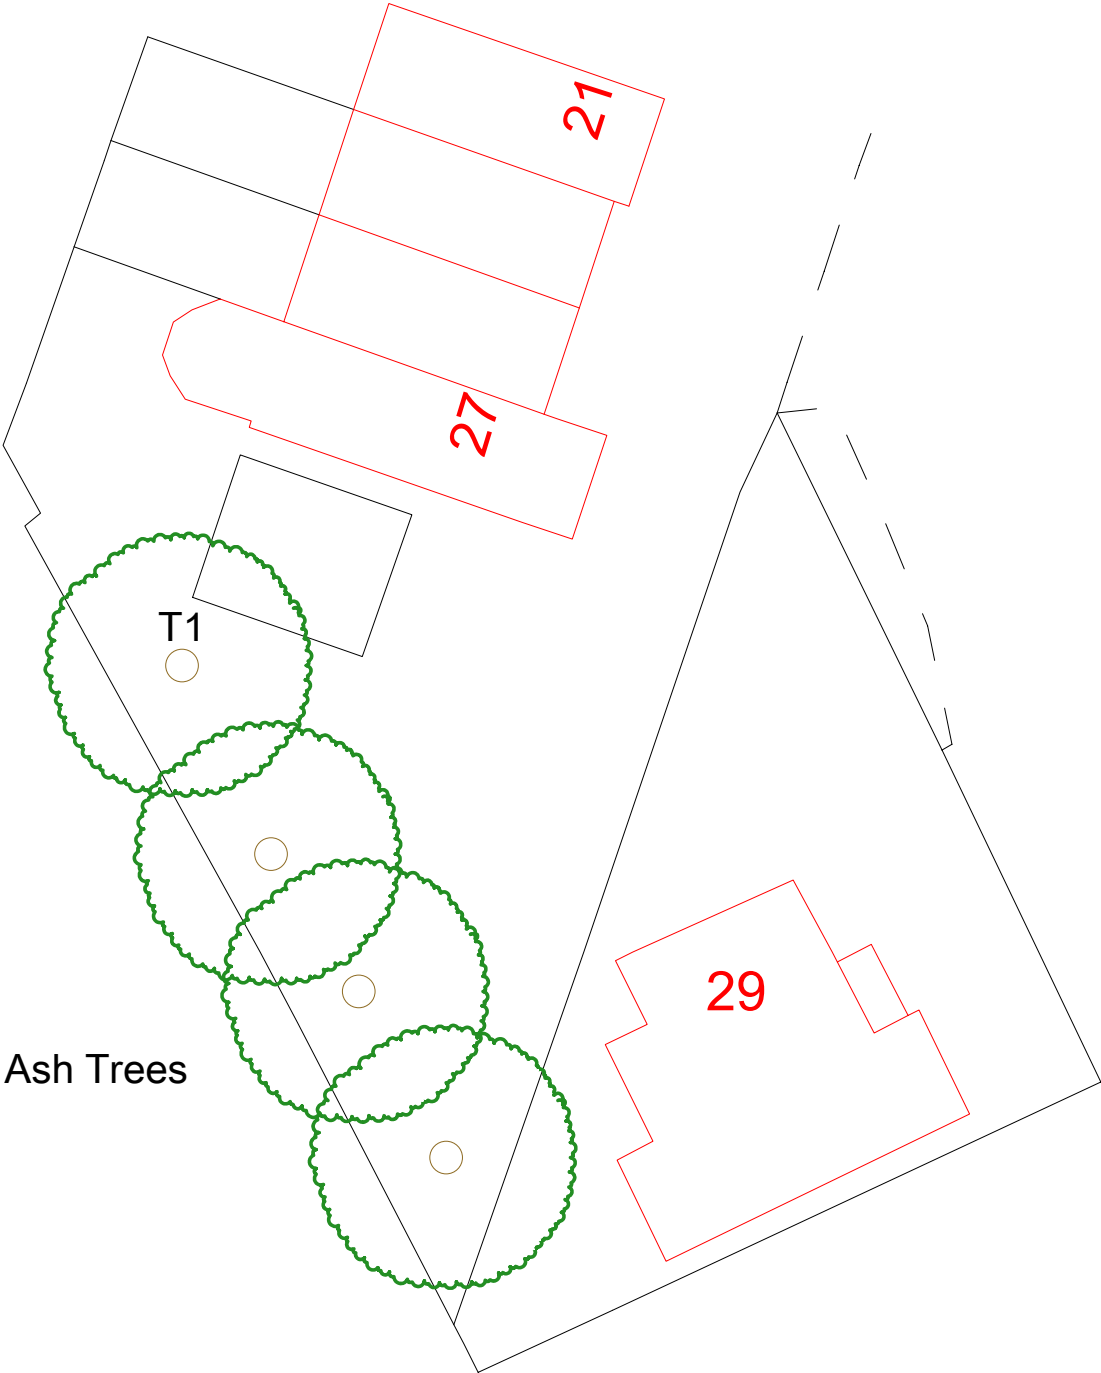
Tree plan

A single early mature Ash tree was surveyed, numbered **T1** on the attached plan. Other less significant vegetation was not surveyed in this instance. Photographs have been included at the end of this report, to highlight the survey findings.
