# Lakeside View, Silkstone Common

## Bat Survey Report

20<sup>th</sup> November 2023

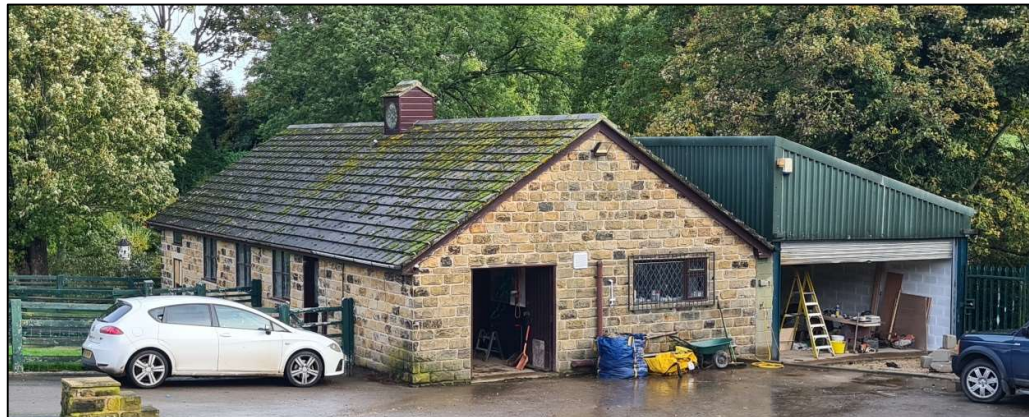
**Plate 1. The Stone stables and adjacent storage barn**

- 5.2.2 The single storey-building was constructed from concrete blocks and stone. An adjoining storage barn (constructed from concrete blocks and a steel frame with corrugated metal cladding) was present to the east. The adjacent barn appeared to have been built more recently (Plate 1). The windows and doors were framed with timber. The soffits and fascias were also wooden. The western side of the building and the north and south gables were faced with stone with an inner skin of concrete blocks. The rear (eastern) aspect which joined the storage barn was constructed solely from concrete blocks.
- 5.2.3 The stables had a two-pitch roof covered with interlocking concrete tiles. A small clock

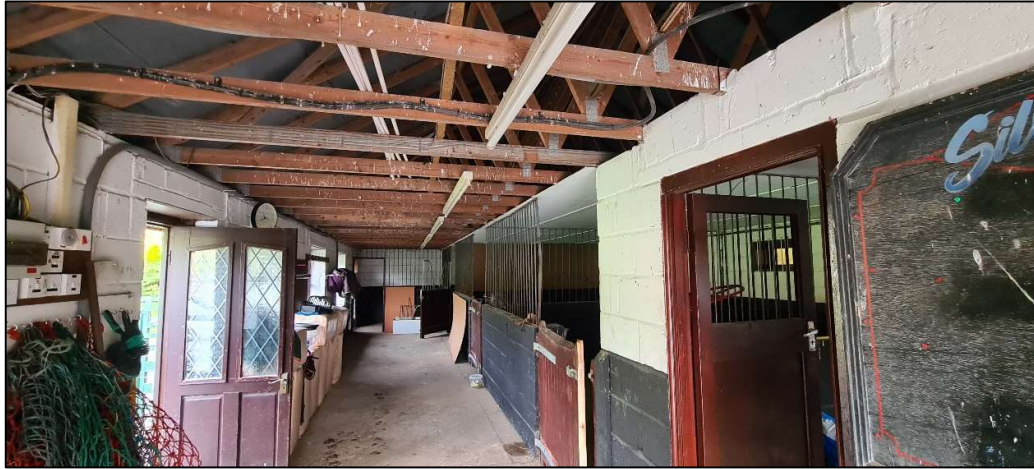
**Plate 3. Interior of the stables**

5.2.6 The majority of the internal space was allocated to stables with a tack room at the southern end. A flat ceiling had been installed over the stables and tack room on the eastern half of the building with the western half open to the roof pitch (Plate 3). The

- 5.2.7 Some bird and rat droppings were present on the ceiling of the stables / tack room but no bats or signs of bats were recorded during the inspection. Features A, B, D, and E could all be inspected with an endoscope and no bats or bat droppings were recorded. It is considered likely that droppings would have been present within the features and that they would have been recorded during the endoscope inspection, if these features had been recently used, or regularly in the past summer season. The gaps between the ridge tiles could not be closely inspected.
- 5.2.8 At the northern end of the building three swallow nests were recorded on the rafters (Plate 5). The swallow nest locations are shown as Feature F on Figure 3.

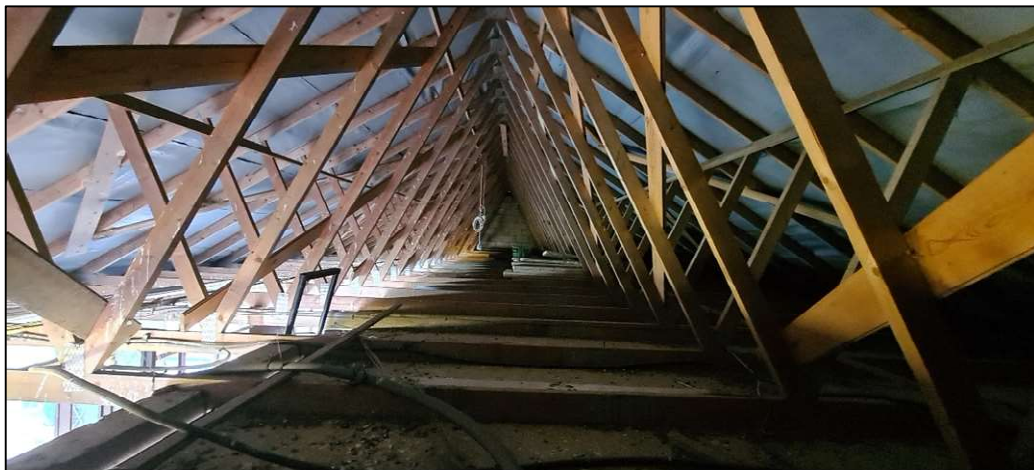
**Plate 4. Roof truss construction**

roof was supported by modern trusses and was backed with a plastic membrane (Plate 4).
