## Engineers Report

**Risk Address** 16 Green Spring Avenue  
Birdwell  
Barnsley  
S70 5RW

**360 Reference** LIV-SN-23-006594  
**Claim Reference** 100-50-225844  
**Policyholder** Mr R Flavell

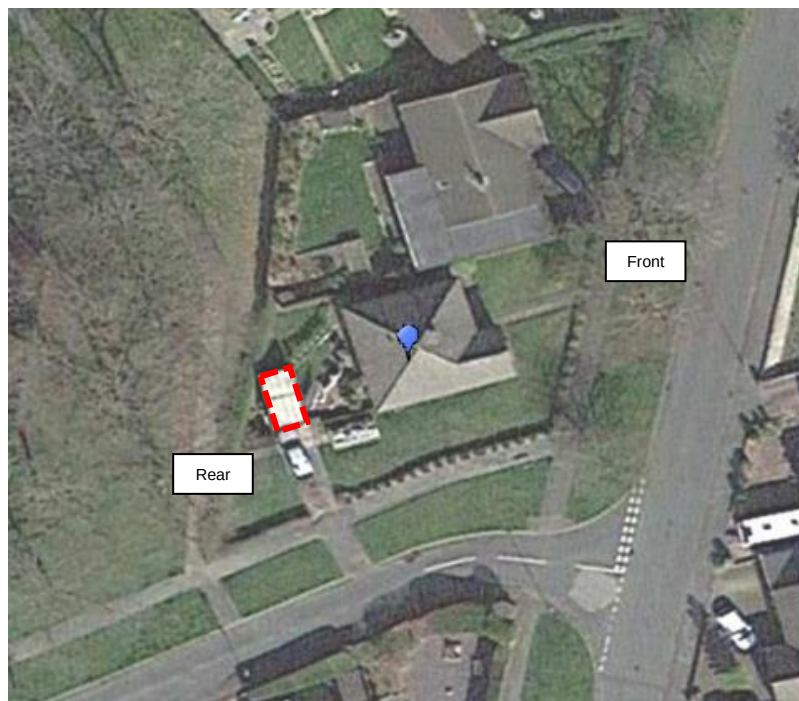
There is a 10-15mm crack to the mid-left-hand section of the garage floor slab, running from side-to-side. This cracking appears to be historic. The extent of this cracking could not be fully determined, due to the contents of the garage internally.

There is a diagonal 5-6mm crack across the rear left-hand section of the floor slab. This cracking appears to be historic.
