# **ARBORICULTURAL REPORT & Impact Assessment to BS5837:2012 at:**

***Dismantled railway between  
Bar Lane and Lee Lane,  
Barnsley***

Prepared for:  
***Barnsley Metropolitan Borough Council***

Reference: AWA4235

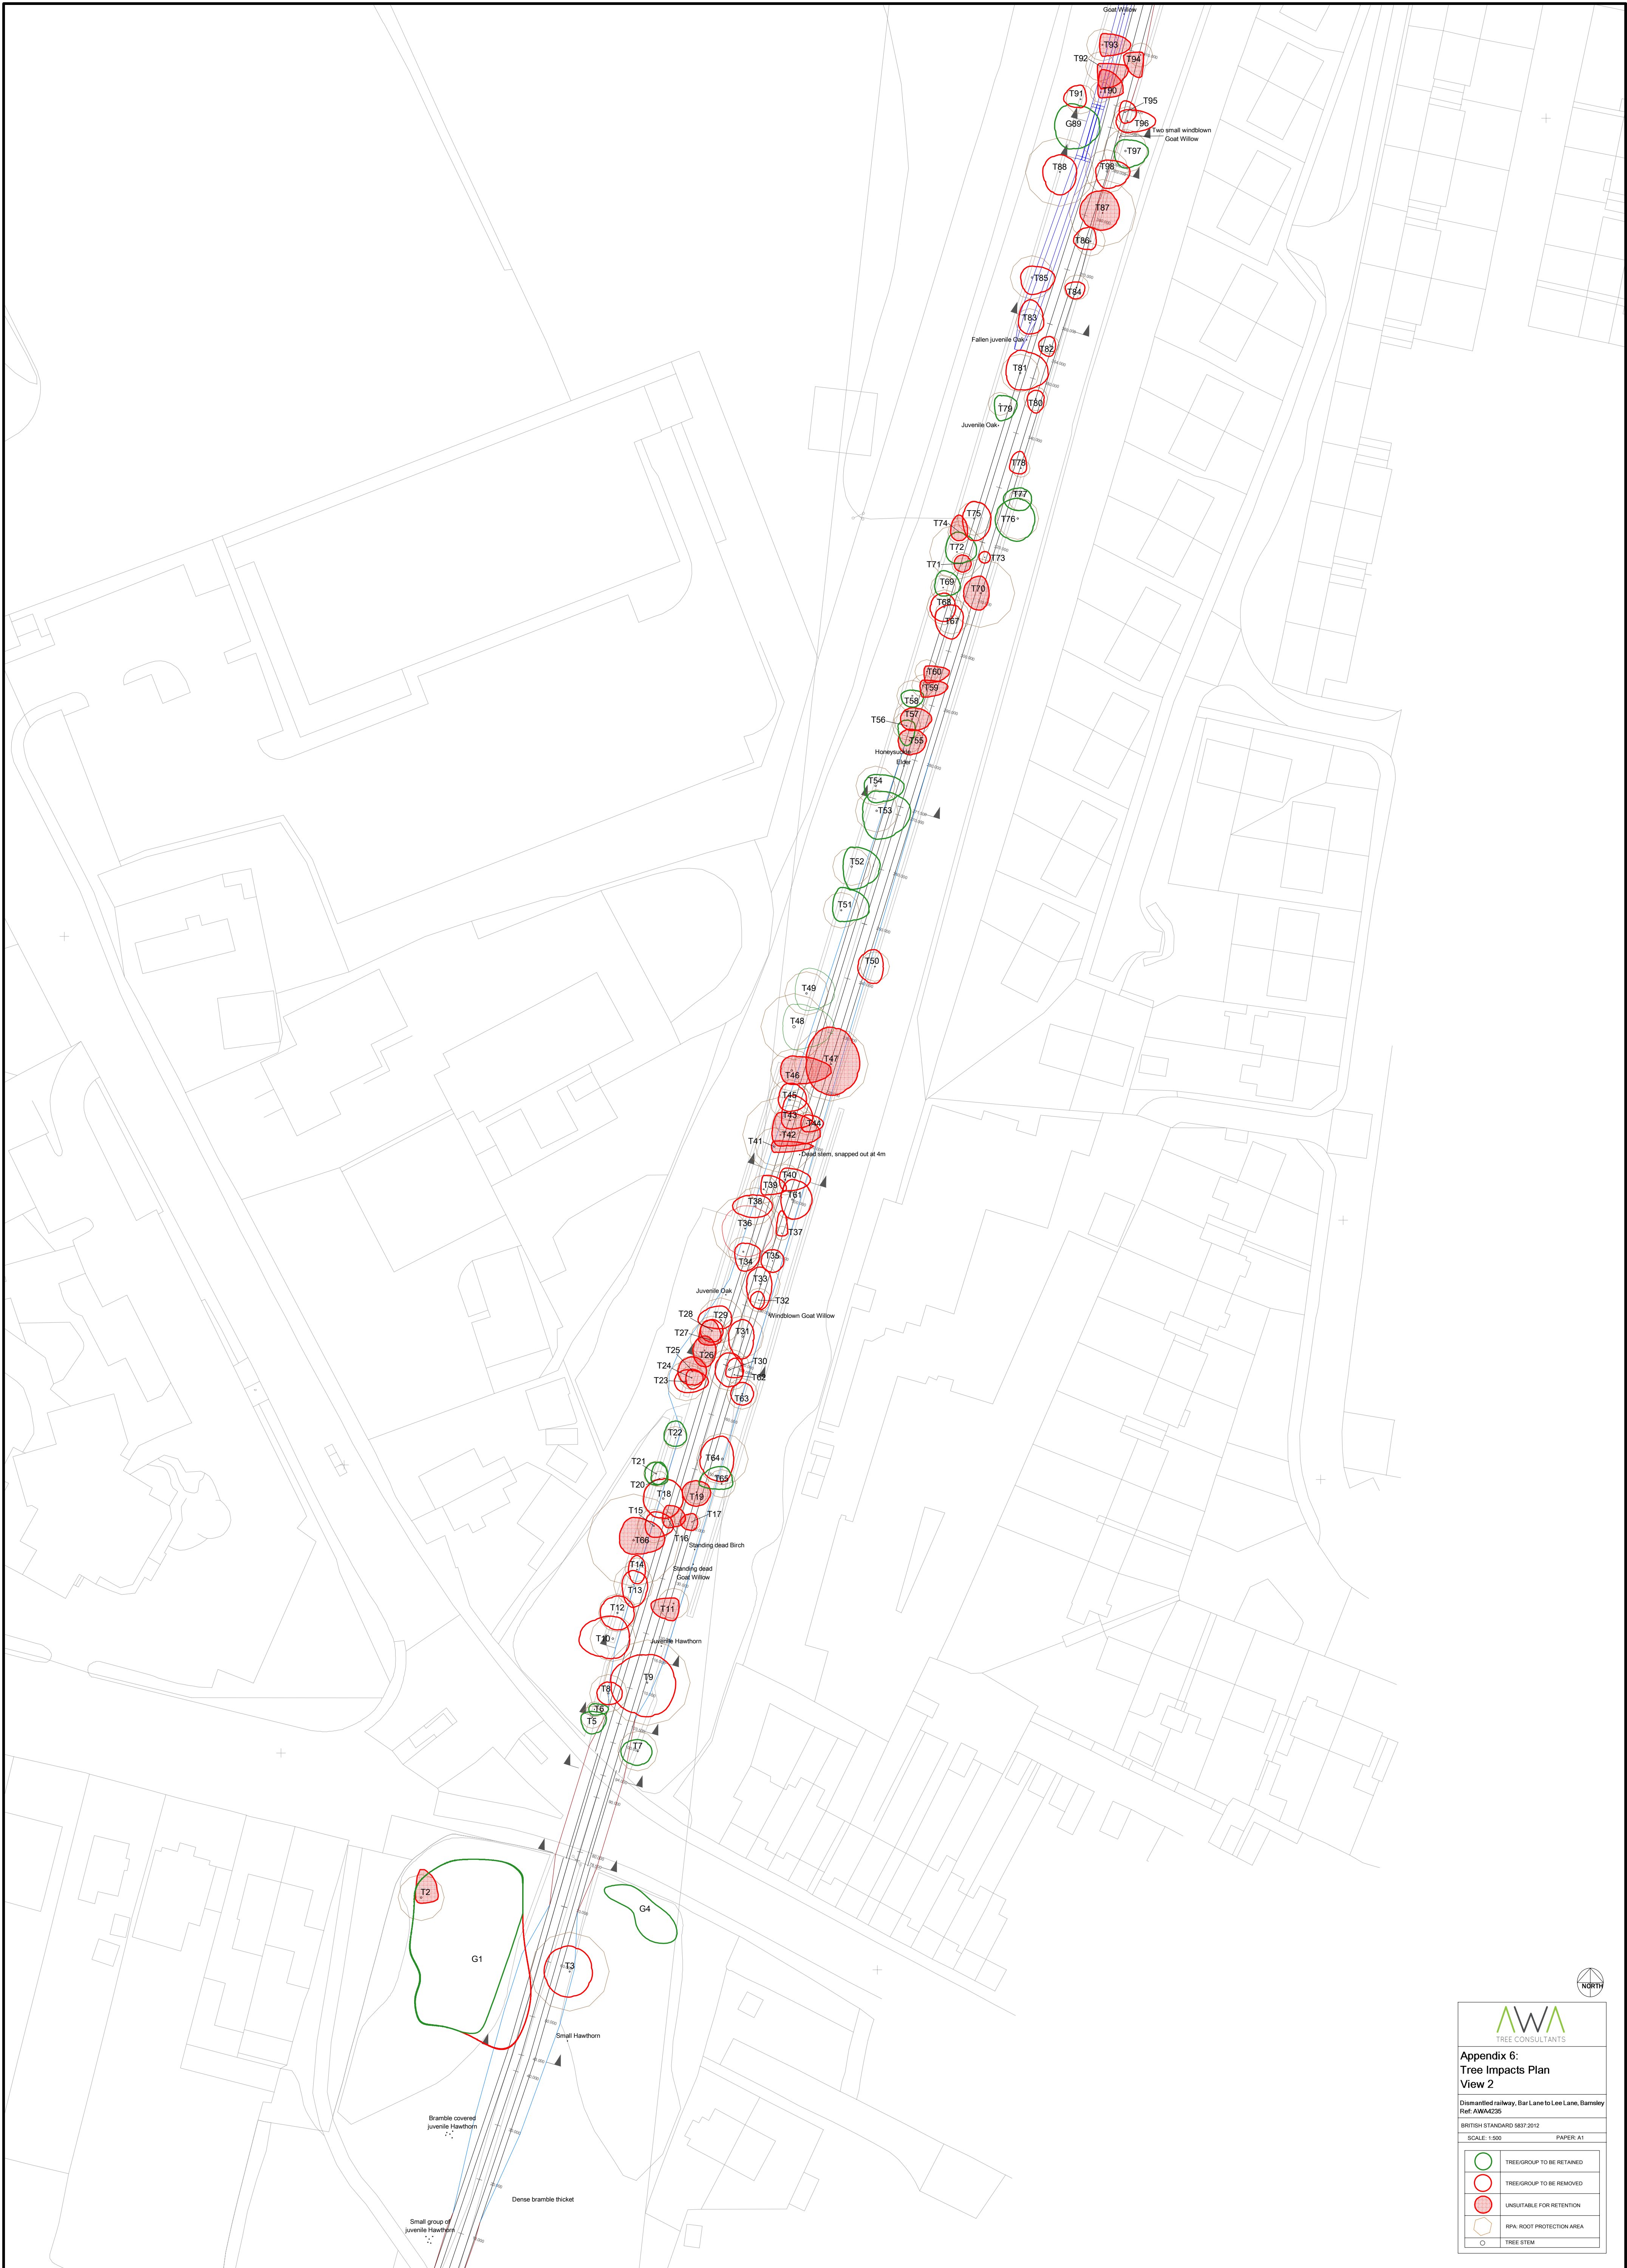
**Appendix 6:**  
**Tree Impacts Plan**  
**View 2**

- 4.2.11 Several trees were found to be in such poor condition or contain significant defects as to be recommended for removal regardless of development. These trees are T2, T11, T16, T17, T19, T25, T26, T27, T41, T42, T46, T47, T55, T57, T59, T60, T66, T70, T71, T74, T87, T90, T92, T93, T94, T100, T105, T110, T112, T135, and T137, identified in shaded red in the Tree Impacts Plan at Appendix 6.
