**PROPOSED CAR PARK, BARUGH  
GREEN, BARNSELY**

Stage 3 Road Safety Audit

### Retail Development Access

### FINAL Stage 3 Road Safety Audit

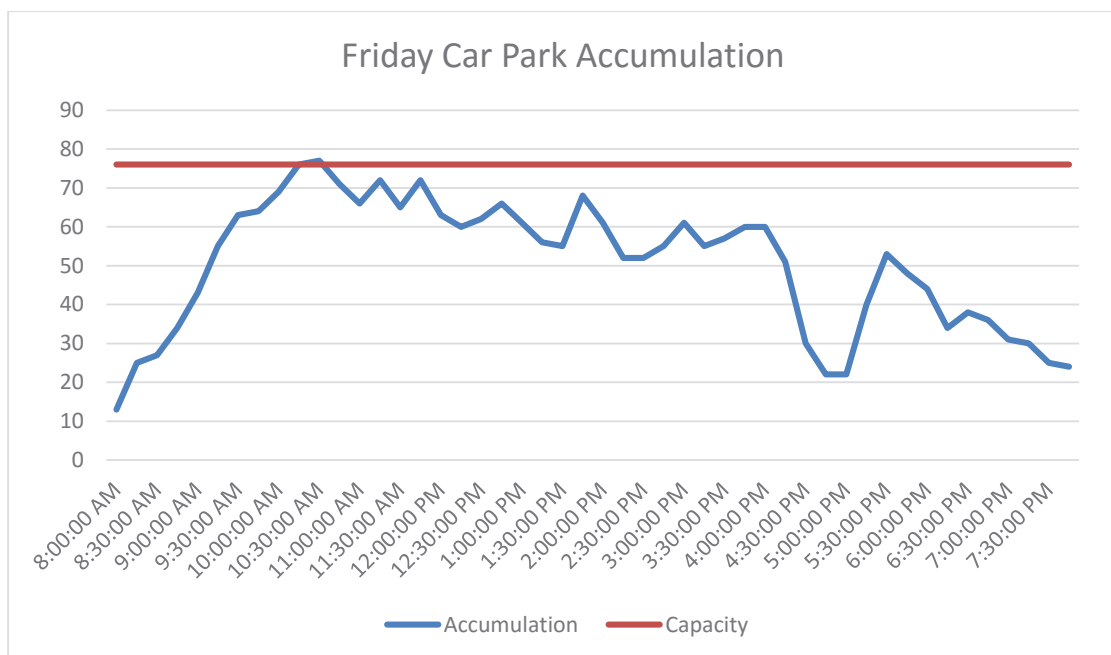
**Figure 2.1 – Car Park Accumulation, Aldi Barugh Green, Friday**

- 2.5** Aldi customer demand is shown to exceed the supply of car parking spaces during the periods of 10:00 AM to 10:45 AM on Friday and 01:45 PM to 02:00 PM on Saturday. The existing car park is shown to have limited spare capacity during the entire Friday AM period; the latter is exhibited for a period extending from 09:00 AM to 06:00 PM on the Saturday.

- 2.6** It has been demonstrated the existing car park is operating over capacity during peak hours on both the Friday and Saturday at present. A car park operating over capacity can result in detriment to the local highway network.

- 3.4** An increase in car parking provision at the existing Aldi Store will mitigate any detriment caused to the network as a result of insufficient car parking capacity on the site.
