## **Structural Inspection Report**

**Trunce Farm, Green Moor, Wortley, S35 7DQ**

**Document No. – R2246-001**

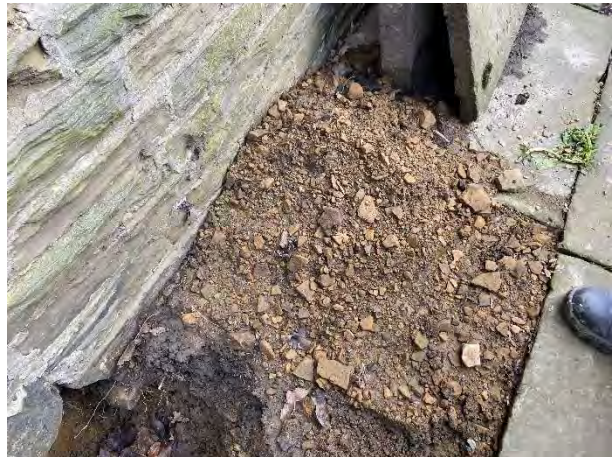
**Figure 5: Trial Pit 1 Arisings**

The wall is generally in a reasonable condition along the front elevation with no structural defects observed. The walls were generally measured to be plumb and vertical when measured using a spirit level at regular intervals along its length. Trial Pit 1 located in front of the former doorway shows the farmhouse to be founded on a stone footing less than 100mm in depth. The arisings indicate a sandy-gravel founding material.

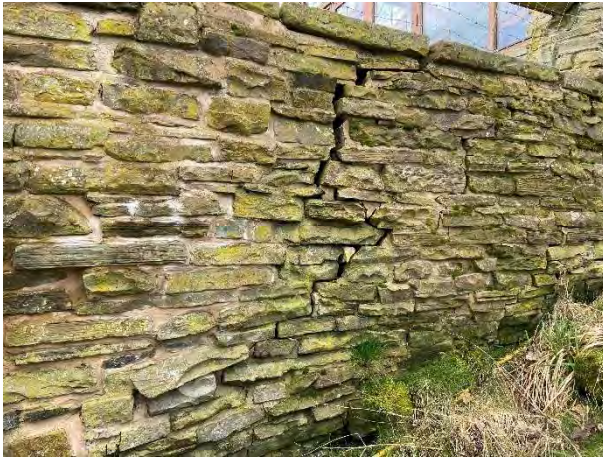
**Figure 8: Patio Retaining Wall**

Movement in the retaining walls supporting the external patio/ terrace area was also observed with the walls settling in the corner where the two walls meet (Figure 7). The walls are bowing with a large open crack observed in the longitudinal wall as it falls away at its end (Figure 8). This in return has caused the patio to drop at the interface with the stone wall. In its current state, the wall is inadequate for retaining the ground.

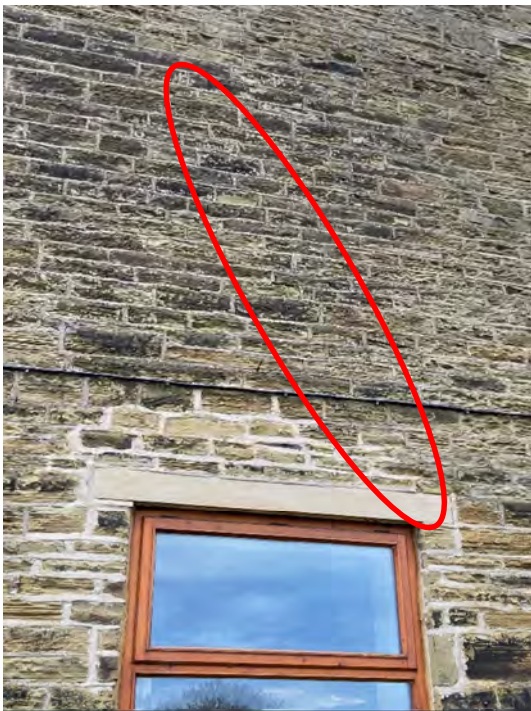
**Figure 10: Farmhouse Rear Elevation Lintel  
(Crack Location Highlighted)**

The lower left-hand window has had its lintel and sill replaced with localised repairs to the masonry and mortar observed. A crack can be seen propagating diagonally upwards approximately 16 stone courses from the right-hand end of the lintel through

the mortar joints and approximately 1 stone (Figure 10). This is likely to have happened when the wall was propped for the installation of the new lintel.

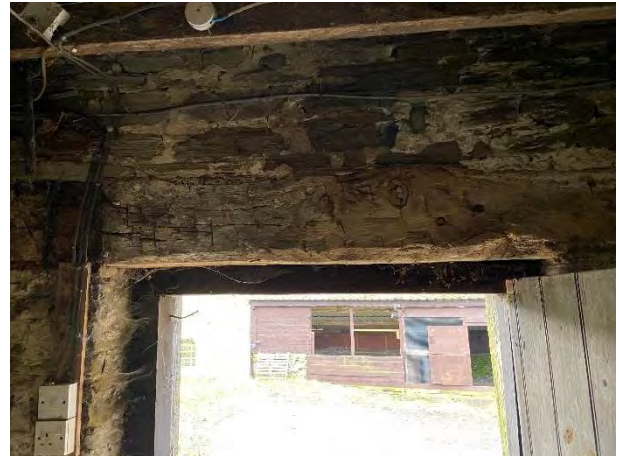
**Figure 24: Barn Internal Rotten Timber Lintel**

The stone lintel over the door from the Barn into the Workshop is cracked and sheared in half (Figure 23). The timber lintels supporting the inner leaf of the external walls over the external door and window in the smaller section of the Barn are also rotten and should be replaced (Figure 24). The lintel over the window in particular is bowing and has split under the weight of masonry above which is loose with open bed joints (Figure 25). The roof structure in this section of the barn could not be observed during the visit due to the presence of the timber mezzanine. Several timber joists are rotten and/or splitting under the floor load above. These have previously been propped with timber posts (Figure 26 & Figure 27).

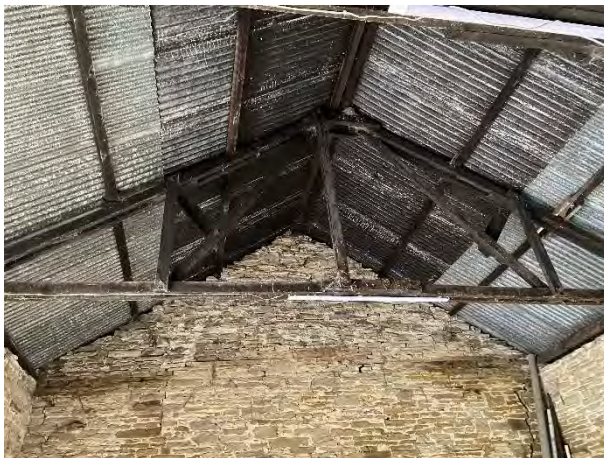
**Figure 34: Barn Timber Roof Truss**

The barn consists of a traditional stone structure with a dividing stone wall and cobbled floors. The roof is duo-pitched cut roof supported off timber trusses (Figure 34) with a metal sheet covering. The external walls measure as being 440mm thick. Checks on the barn's corners confirm them to be plumb, with only minor deviations found on the front and rear elevation.

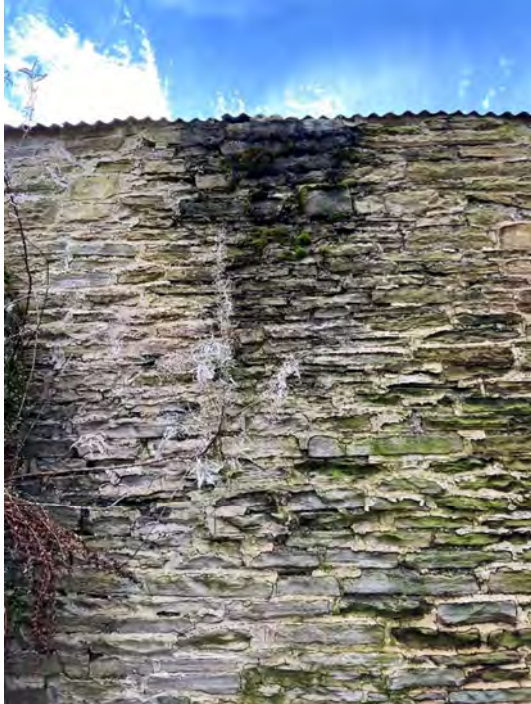
**Figure 36: Barn Rear Wall 2**

In general, the rear elevation is in a reasonable visible condition. The masonry in lower right-hand corner of the elevation should be repointed (Figure 35). The stonework is also pitted and weathered which is most probably a result of driving rain. There is a localised area at the head of the wall which is saturated with vegetation (moss) growing (Figure 36). The wall appears to be bowing by approximately 25mm over a length of 925mm in the middle of the wall at the rear door location.

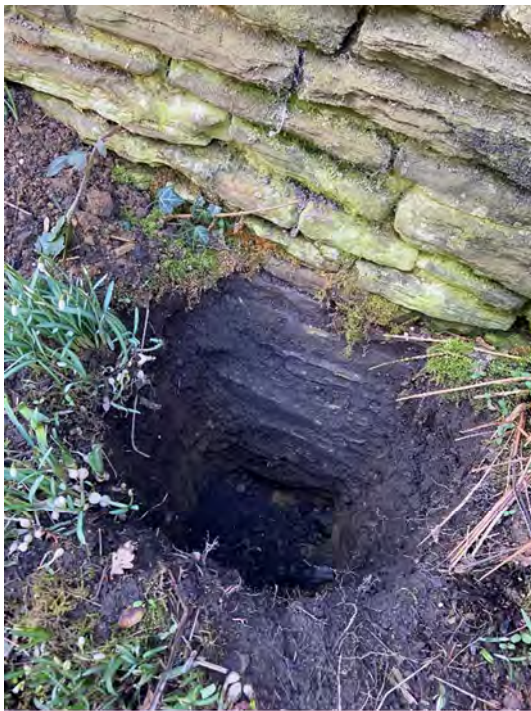
**Figure 40: Trial Pit 6 Arisings**

The Slaughterhouse consists of a small single-storey traditional stone masonry barn with a traditional timber cut roof. The roof comprises stone slates supported on timber rafters with canted timber purlins spanning between external walls. Trial Pit 6 indicates the structure is founded on stone footings approximately 700mm below existing ground level on sandy gravel (Figure 40). There is a level change of approximately 300mm from ground level at the North side of the building and the internal floor level.

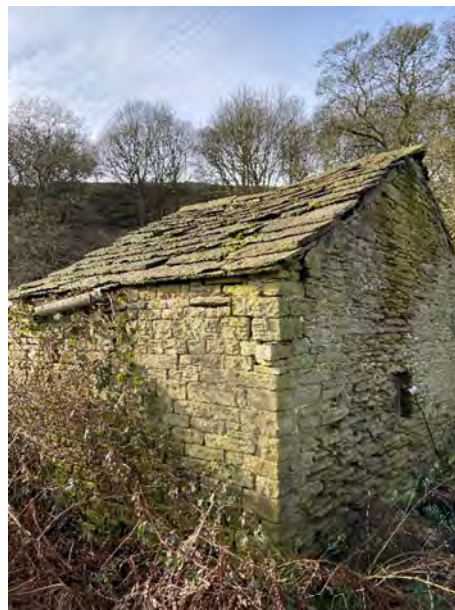
**Figure 41: Slaughterhouse North and East Elevations**

Overall, the walls are in a reasonable condition. However, some defects are present. The stonework is badly weathered on the North elevation which is most likely a result from driving rain and wind (Figure 41). The timber lintel over the entrance (Figure 45) and the timber sill on the Southern elevation are also rotten and need replacing (Figure 42).

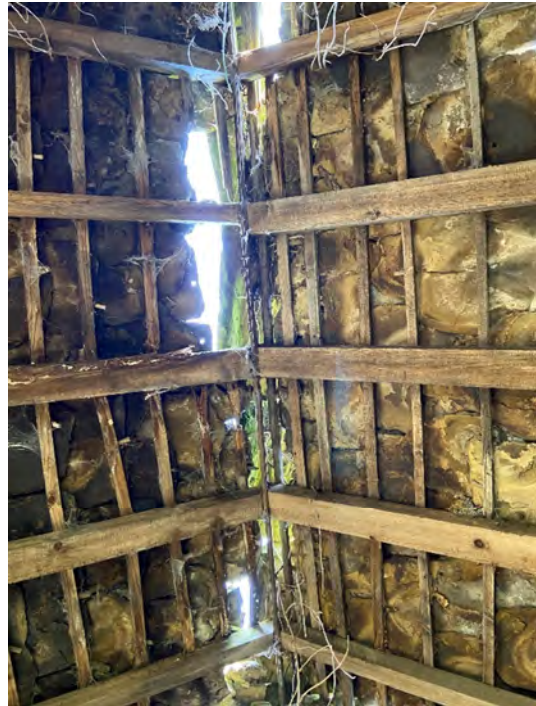
**Figure 43: Slaughterhouse Roof 1**

The canted timber purlins were also observed to be bowing in both directions resulting in roof spread at the eaves (Figure 44). This ridge is sagging, and daylight can be seen through the roof tiles (Figure 43). The roof spread has caused some cracking and deviation at the head of the external walls. Otherwise, they were found to be plumb.
