# Arboricultural Report

## Tolson Court - Penistone

| Report Ref: | TCPB01-21 | Report Date: | 20th July 2021 |

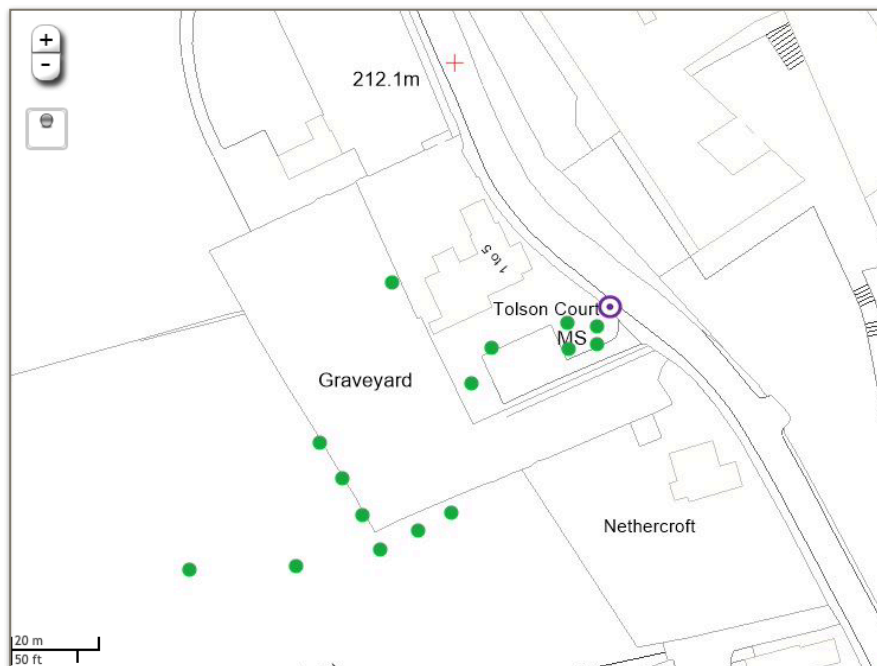
Figure 1

Information obtained from the Barnsley District Council website visited on the 20th July 2021 shows that the trees surveyed are each protected by a Tree Preservation Order (TPO). A screen shot from this search has been given in Figure 1.
