41 Hoyland Road, Hoyland Common

Bat Survey Report

21st August 2025

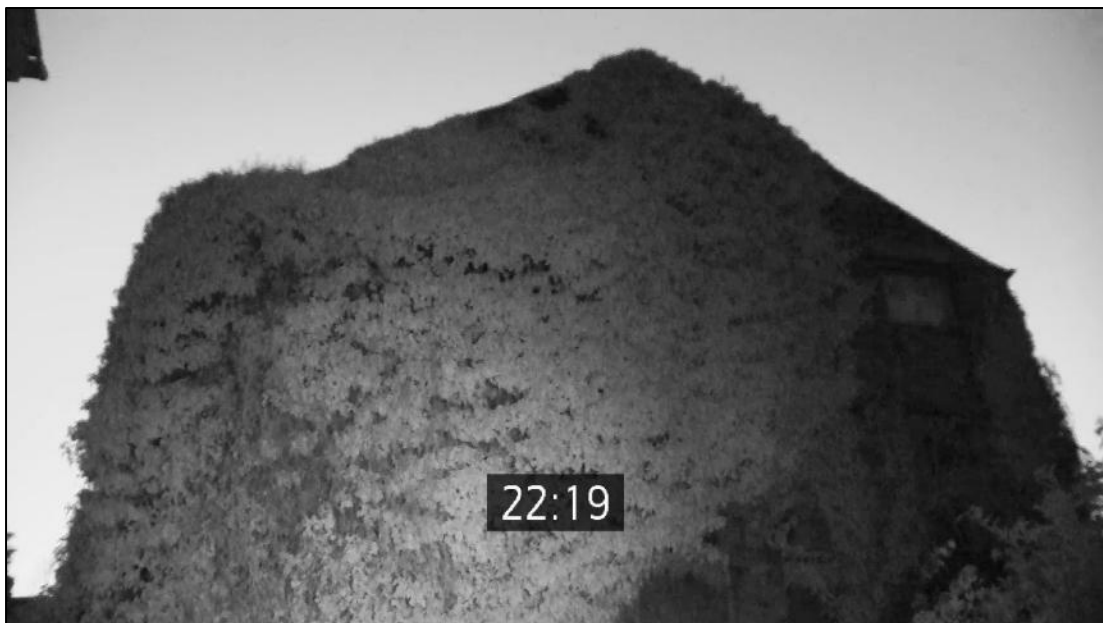
4.2.6 During the first nocturnal survey, all elevations of the chapel were covered. During the second survey visit the southeast gable was not included due to the lack of access to the private garden facing this elevation. This lack of coverage of the southeast gable during the second survey visit was not considered a significant constraint as the associated gable was not considered to display more than a low level of bat roost suitability. Surveyor locations are shown on Figure 3.

Plate 1. Image from footage of southeast gable, taken 42 minutes after sunset

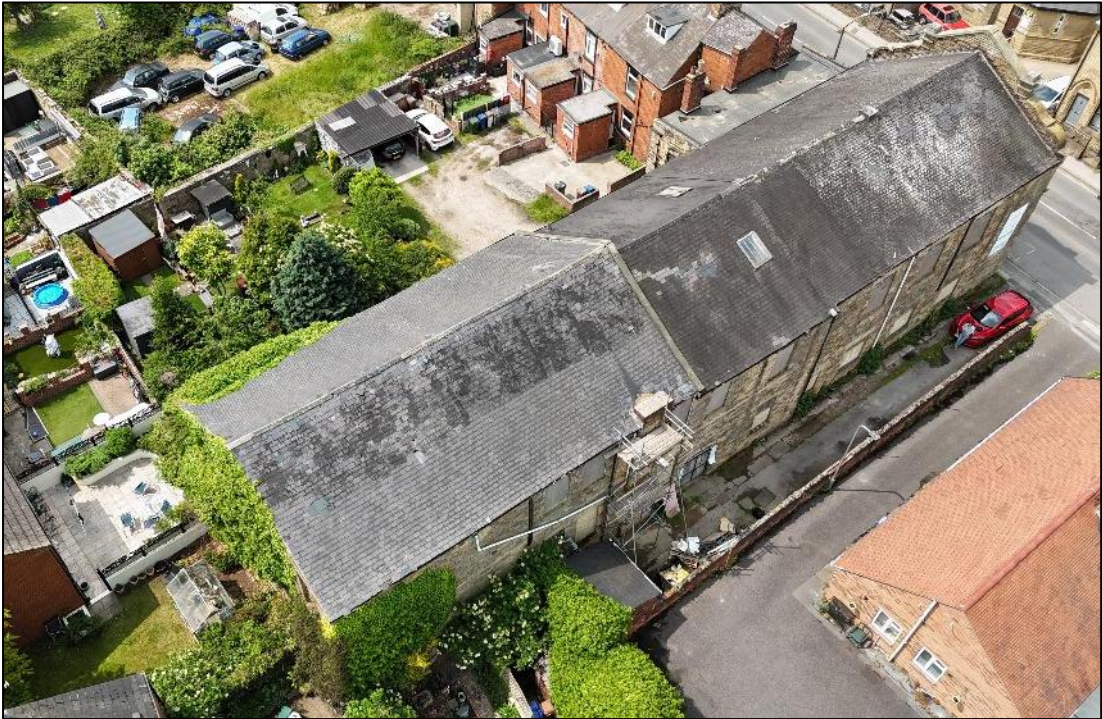
Plate 2. Building viewed from east corner

5.2.3 The former Wesleyan Chapel comprised a large stone-built two-storey former church, built in 1894 (Plates 2-6). The roof was dual pitched, with the ridge height stepping up towards the southeast end of the building (Plates 2, 4 & 6). The building roof was covered with Welsh slates, with mortar-bedded clay ridge tiles. An ornate stone parapet was present on the façade/northwest gable, with coping present on top of the section of wall where the ridge line stepped up. There was a mortar-filled verge on the southeast gable and the building had a wooden fascia board with plastic guttering. Windows were wood-framed and single-paned, although most windows were boarded or otherwise covered with mesh. Two skylights were present together with a single chimney. A stone-built single storey extension with a single-pitch Welsh-slate-covered roof was present on the building's northeast elevation.

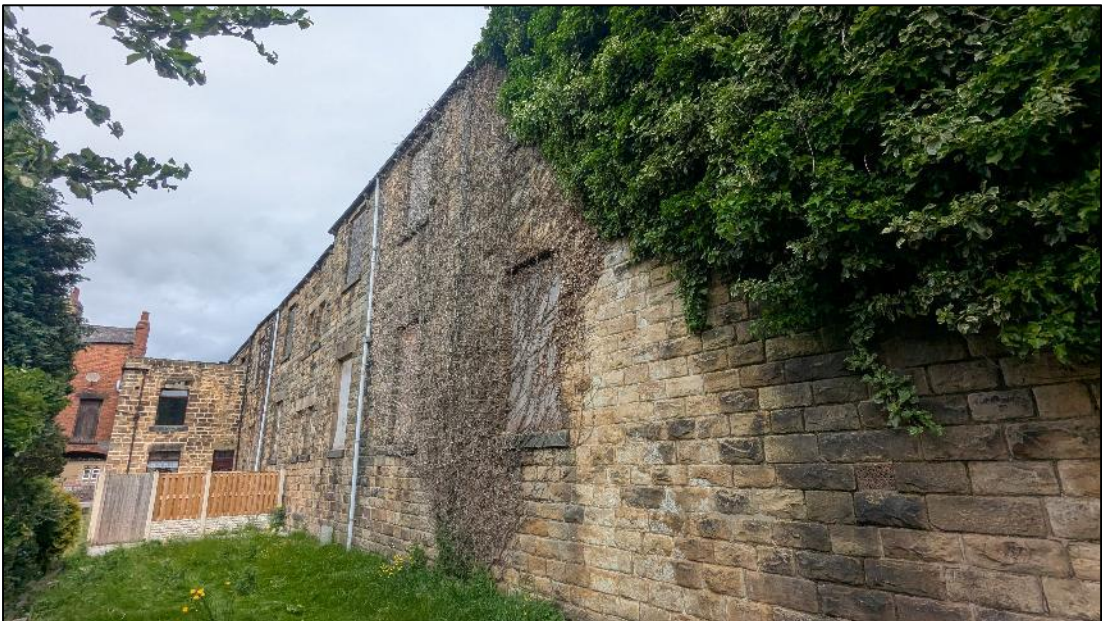
Plate 3. Looking northwest along southwest elevation

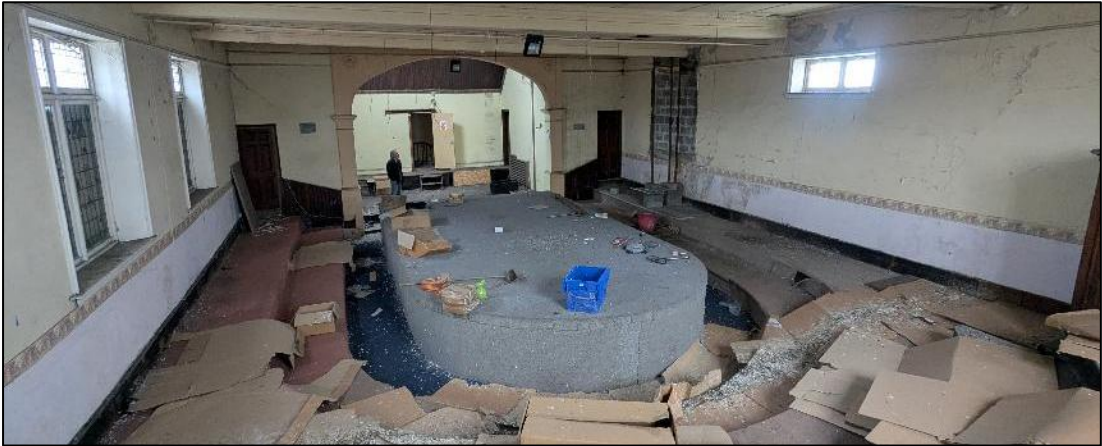
Plate 10. First floor section of building
