**Whitcher Wildlife Ltd.
Wildlife Consultants.**

OAKS FARM, DARTON.

BAT SURVEY.

Ref No:- 141030.

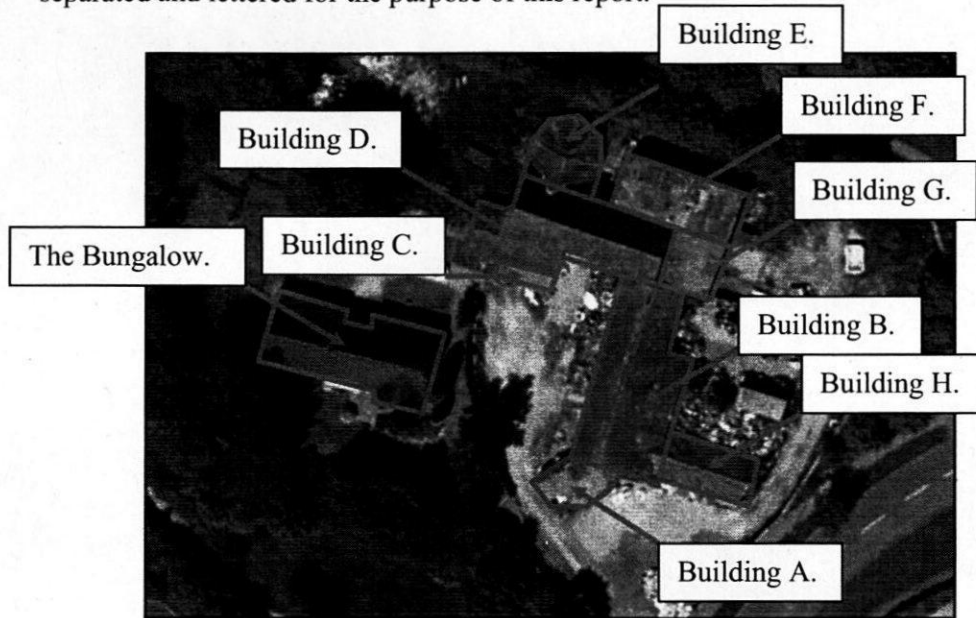
3.2.1. The aerial photograph below shows the surveyed buildings which have been separated and lettered for the purpose of this report.
