Project No: 22131

Project: Roughbirchworth Lodge
Roughbirchworth Lane
Oxspring
Barnsley
S36 8YZ

Subject: Road Condition Report

Date: 24th October 2023 (Issue 02)

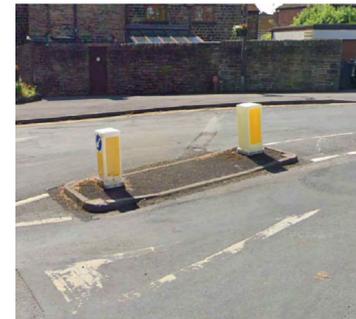
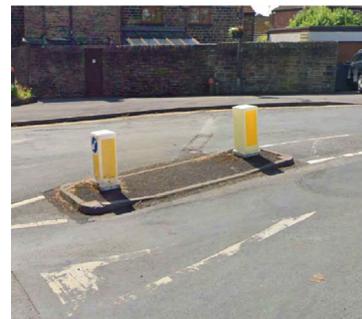
Image 23 (Chainage 188m)

Image 23 reveals the current condition of traffic bollards that are in reasonable condition. However road markings are in poor condition and kerbs are in reasonable condition.

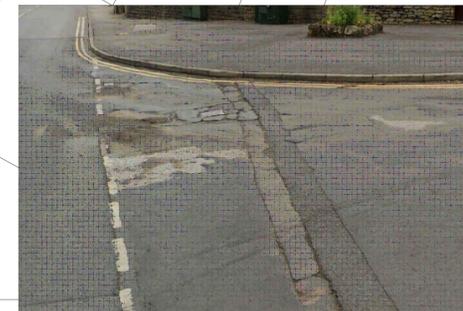
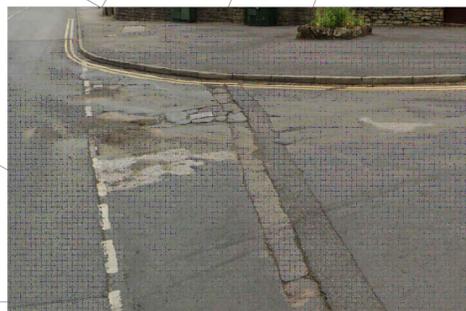
Image 21 (Chainage 192m)

Image 21 reveals the failure of several patch repairs forming cracking, crazing and potholes. This failure does not require an immediate repair, however, it is considered that these road surface failures will be exacerbated by water ingress and freeze thaw effects. In addition, road markings are in poor condition.

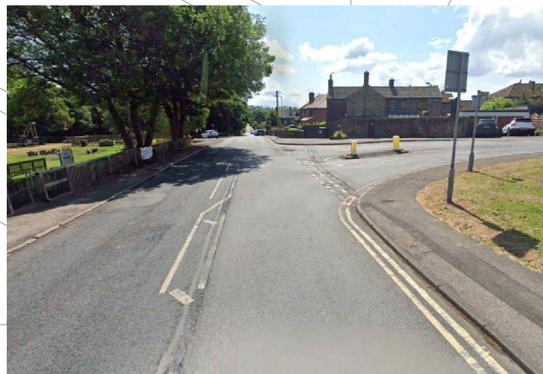
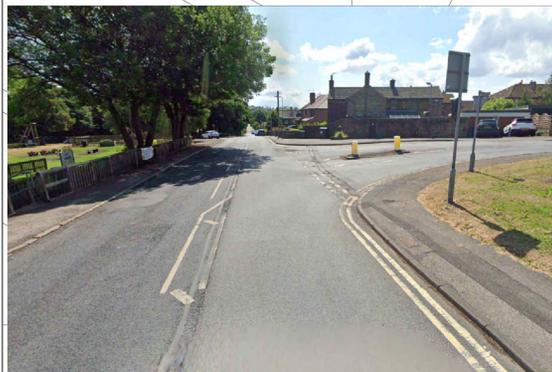
Image 25 (Chainage 192m)

Image 25 reveals the failure of several patch repair forming cracking, crazing and potholes. This failure does not require immediate repair, however, it is considered that these road surface failures will be exacerbated by water ingress and freeze thaw effects. In addition, road markings are in poor condition.

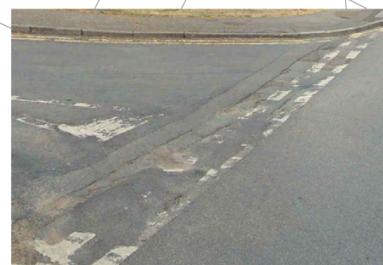
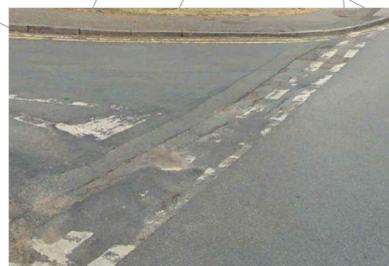
Image 22 (Chainage 192m)

Image 22 reveals the failure of several patch repairs forming cracking and crazing. This failure does not require immediate repair, however, it is considered that these road surface failures will be exacerbated by water ingress and freeze thaw effects. In addition, road markings are in poor condition.

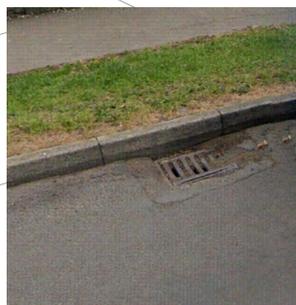
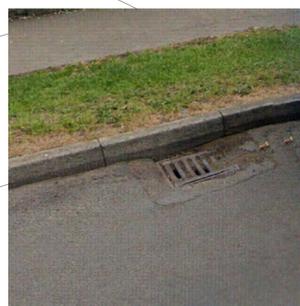
Image 16 (Chainage 107m)

Image 16 reveals the failure of the gully surround and patch repair. This failure does not require immediate repair, however, it is considered that these two patch repairs will form potholes.

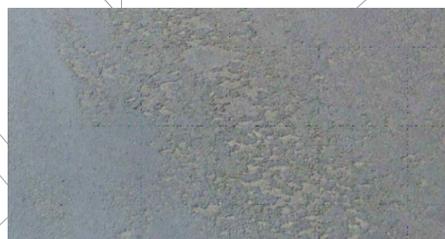
Image 14 (Chainage 82m)

Image 14 reveals fretting of the surface course, which is usually caused by the loss of aggregate in the road surface. Due to water ingress this will eventually cause potholes.

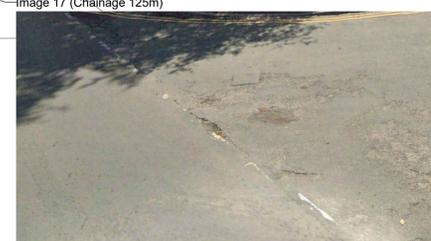
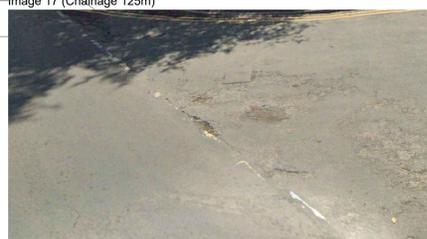
Image 17 (Chainage 125m)

Image 17 reveals crazing of the surface course, which is usually the symptom of partial or total failure of the road surface layer.

In addition, potholes are forming along the joint. Not all potholes that form on roads require immediate repair and most reported to us generally receive a lower category of priority for repair depending on their depth, position in the road and the volume of traffic using the route. In addition, road markings are in poor condition.

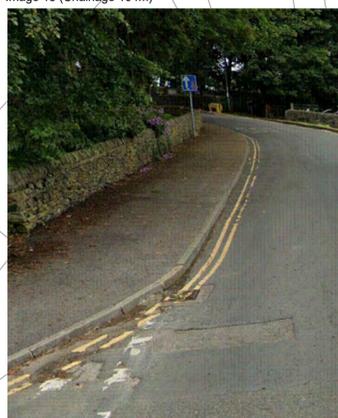
Image 15 (Chainage 104m)

Image 15 reveals the failure of the gully surround and patch repair. This failure does not require immediate repair, however, it may be likely that these two patch repairs will form potholes. In addition, road markings are in poor condition.

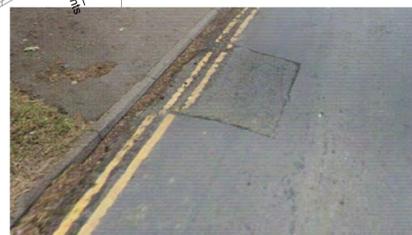
Image 13 (Chainage 62m)

Image 13 reveals settlement of a patch repair. Generally road markings are in reasonable condition and kerbs are in poor condition.

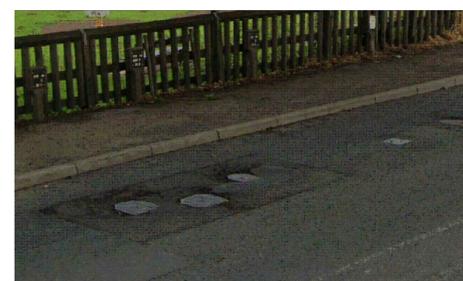
Image 20 (Chainage 192m)

Image 20 reveals reveals the failure of several patch repairs surrounding ironwork. This failure does not require immediate repair, however, it is considered that these patch repairs are likely to form potholes. In addition, road markings are in poor condition.

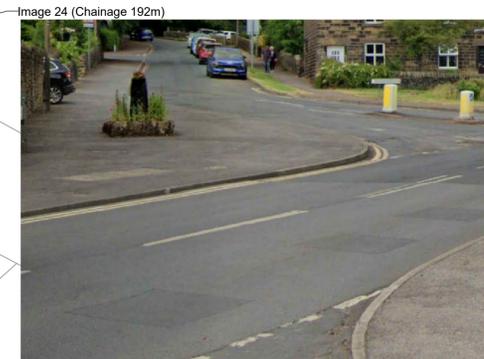
Image 24 (Chainage 192m)

Image 24 reveals the failure of several patch repair forming cracking, crazing and potholes. This failure does not require immediate repair, however, it is considered that these road surface failures will be exacerbated by water ingress and freeze thaw effects. In addition, road markings are in poor condition.
