# **ARBORICULTURAL REPORT & Impact Assessment to BS5837:2012 at:**

***Lee Lane,  
Millhouse Green,  
Sheffield  
S36 9LN***

Prepared for:  
***White Agus Partnership***

Reference: AWA3917

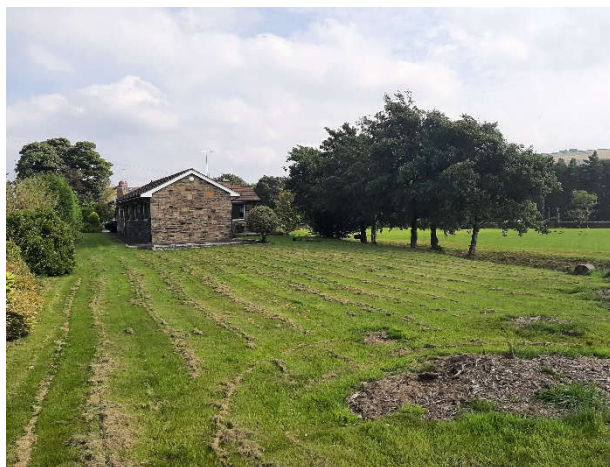
Photo 1: The site, as viewed from the west

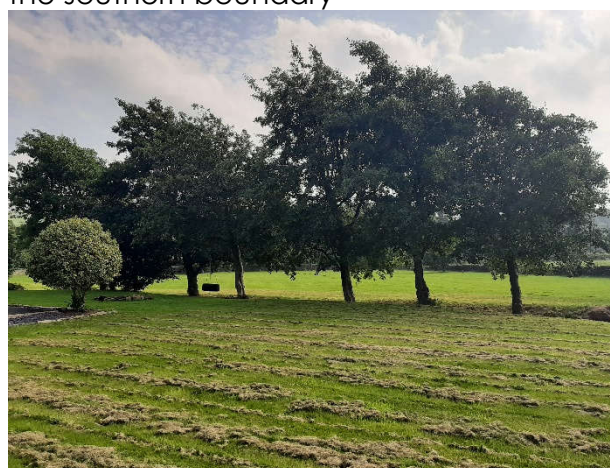
- 3.2.3 At the southern boundary of the garden are Hawthorn T1, Cherry T2, Alder T3 and T5 to T9, and Beech T4. These trees are situated on, or at the top of, a slight banking, and due to their exposed location a number of the trees are leaning with the prevailing wind. T3, T5, T6 and T7 appear to have been reduced in the past, with upper crowns typical of previously topped trees. T6 and T8 were previously twin-stemmed trees, however stems have previously been removed resulting in old pruning wounds with signs of decay at the base, which may limit long-term prospects. The trees at the southern boundary typically have low individual value, but collectively provide reasonable screening for the highway to the south.

Photo 4: Trees at the southern boundary provide screening from the highway to the south
