Woodwalk, Hoyland – BS 5837: 2012 Arboricultural Report, Impact Assessment and Method Statement

Ref: 21805

Report Title: Wood Walk Hoyland – BS 5837:2012 Arboricultural Report,
Impact Assessment and Method Statement

Version: V5.0
Issue Date: May 2026
Report Ref: 21805

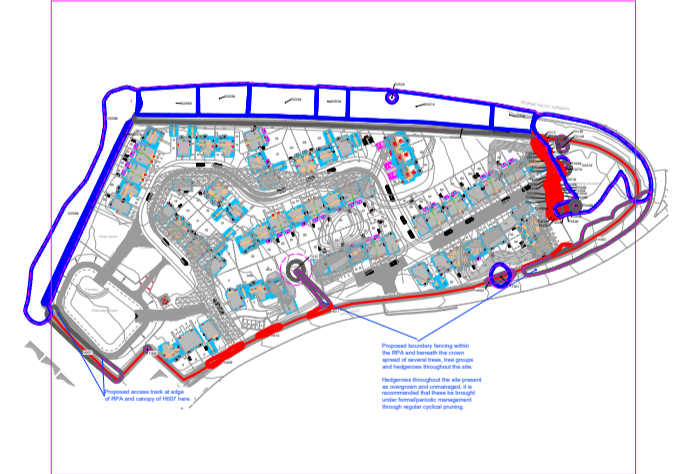
Proposed boundary fencing within the RPA and beneath the crown spread of several trees, tree groups and hedgerows throughout the site.

Hedgerows throughout the site present as overgrown and unmanaged, it is recommended that these be brought under formal/periodic management through regular cyclical pruning.
