Gun Room in Wentworth Castle Gardens

Bat Survey Report

7th May 2025

Document ref: MBE/BAT/2025/011/02				
Purpose and Description	Originated	Checked	Reviewed	Date
For Planning	R Bell MCIEEM <i>R Bell</i>	P Middleton MCIEEM <i>P Middleton</i>	R Bell MCIEEM <i>R Bell</i>	07/05/2025

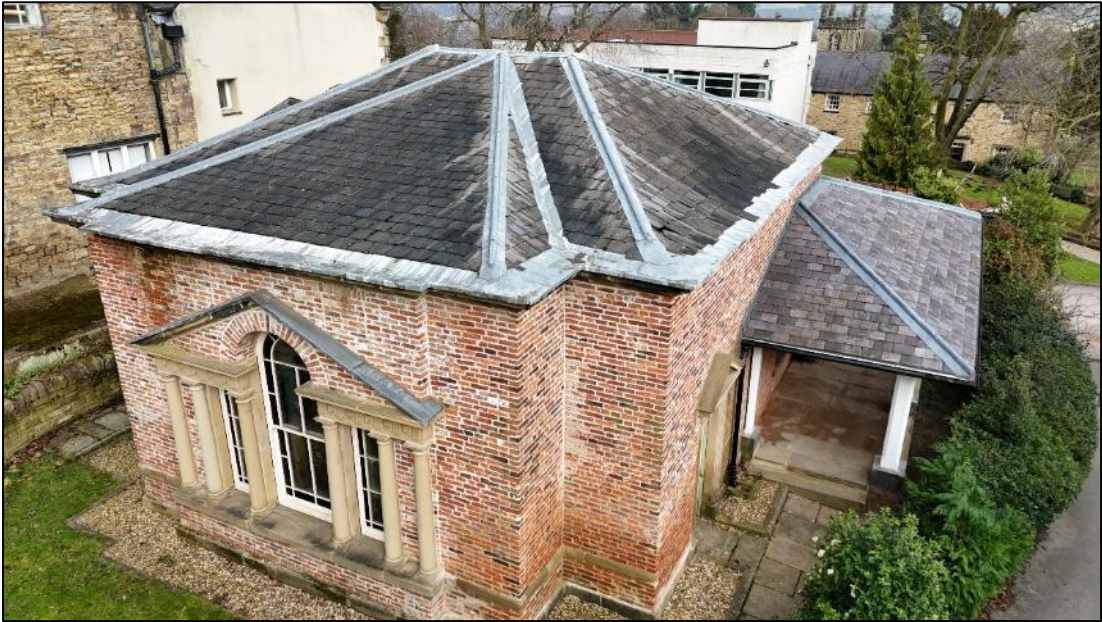
- 5.2.4 The main building, parts of which date back to the mid-18th Century, was single storey and constructed from a mix of brick and stone, with decorative masonry on the façade (southwest elevation)(Plate 3). The Welsh slate covered roof was multi-pitched, with sheet lead covered ridge, hips and wall tops. A single chimney was present on the northwest elevation. The windows were single paned and wood framed with the door also wooden. Guttering was cast iron, where present.

Plate 3. Southern corner of Gun Room

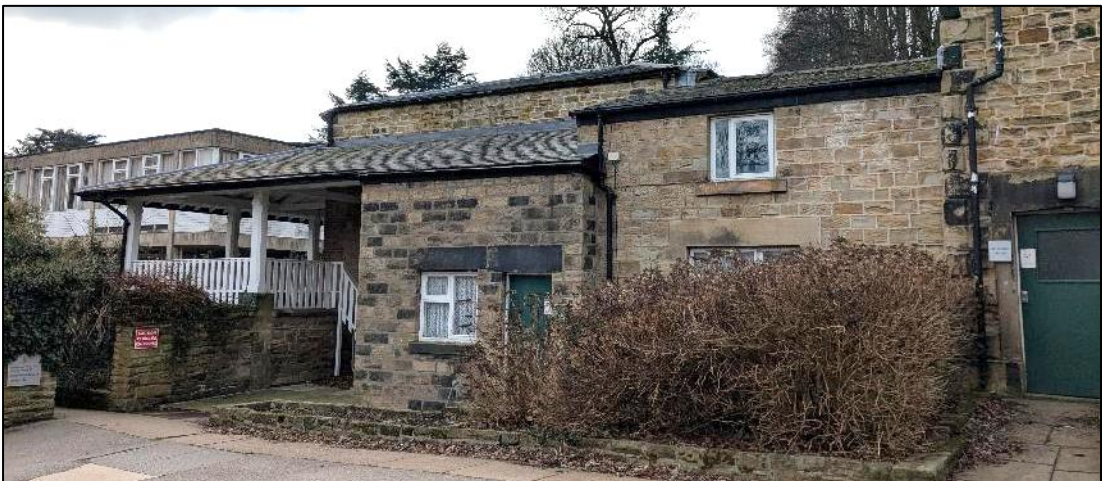
- 5.2.6 Daisy Cottage comprised a stone and brick built single storey extension. Daisy Cottage shared a recently renewed single pitched and Welsh-slate covered roof with the veranda (Plates 2 & 5-6). A single paned wood-framed window was present, together with a wooden door. Guttering was cast iron.

Plate 5. Daisy Cottage and veranda on northeast elevation of Gun Room

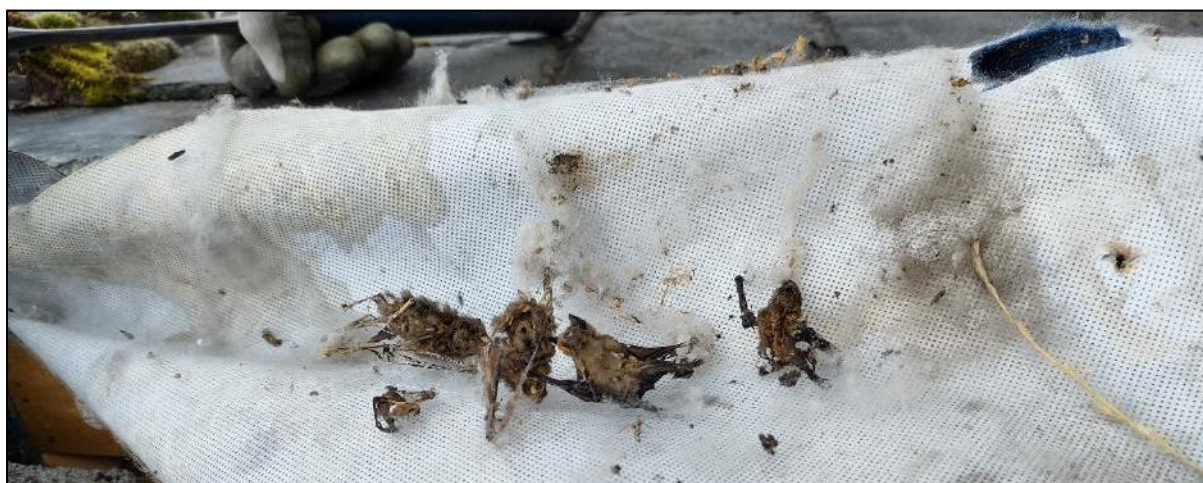
One example we have encountered comprised a pipistrelle roost which formed in a building extension constructed in 2009. Over the course of just 13 years the roofing felt degraded to the extent that it trapped and killed more than 10 bats. Fortunately, the problem in this roost was identified and remedial work was undertaken to replace the roofing membrane in 2022.

Plate A2.1. Four dead pipistrelles tangled in breathable roofing membrane

Traditional bituminous Type 1F roofing felt is a non-breathable product and therefore ventilation is required. Sufficient ventilation can be usually be achieved, even in buildings with vaulted ceilings, however, some consideration during the design stage is required. Products to increase the ventilation within roofs where bituminous Type 1F felt has already been installed are also available.

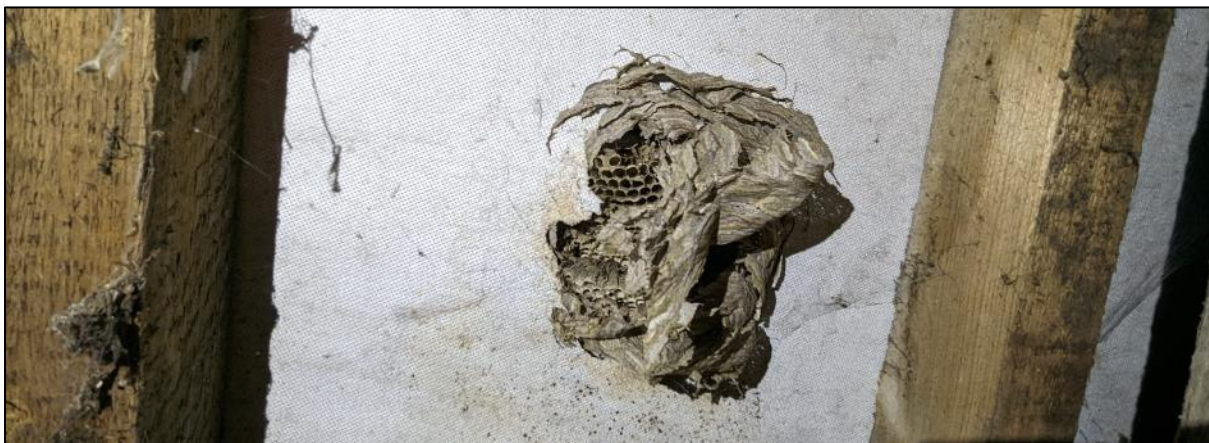
In recent years a fairly substantial proportion of the lofts we have surveyed which had existing breathable felt, were found to have been damaged by wasps (Plate A3.2). The wasps appear to have chewed holes in the felt and formed nests. This doesn’t appear to be a problem associated with traditional bitumen coated roofing felt. Any holes within roofing felt are likely to significantly reduce its functionality as a secondary weather barrier. Where bats or birds come into contact with breathable roofing membranes, they can also damage it causing it to leak, they can also significantly reduce the breathability of the felt in that location.

Plate A2.2. Damage to a breathable roofing membrane adjacent to a wasp nest
