## **SHAW LANE, CARLTON, S278 WORKS**

**Combined Stage 1 and Stage 2 Road Safety Audit**

**Client: Vistry Group**

**19/08/2026**

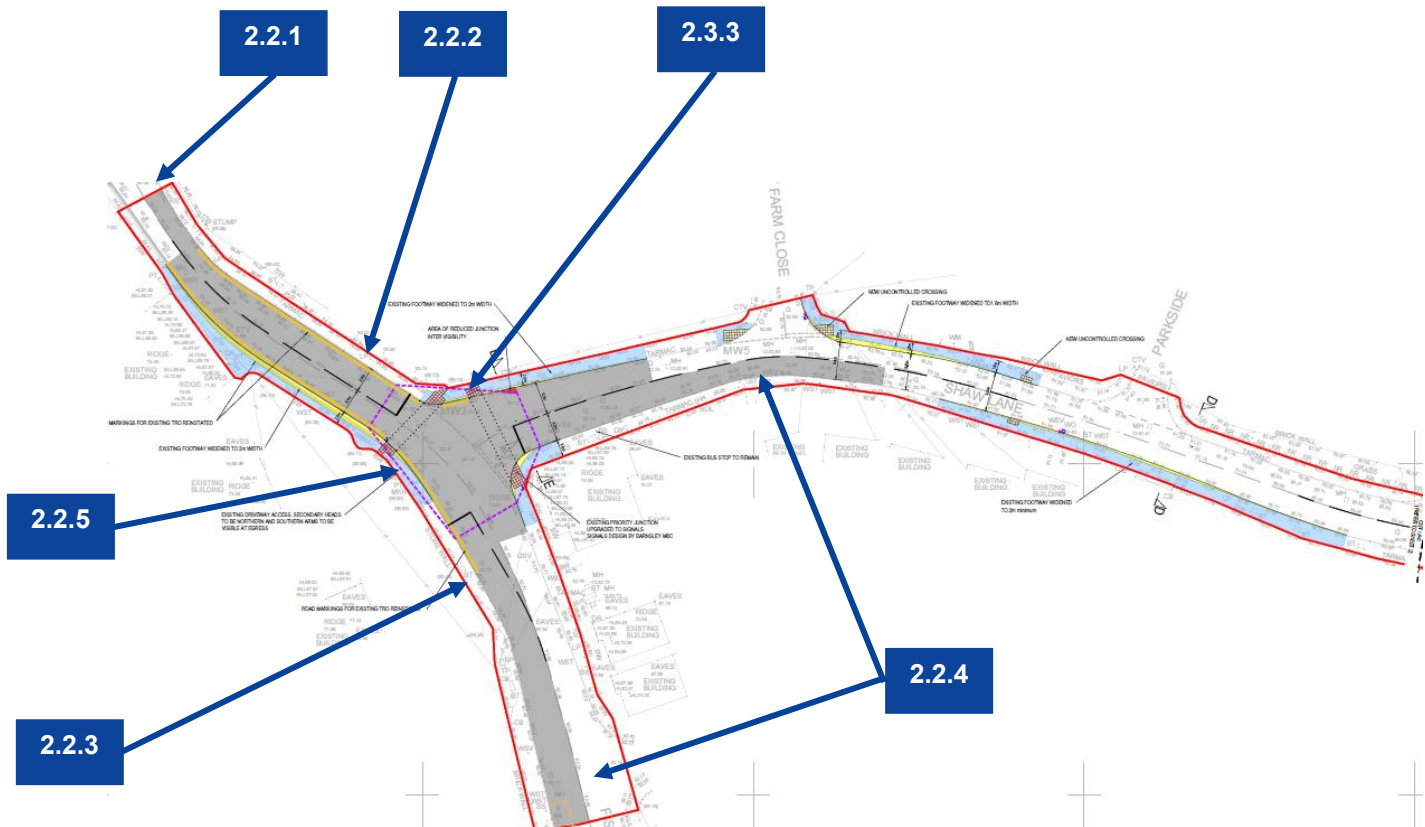
**General Problems at junction**  
 2.1.1 – Maintenance vehicle parking  
 2.1.2 – Redundant bus stops

| PROBLEM 2.1.1 | |
|---|---|
| <p>There are two redundant pairs of bus stops in Shaw Lane:</p> <ul style="list-style-type: none"> <li>• westbound and eastbound bus stops near the proposed Fish Dam Lane traffic signals; and</li> <li>• westbound and eastbound bus stops adjacent to the proposed site access junction.</li> </ul> <p>If these bus stops are brought back into use, stopped buses could restrict visibility on the approach to traffic signals and / or become a hazard for turning traffic at site access junction.</p> <div style="display: flex; justify-content: space-around;"> </div> | |

| PROBLEM 2.1.1 | |
|---|---|
| It is recommended that the redundant bus stop poles / flags are removed. | |

| It is recommended that there are safe and convenient maintenance vehicle parking locations at both the traffic signal junction and the Toucan crossing. | |

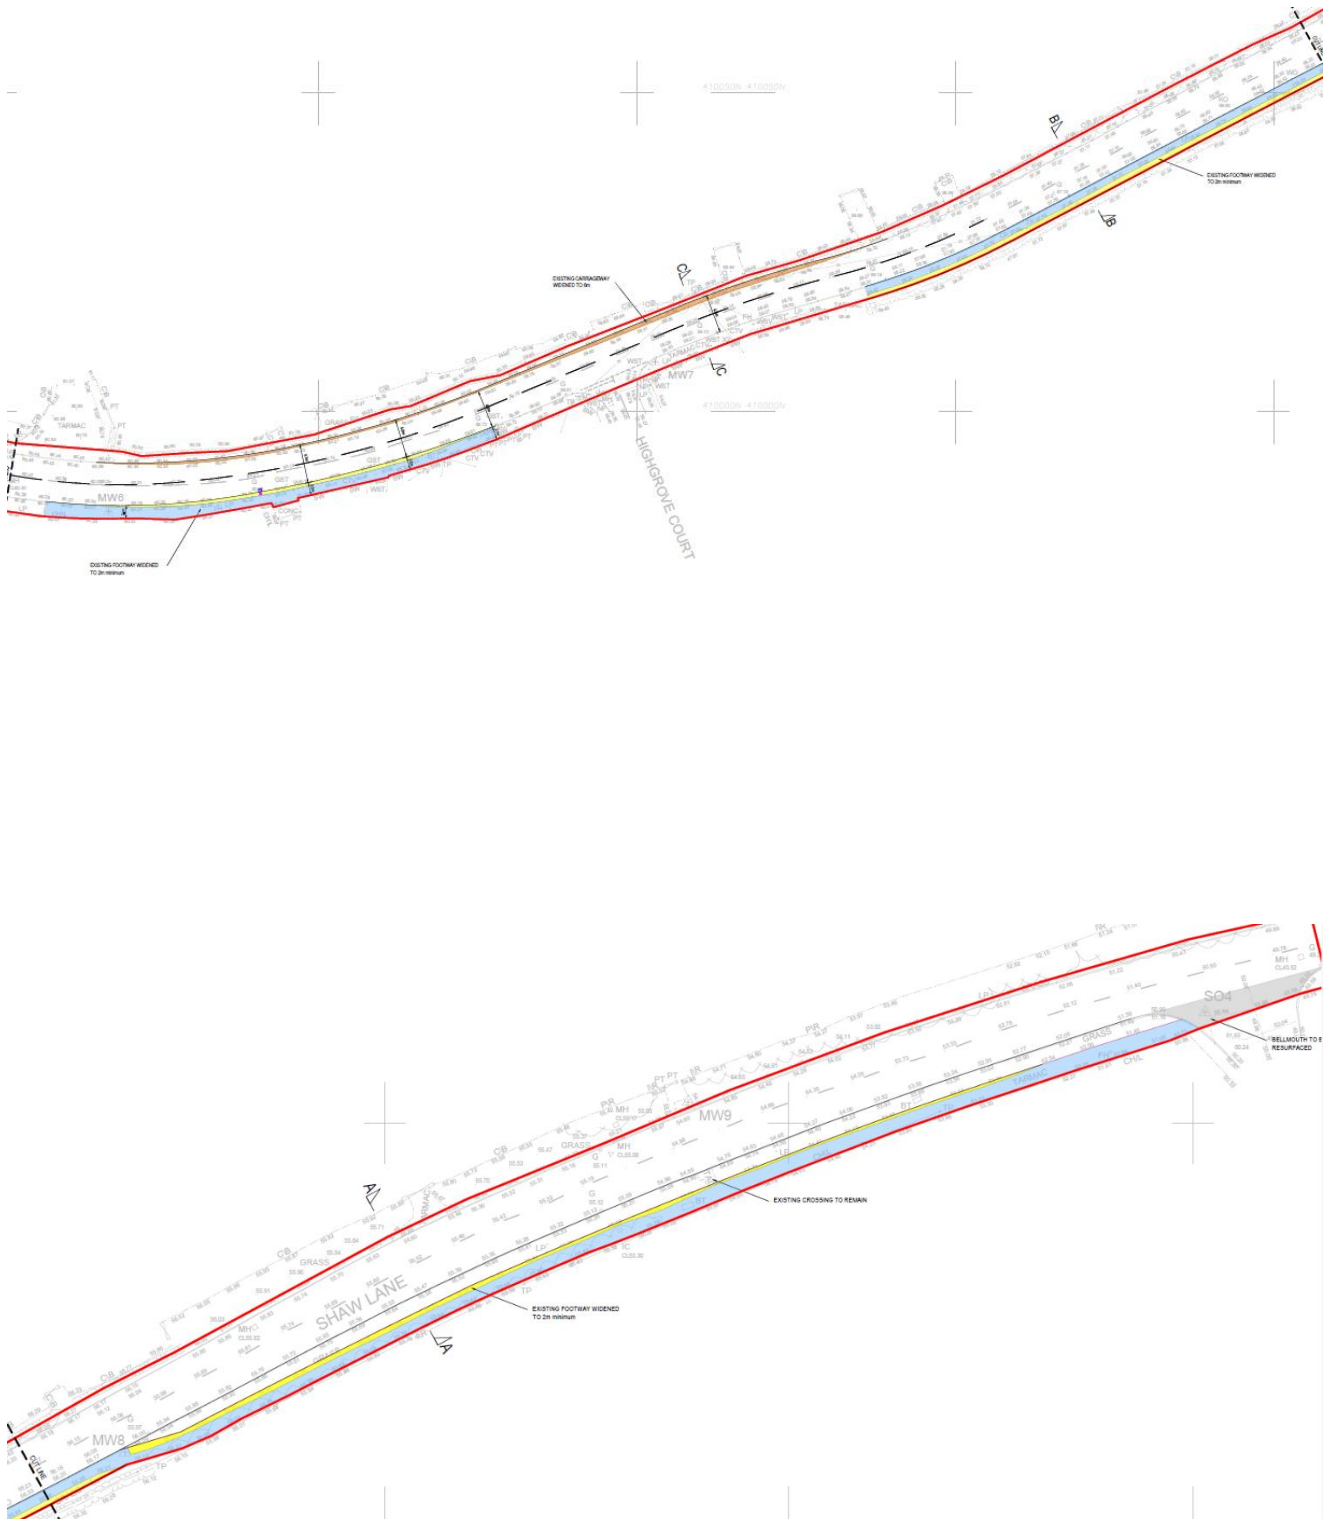
## General Problems at junction

### 2.1.1 – Maintenance vehicle parking

### 2.1.2 – Redundant bus stops
