**Arboricultural Impact Assessment
(including Tree Survey)**

**Land South of Halifax Road,
Penistone**

Report reference: AR-3706-02.02
May 2021

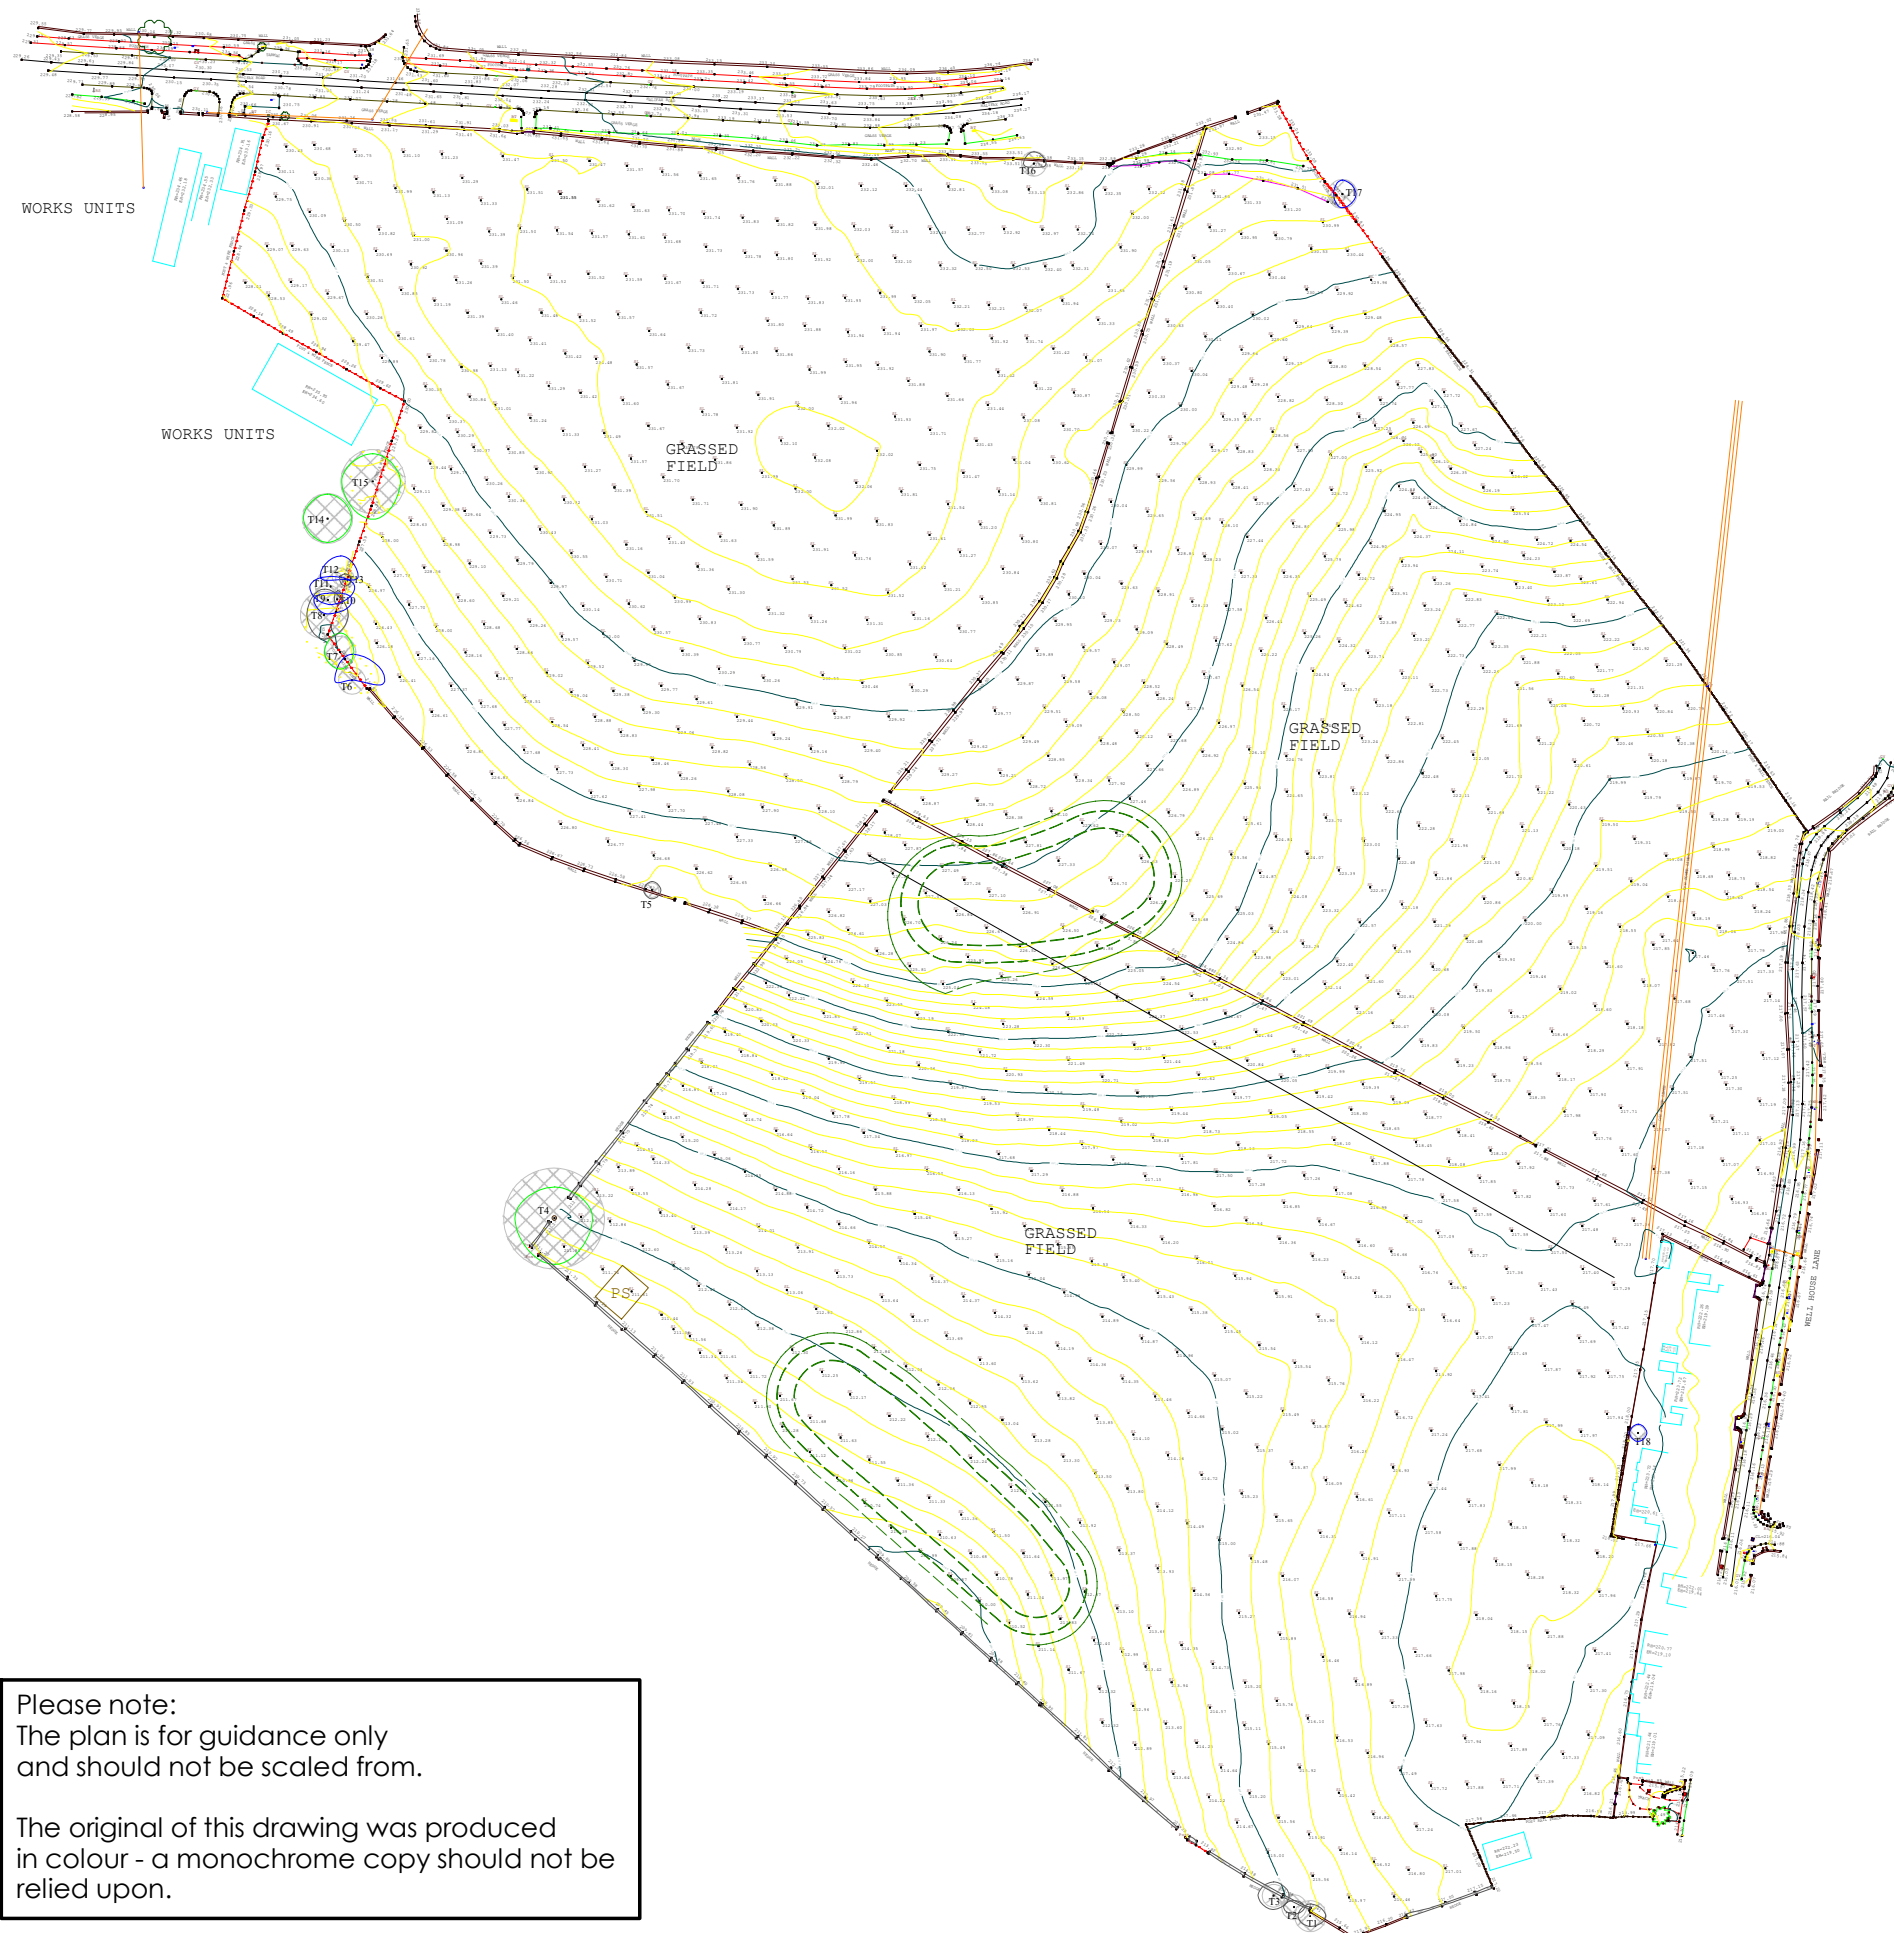
DR-3706-01.02 Tree Constraints Plan

T15 oak located just outside the Site boundary fence and overhanging the Site. This tree should be protected from damage during development.
