Descriptive Report with Remarks and Observation Images

Site: Gawber Road , Barnsley

Client: Mott Macdonald	Location (Street Name): Gawber Road	City/Town/Village Barnsley	Cust Job Ref.	Surveyors Name: Jordan Beckett	Date: 28/01/2019
---------------------------	--	-------------------------------	---------------	-----------------------------------	---------------------

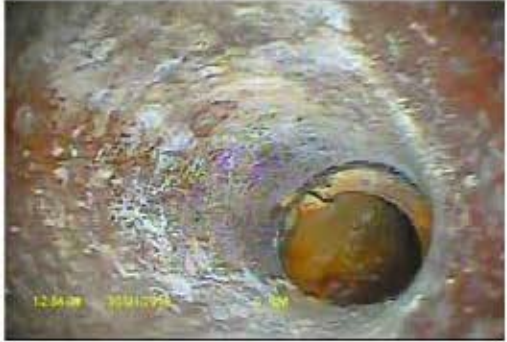
Pos	Video Ref	Code	Description	Image
00.00m		MH	Start node type, manhole MH07	
00.00m	0:00:00	WL	Water level: 0% Height/Diameter	
00.10m	0:00:06	LRQ	Line of drain/sewer deviates right [quarter]	Image Provided - Ref: 18_2

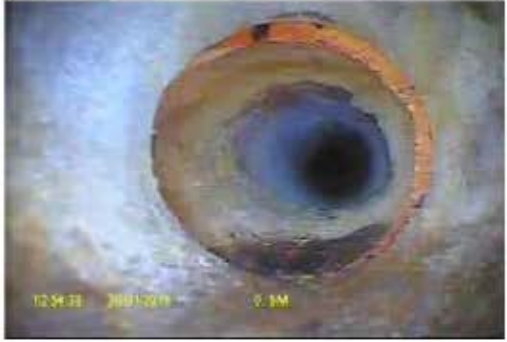
00.50m	0:00:10	JDL	Joint displaced large - Severity 4	Image Provided - Ref: 18_3

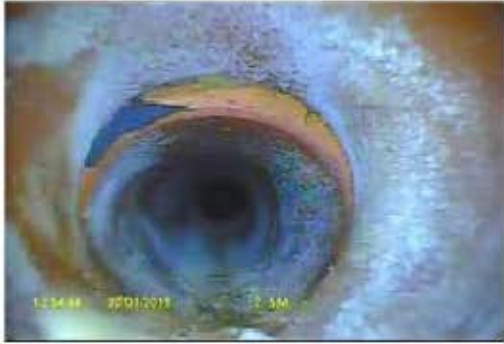
Pos	Video Ref	Code	Description	Image
02.50m	0:00:15	JDL	Joint displaced large - Severity 4	Image Provided - Ref: 18_5

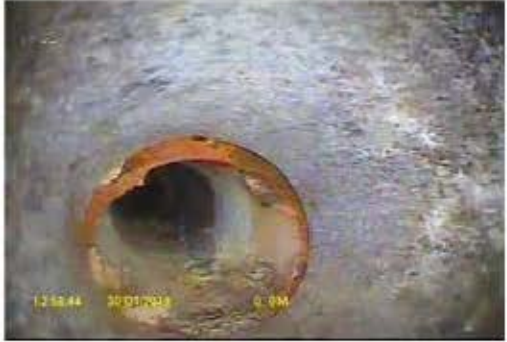
Pos	Video Ref	Code	Description	Image
00.00m		MH	Start node type, manhole MH07	
00.00m	0:00:00	WL	Water level: 0% Height/Diameter	
00.10m	0:00:07	JDL	Joint displaced large - Severity 4	Image Provided - Ref: 19_2

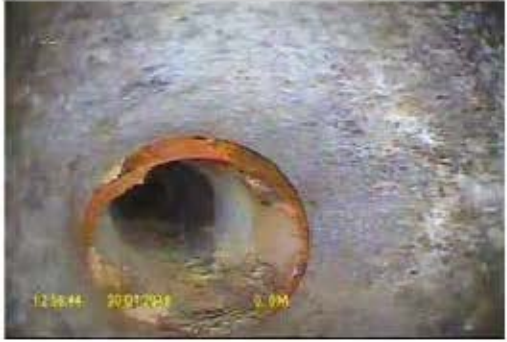
00.10m	0:00:07	LLQ	Line of drain/sewer deviates left [quarter]	Image Provided - Ref: 19_3

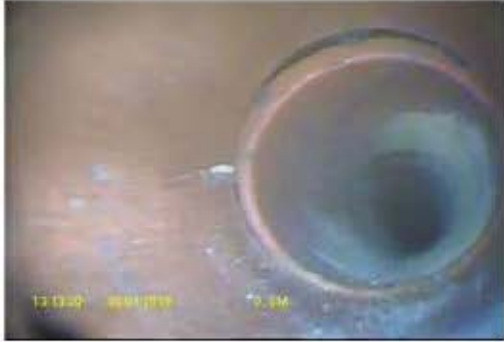
Pos	Video Ref	Code	Description	Image
00.00m		MH	Start node type, manhole MH07	
00.00m	0:00:00	WL	Water level: 0% Height/Diameter	
00.10m	0:00:07	JDL	Joint displaced large - Severity 4	Image Provided - Ref: 20_2

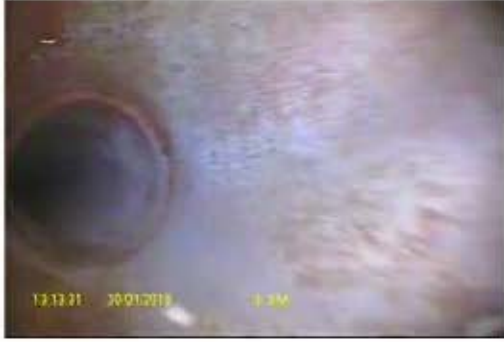
05.90m	0:00:18	LLQ	Line of drain/sewer deviates left [quarter]	Image Provided - Ref: 20_3

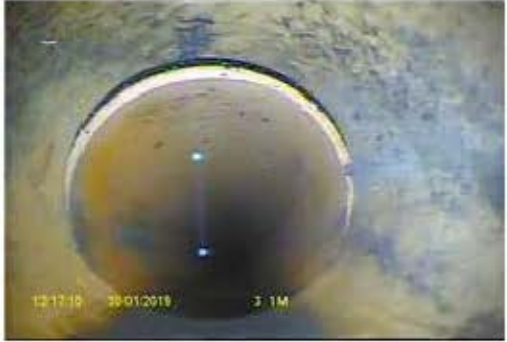
Pos	Video Ref	Code	Description	Image
00.00m		MH	Start node type, manhole MH08	
00.00m	0:00:00	WL	Water level: 0% Height/Diameter	
03.10m	0:00:19	JDL	Joint displaced large - Severity 4	Image Provided - Ref: 24_2

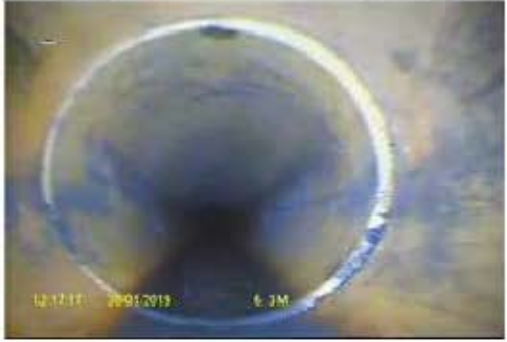
06.30m	0:00:26	JDM	Joint displaced medium - Severity 3	Image Provided - Ref: 24_3

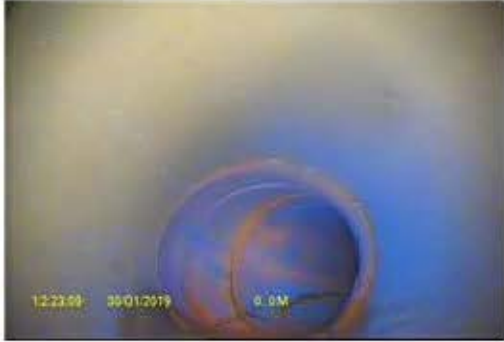
Pos	Video Ref	Code	Description	Image
00.00m		MH	Start node type, manhole MH08	
00.00m	0:00:00	WL	Water level: 0% Height/Diameter	
00.10m	0:00:06	LRH	Line of drain/sewer deviates right [half]	Image Provided - Ref: 25_2

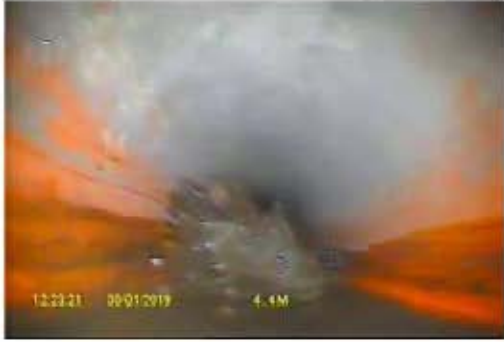
04.40m	0:00:18	DER	Settled deposits coarse: 90% Cross sectional area loss - Severity 3	Image Provided - Ref: 25_3

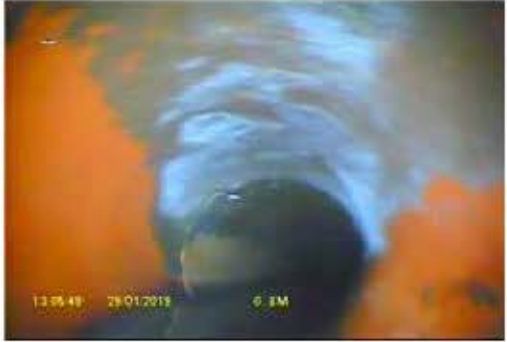
Pos	Video Ref	Code	Description	Image
00.00m		MH	Start node type, manhole MH09	
00.00m	0:00:00	WL	Water level: 0% Height/Diameter	
00.80m	0:00:11	LRQ	Line of drain/sewer deviates right [quarter]	Image Provided - Ref: 27_2

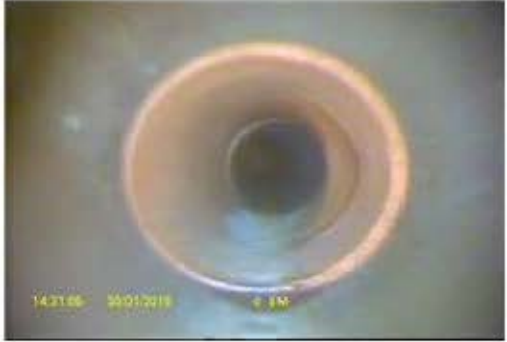
Pos	Video Ref	Code	Description	Image
00.00m		MH	Start node type, manhole MH09	
00.00m	0:00:00	WL	Water level: 0% Height/Diameter	
00.80m	0:00:18	JN	Junction at 03 o'clock: 100mm Diameter	Image Provided - Ref: 28_2

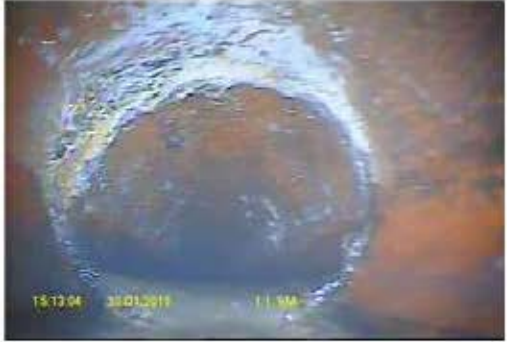
Pos	Video Ref	Code	Description	Image
00.00m		MH	Start node type, manhole MH11	
00.00m	0:00:00	S1 WL	Water level 0m - 17.6m: 30% Height/Diameter	
11.90m	0:01:29	JDM	Joint displaced medium - Severity 3	Image Provided - Ref: 32_2

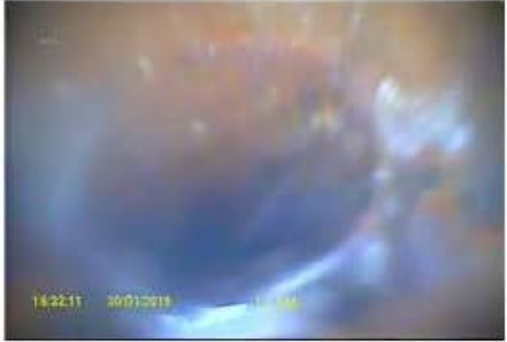
Pos	Video Ref	Code	Description	Image
00.00m		MH	Start node type, manhole MH15	
00.00m	0:00:00	WL	Water level: 0% Height/Diameter	
13.60m	0:00:37	JDL	Joint displaced large - Severity 4	Image Provided - Ref: 34_2

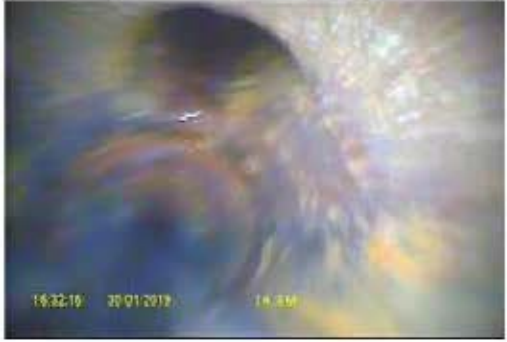
14.80m	0:00:41	JN	Junction at 01 o'clock: 100mm Diameter	Image Provided - Ref: 34_3

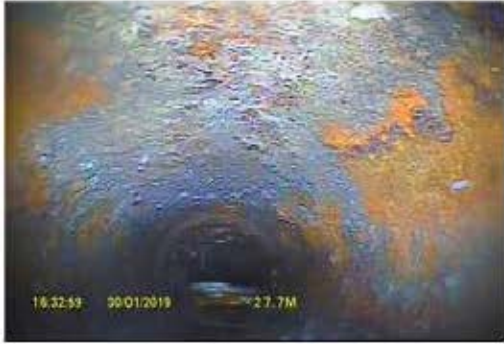
Pos	Video Ref	Code	Description	Image
27.70m	0:01:24	DER	Settled deposits coarse: 60% Cross sectional area loss - Severity 3	Image Provided - Ref: 34_5

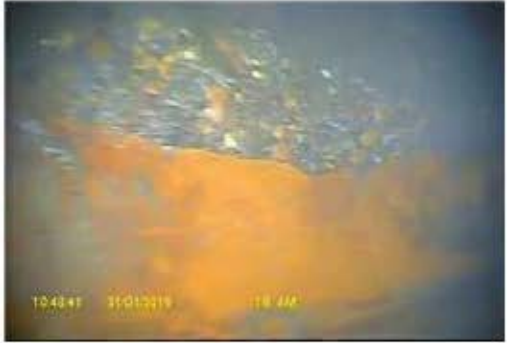
Pos	Video Ref	Code	Description	Image
00.00m		MH	Start node type, manhole MH17	
00.00m	0:00:00	WL	Water level: 0% Height/Diameter	
16.40m		MHF	Finish node type, manhole MH14	Image Provided - Ref: 38_9999

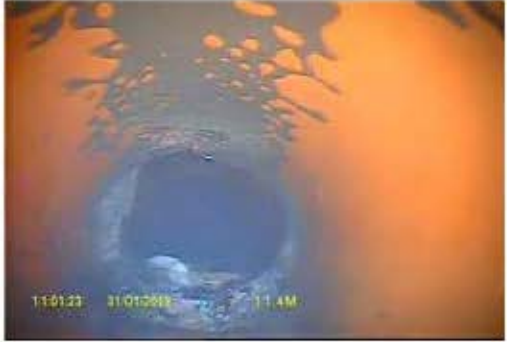
Pos	Video Ref	Code	Description	Image
00.00m		MH	Start node type, manhole MH17	
00.00m	0:00:00	WL	Water level: 0% Height/Diameter	
11.40m	0:00:23	JDL	Joint displaced large - Severity 4	Image Provided - Ref: 39_2

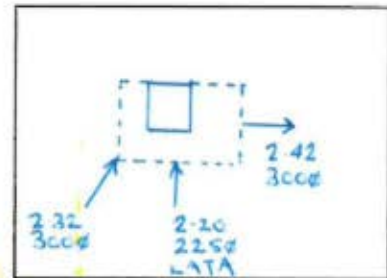
MH No	01								
COVER SHAPE	Square	/	Rectangle		Triangle		Circle		Other
COVER DUTY	Light		Medium		Heavy	/			
CONSTRUCTION	Concrete		Brick	/	Plastic				
FUNCTION AT OUTFALL	Surface		Foul	/	Combined

Depth of cover = 0.46m  
Frame changed

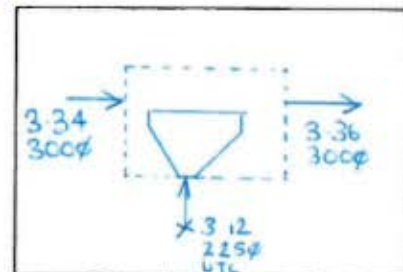
Depth of cover = 1.72m  
Unable to Camera  
Man Access Required

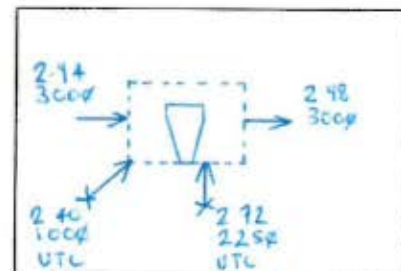
Depth of cover = 1.35m  
Man Access Required  
Unable to Camera

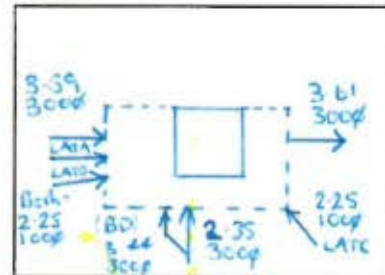
Depth of cover = 1.55m  
Back Drop (BD)
