# Wentworth Castle

## Plaster Ceiling Survey

02/08/2024

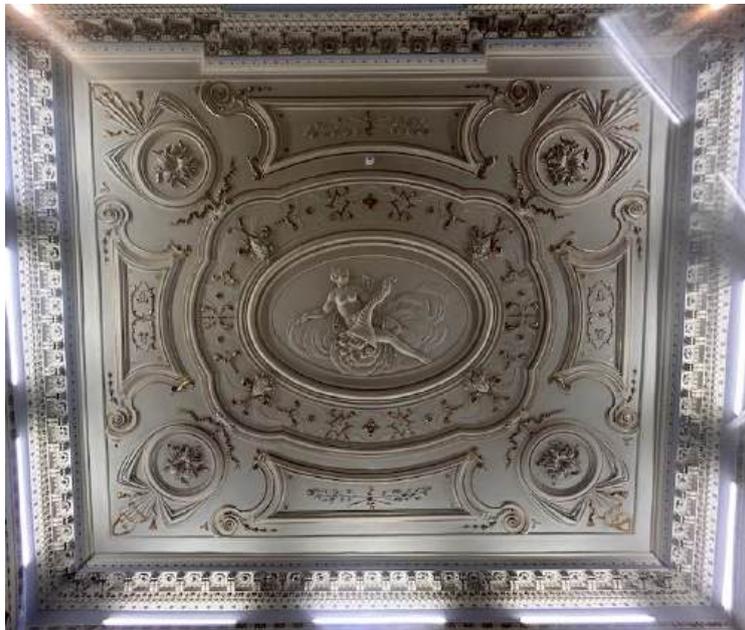
*Figure 2. Blue Room, North End Room Ceiling*

- The Blue Room, North End Room was found to be in good and stable condition.
- Multiple hairline fractures were noted throughout the ceiling and through the decorative details and cornice (Figure 3).
- There were multiple fractures noted at the junction between the ceiling and mouldings.
- The ceiling was found to be solid and stable from push testing.

- The ceiling expanse was found to be in stable condition from observation and tactile testing of the underside.
- If possible, observation of the upper side of the ceiling is recommended to ensure stability of the ceiling and its composing elements.

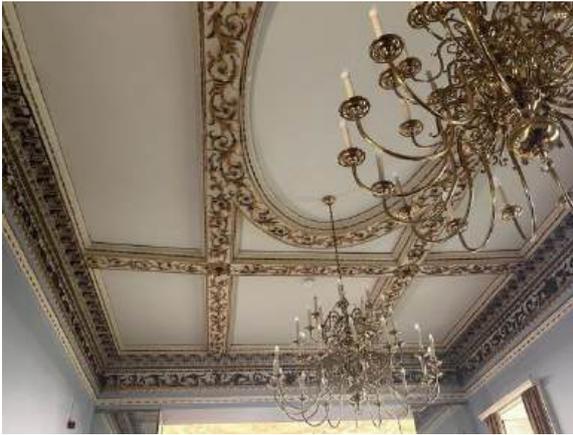
- The full ceiling exhibited evidence of displacement, observed as bowing from East to West along the full expanse of the ceiling (Figure 6).
- Bowing and displacement were noted on the West facing wall's cornice from North to South (Figure 7).

*Figure 6. Ceiling bowing from East to West, visible on the beam.*

- It is possible that the underside ceiling appears to be bowing due to the stabilization methods employed above which could have suspended the sagging of the plaster ceiling and held it in place. The plaster ceiling below could therefore be stopped from any further displacement yet was stabilized at the level of displacement found when the interventions occurred, resulting in the current visible condition of the ceiling.

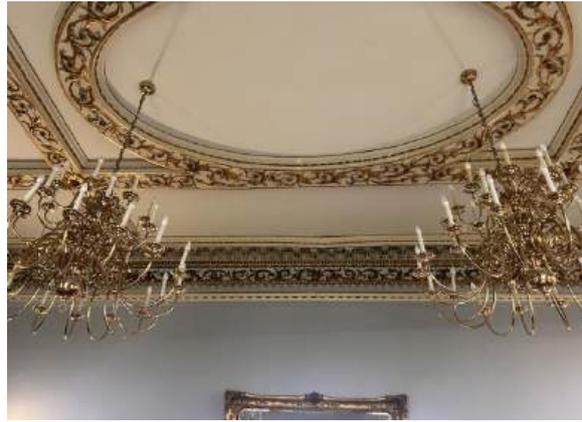
*Figure 7. Bowing noted on West wall cornice.*

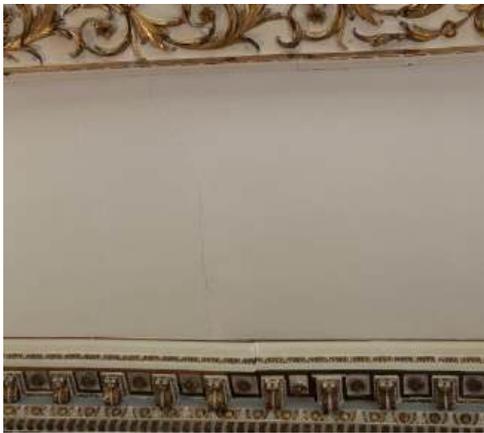
- Multiple hairline fractures were noted throughout the plaster, decorative elements, and cornice (Figure 8).
- Hairline fractures were noted on multiple enrichments; however, these may have been deliberate cuts created for the historic stabilization work on the upper ceiling (Figure 9).

*Figure 8. Hairline fractures noted throughout the ceiling.*

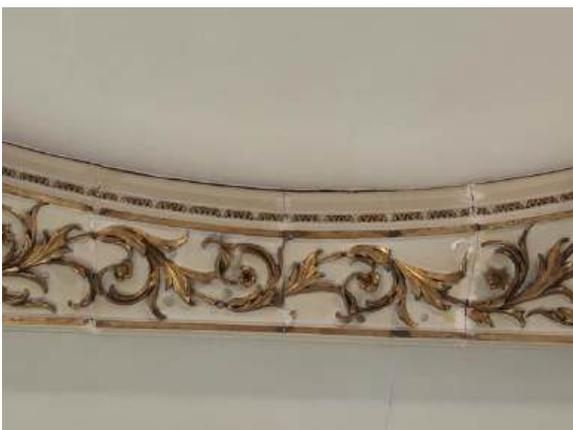
- Multiple hairline fractures were noted along the enriched decorative beams in equally spaced sequences. These also appeared to be deliberate cuts which could have been from the previous stabilization work to the upper side of the ceiling. Evidence supporting the insertion of deliberate cuts is aided by the visible presence of multiple bolts found between each fractured section. (Figure 11). These were found mirrored on both the East and West ends of the central decorative oval (Figure 12). These bolts match to the stabilization bolts viewed from the upper ceiling (Figure 13).

*Figure 10. Equally spaced fractures which could be deliberate cuts from upper ceiling stabilization work.*

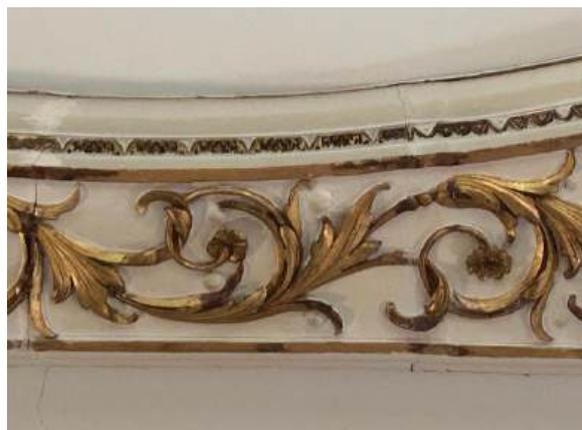
*Figure 11. Bolts visible give evidence on the underside ceiling of the stabilization methods which occurred on the upper side of the ceiling.*

- The fractures and bolts which were visible from the underside of the ceiling give evidence that sections of plasterwork were removed to allow the fitting of the main steels, which run East to West. The plaster was then refixed and screwed in place using bolts. The deflection in the ceiling also therefore corresponds with the placement of the replaced beams above (Figure 22) and could have been caused by the loss and rotting of the original structural elements.

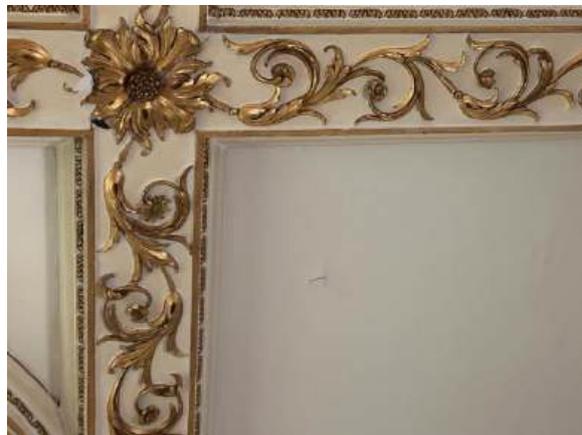
- Multiple minor areas of loss and minor cracking and flaking were noted throughout the ceiling (Figure 14).

*Figure 14. Minor delamination of skim coat and loss visible surrounding the enrichment.*

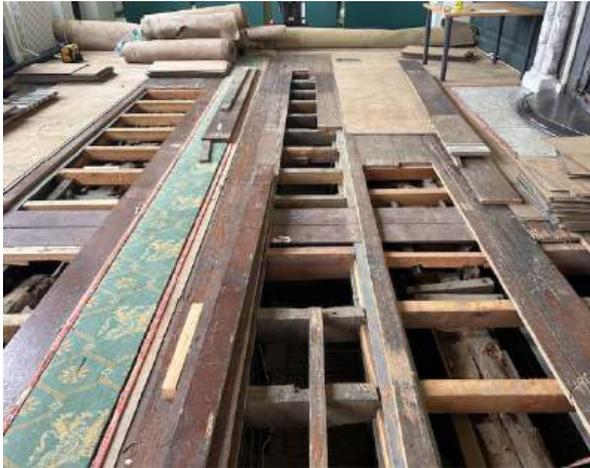
- The upper side of the ceiling was assessed visually from expanses of lifted floorboards (Figure 15).
- The inspection revealed multiple materials added historically to structurally stabilize the Blue Room ceiling. These materials include steel beams, plasterboard, bolts, and bat straps.

*Figure 15. Access to upper side of the ceiling was provided by expanses of the floorboards being lifted.*

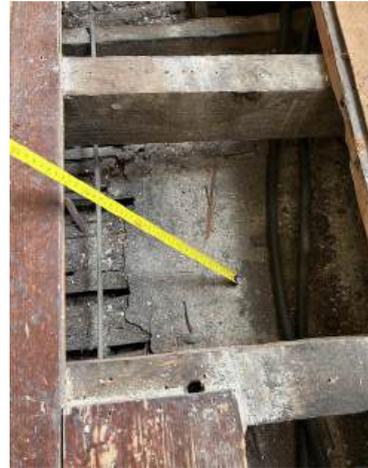
- Pugging was noted only around the perimeter of the upper ceiling corresponding with the cornice below. It is possible that the pugging only extended 750 – 800 mm from the wall (Figure 16).

*Figure 16. Pugging extending only partially over the edges of the ceiling.*

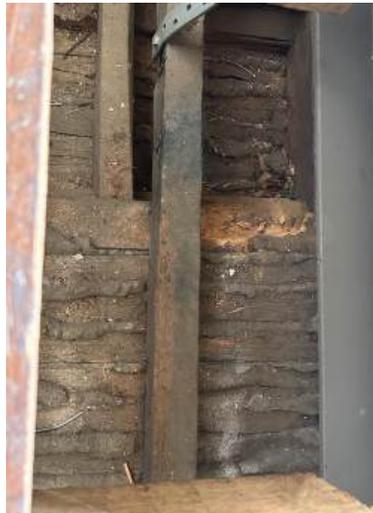
- Nibs and Laths were overall found to be in good condition (Figure 17).
- It appears that there were two major phases of renovation historically to the Blue Room ceiling. This is evidenced by red coloured inserted steel beams running East to West (Figure 17) and grey coated steel beams of a later manufacture found inserted running North to South (Figure 18). The later grey coated beams have bat straps attached which are fixed to the plaster ceiling below. Earlier steels were also found affixed in a support system for the remaining original timber beams (Figure 19).

*Figure 17. Close up of nibs and laths.*

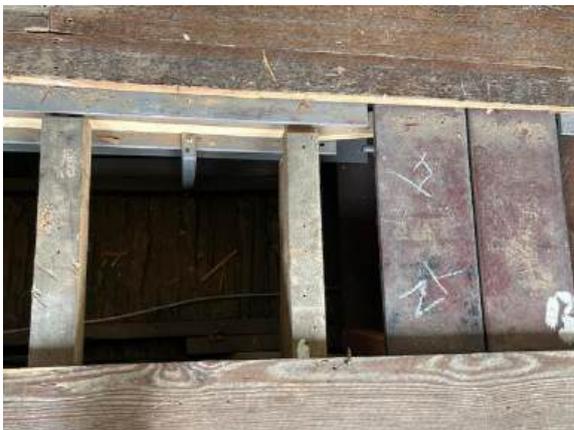
- It is possible that these interventions resulted from the collapse or partial collapse of the blue room ceiling and the subsequent repair resulted in the bowing and displacement visually observed from the underside of the ceiling.

*Figure 17. Red coloured steel beams running East to West give evidence of the first major intervention to the ceiling's structural stability.*

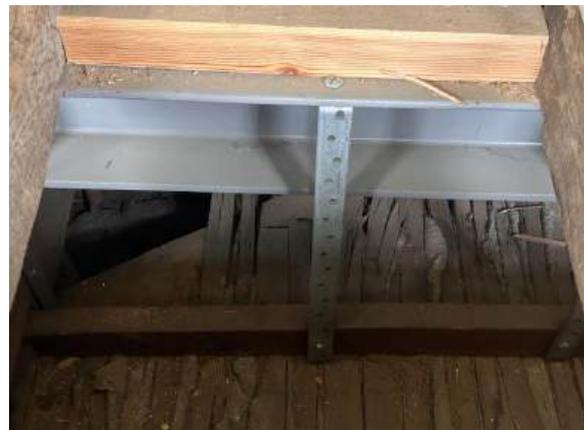
- The floor structure is separate from the plaster ceiling below. The only connection between the plaster ceiling and the upper room's floor structure are bat straps and the later intervention bolts. New timbers were found to be attached to the steel beams with bat straps attached to the joists. (Figure 18). Therefore, the floor is free floating above the ceiling structure and it appears that the steel beams are taking the majority of the weight of the floor, therefore bearing no weight on the plaster ceiling below. The previous stabilization works to the upper side of the ceiling may have arrested the plaster ceiling from dropping any further but did not return the plaster ceiling from its slightly bowed and deflected state.

*Figure 18. Later steel beam gives evidence of a second phase of intervention and stabilization. Bat straps are attached, connecting the plaster ceiling to the structural repairs above.*

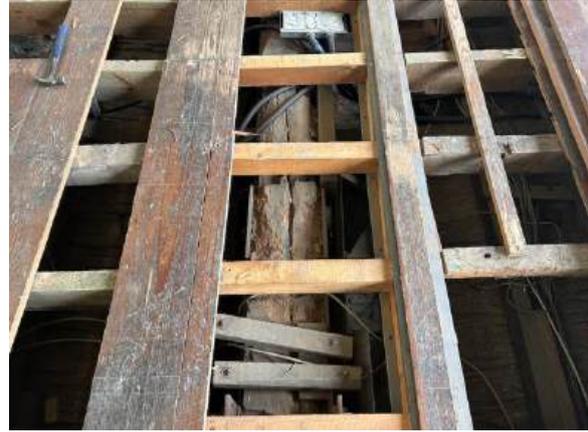
- The wooden beams and joists are original to the ceiling and it appears that the later steel beams were inserted to give additional structural support to the failing timber beams (Figures 20 & 21). Steel beams were also found where timber beams were missing (Figure 22). These inserted steels could have possibly replaced a rotten or failing original timber beam. The earliest inserted steel beams were found running above the timber beams (Figure 23).

*Figure 20. Timber beam supported by steels on either side.*

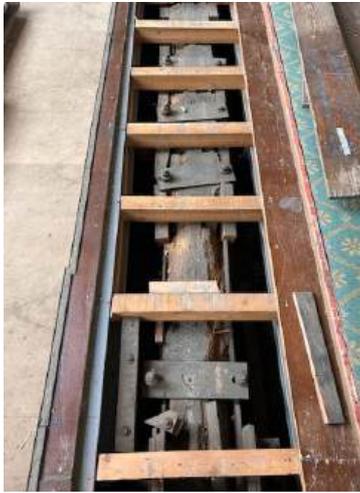
*Figure 21. Timber beams being aided by later added support system.*

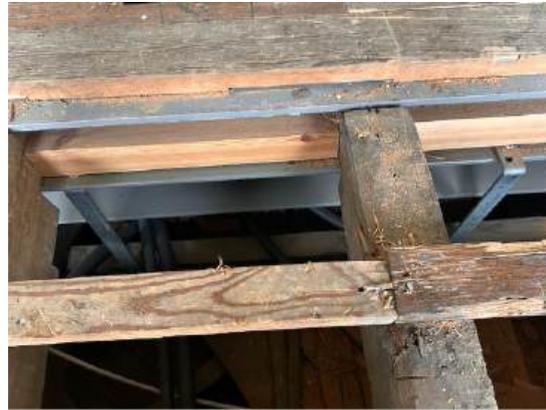
*Figure 22. Steel beams found where timber beam would have originally been.*

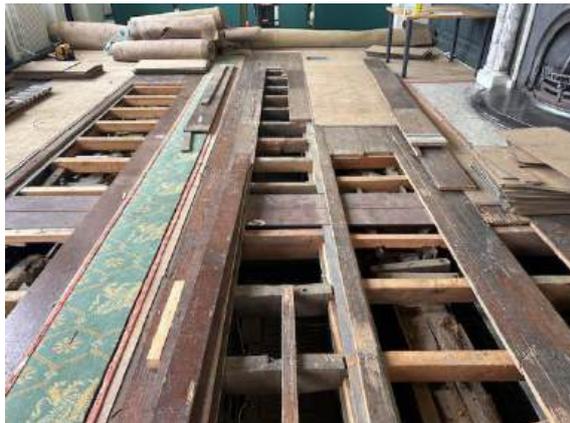
*Figure 23. Two red steel beams inserted East to West above timber beams.*

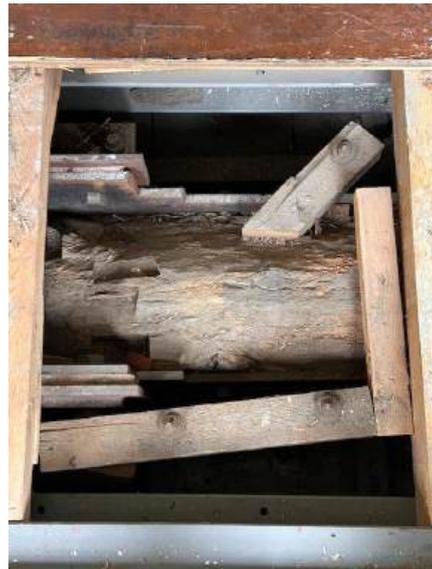
*Figure 24. Loose timber elements affixed with bolts requiring extra stabilization agreed upon with architect.*

- Extra support to the two timber joists which were found to be loose during the survey was recommended on site and a plan was devised with the architect for design and placement of the added support (Figure 24).

- It is recommended that the close consultation with the structural engineer is conducted to inform the best course of action for any additional stabilization requirements or plans.

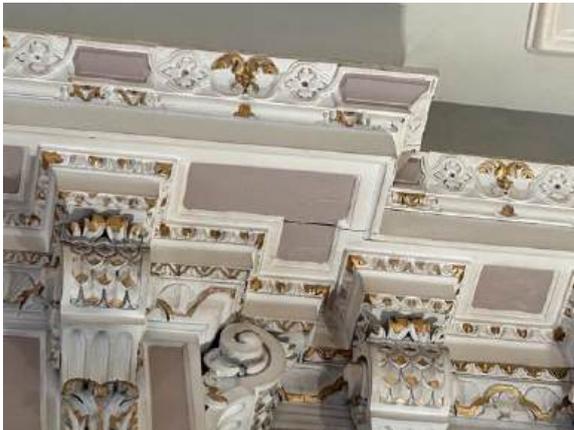
*Figure 27. Fracture visible on the cornice.*

- It is recommended that the upper side of the ceiling is inspected to fully understand the stability of the ceiling and its composing elements.

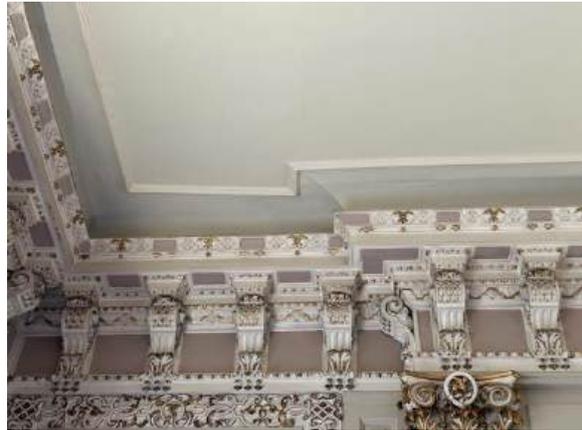
*Figure 28. Minor deflection and evidence of a previous repair over the South wall cornice.*

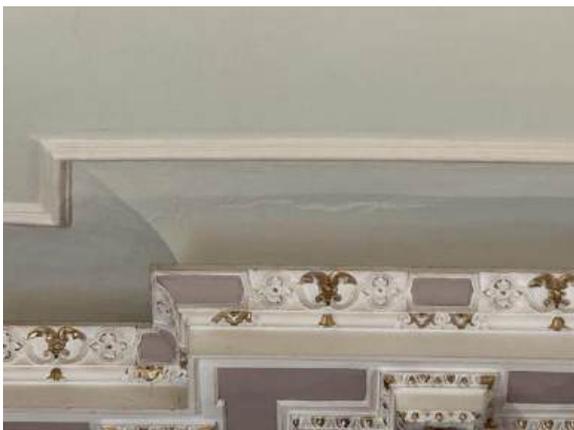
*Figure 29. Previous patch repair visible.*

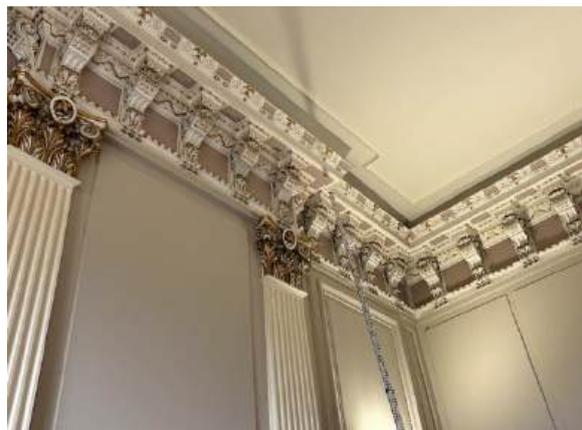
*Figure 30. Push test revealed the plaster ceiling to be stable.*

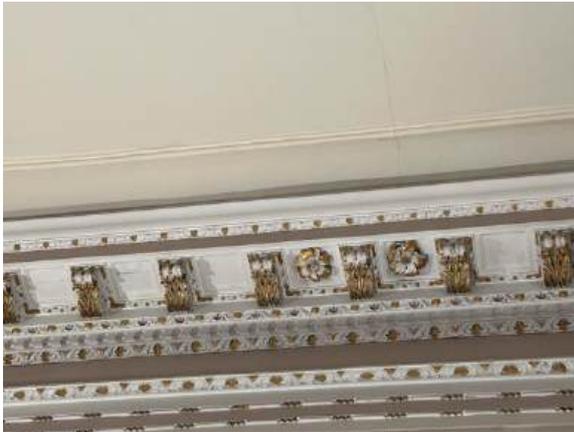
*Figure 33. Hairline fractures running through the plaster ceiling.*

- It is recommended that the upper side of the ceiling is inspected to fully understand the stability of the ceiling and its composing elements.

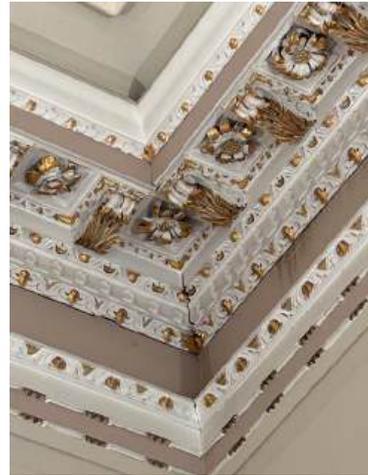
*Figure 34. Cracks visible in the mitres.*

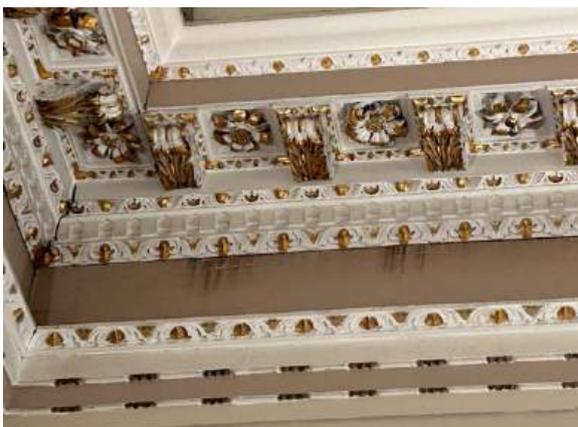
*Figure 35. Possible water ingress visible on the cornice.*

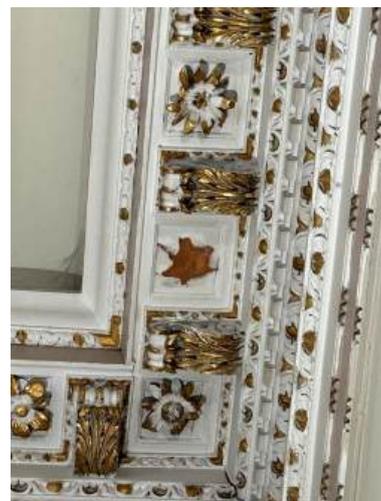
*Figure 36. Missing embellishments throughout the cornice.*

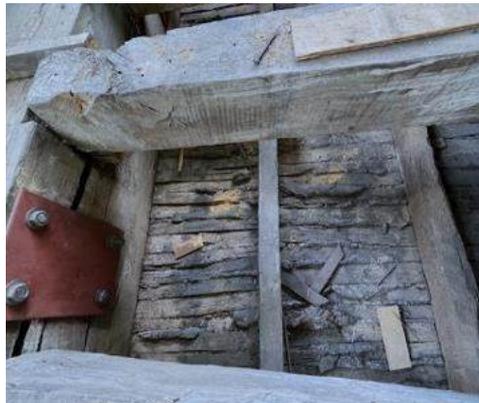
- The condition of the lath and plaster is considered to be very poor especially when compared to the other areas observed within the Long Gallery. Laths are fixed very closely to each other and there are minimal plaster nibs/keys evident. Where they are present many were found to be fractured when subjected to tactile examination. There is clear evidence of woodworm activity and decay of the laths which were reduced to dust when physically examined. In addition, a significant amount of springing laths were found.

- There are signs of previous interventive works such as metal joist hangers which are found to be too rigid. Additionally, multiple steel plates were found inserted in the oak beams where they have split over time. None of these methods have assisted in supporting the plasterwork.
- There are signs of wood worm, heavily decayed and loose/springing lath, and loose joists.
- Tight laths with no keys were found to be present.
- Where the reverse of the ceiling is exposed, the limited haired lime grinning through the lath, that have mostly been originally installed too close to each other, shows 'very little or no key/nibs' at all. It seems that when the void was potentially cleaned out some time back, all the key/nibs were scrapped-off and removed along with the pugging layer etc resulting in a ceiling which is unstable and requires stabilization.

*Tight lath and minimal key, previous interventions visible.*

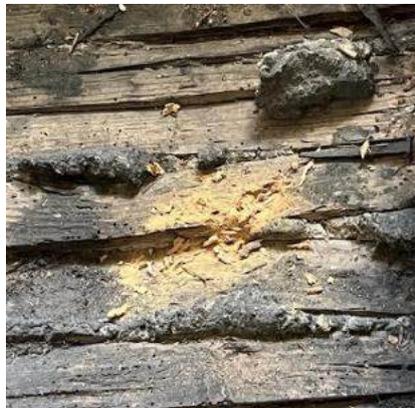
*Insect presence visible.*

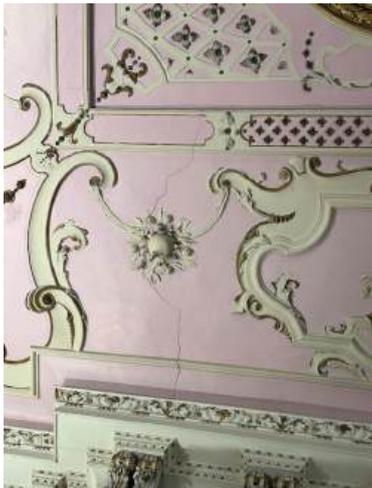
- The ceiling had multiple hairline fractures and cracks visible throughout the expanse of the ceiling, cornice, and decorative elements (Figure 39).
- An area of splitting was observed on the East wall cornice (Figure 40). Splitting was also found in multiple areas on the South wall cornice and between the ceiling and cornice at the corner of the South and East walls (Figure 41).

*Figure 39. Hairline cracks visible throughout the ceiling and cornice.*

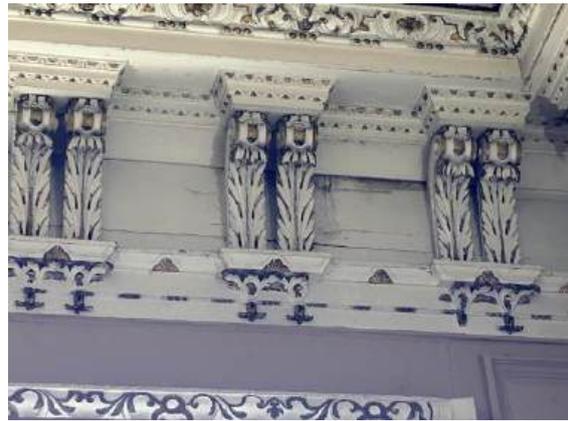
*Figure 40. Splitting and ingress visible on the East wall cornice.*

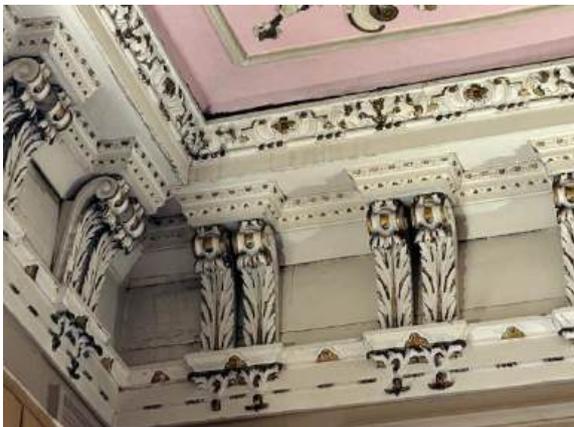
- What appears to be water ingress was visible on the East wall (Figure 41). Additionally, some paint loss was noted in the area of localized damage on the East wall. Possible water ingress was also visible on the South wall cornice (Figure 42).

*Figure 41. Splitting and ingress observed on the South wall cornice and ceiling.*

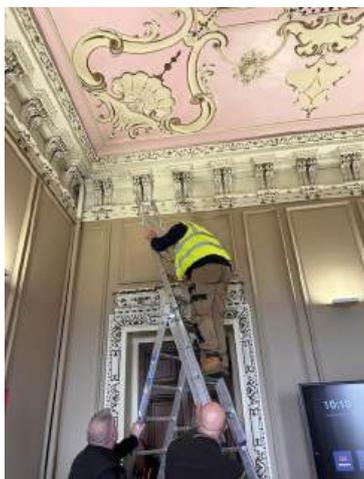
- There were multiple embellishments missing from the cornice (Figure 42).
- One loose embellishment was removed during the survey as it was found to be a hazard to visitors to the room (Figure 44 & 45). A second embellishment on the West wall was found to be loose but not deemed dangerous or urgent to remove.

*Figure 43. A loose embellishment was removed above the West wall during the survey due to being a hazard to visitors to the room.*

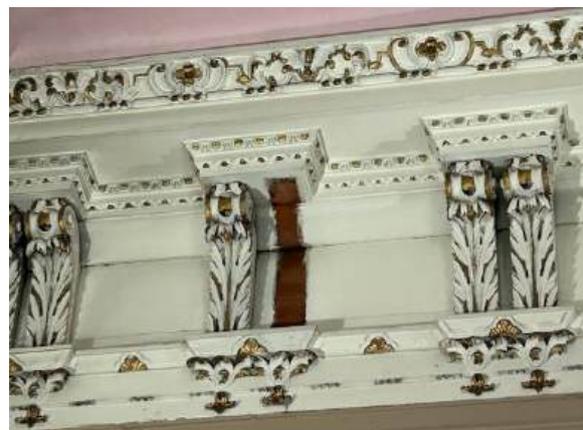
- The cornice and embellishments appear to be made from timber. Removal of the loose embellishment confirmed the materials was made of timber (Figure 45).

*Figure 44. Removed loose embellishment revealing the cornice to be made of timber.*

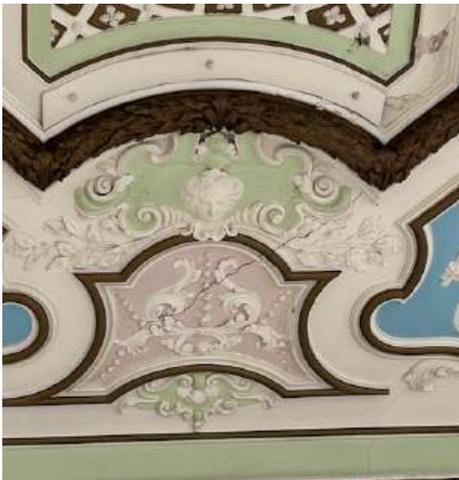
*Figure 47. Hairline fractures visible throughout the ceiling.*

- A closer in-depth tactile survey is recommended to fully understand the level of damage and stability of the structure of the ceiling.
- If possible, it would be beneficial to access the upper side of the ceiling to fully understand the condition of the ceiling structure and support system.
- It is important to understand if there is any ingress which could be causing the areas of loss and damage.

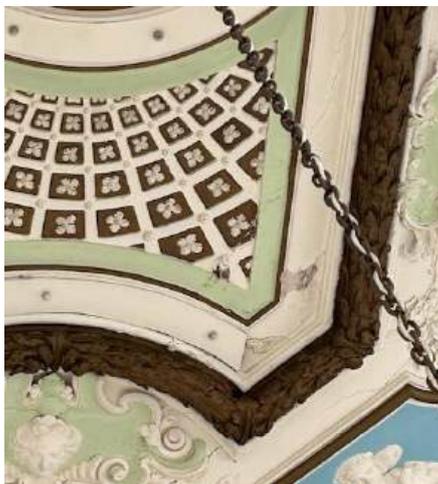
*Figure 49. Area of loss on central border.*

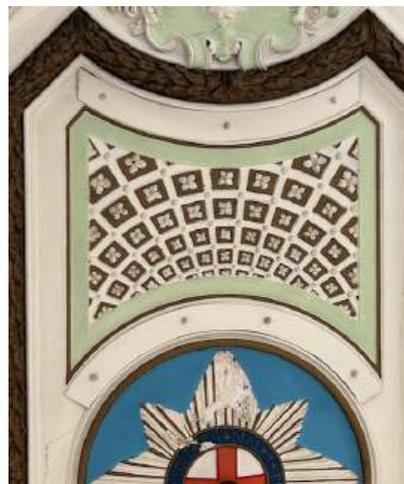
*Figure 50. Support straps attached with bolts.*

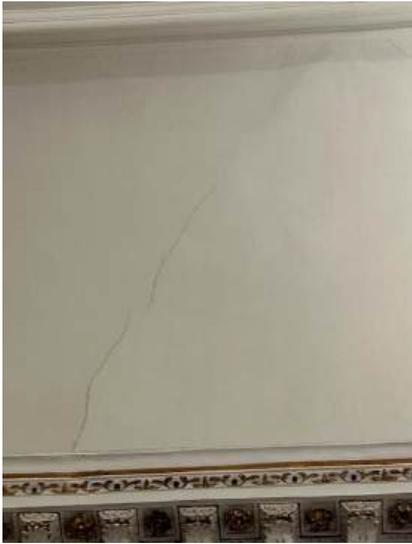
- Multiple hairline fractures were found throughout the expanse of the ceiling (Figure 53). Two repeating hairline fractures were found mirrored on the North and South coves (Figure 53).
- Markings which could potentially be water ingress marks or salts were observed on the North wall cornice (Figure 55).
- Fractures resulting in flaking paint were noted and some small areas of loss of the skim coat of plaster and delamination of the plaster skin were observed (Figure 55).
- Minor deflection was noted between the two South columns.

*Figure 53. Hairline fractures noted throughout the ceiling.*

- A closer in-depth tactile survey is recommended to confirm the ceilings stability and damage level.
- If possible, it would be beneficial to further access the upper side of the ceiling to fully understand the condition of the ceiling structure and support system.
- It is important to understand if the ingress is ongoing and requires intervention or is stable, inspection of the roof and lead flashing and tiles may further inform on this.

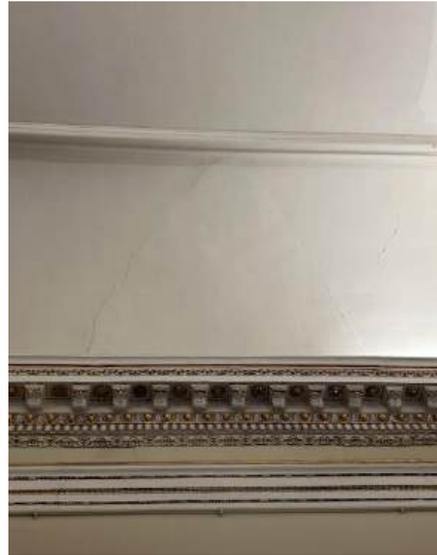
*Figure 54. Shape of hairline fractures on North and South wall coves.*

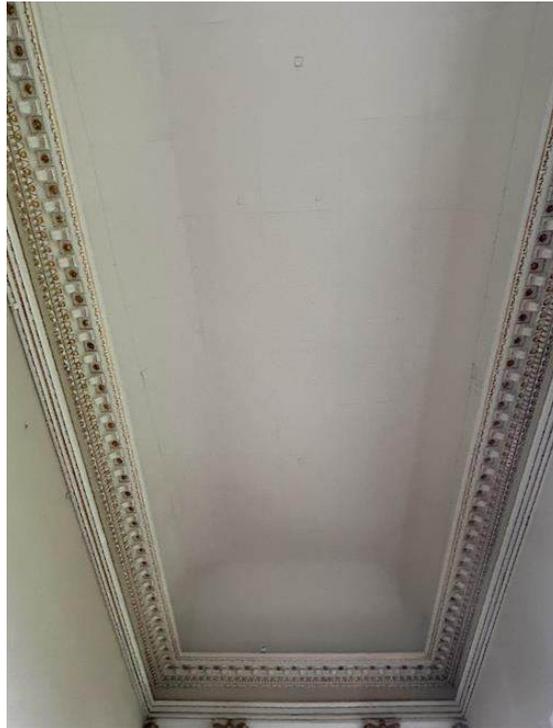
*Figure 58. Long Gallery, North End Section.*

- A large expanse of the ceiling appears to be covered in boarding. The edges of the cove appear to be original with the majority of the expanse of the upper ceiling being covered in plywood, used as propping after historic failure of the ceiling in this area.
- There are multiple hairline fractures noted throughout. Fractures were noted on the mitred edges of the ceiling.
- Fractures were observed in multiple enrichments.
- Potential water ingress or marks of historic water ingress were visible in multiple areas of the ceiling. With damage to the dental blocks and enrichments.

- A closer in-depth tactile survey is recommended to fully understand the level of damage and stability of the structure of the ceiling.
- If possible, it would be beneficial to access the upper side of the ceiling to fully understand the condition of the ceiling structure and support system.
- Additionally, it would be beneficial to understand why the plasterboard was added and what defects were found previously in the ceiling and to understand if any different or additional fixing methods may be required.
- It is important to understand if the ingress is ongoing and requires intervention or is stable.

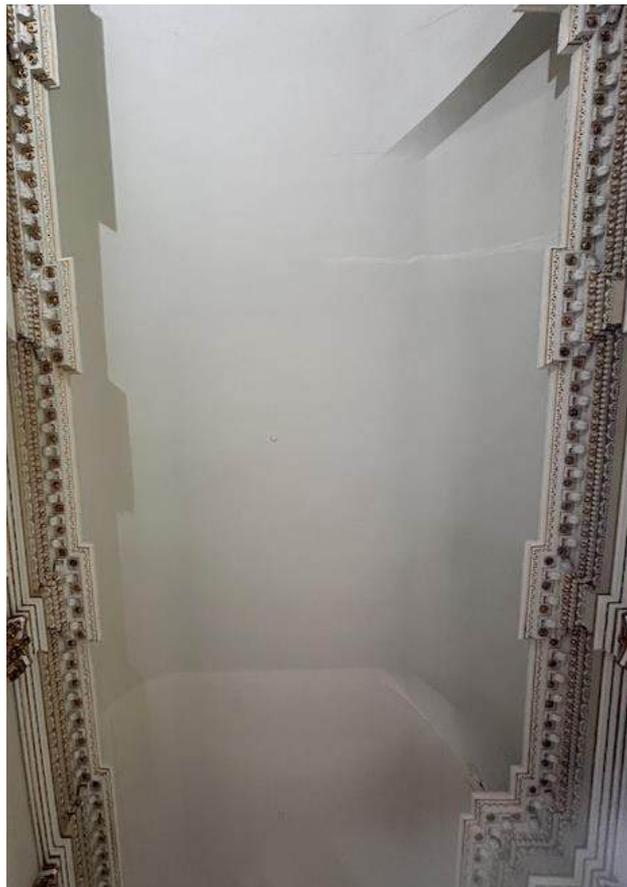
*Figure 61. Long Gallery Central Section.*

- Multiple hairline fractures were noted running East to West along the expanse of the ceiling (Figure 62).
- A small section of map crazing was noted on the East wall cove.
- Evidence of water ingress was noted to the north side, and appears to follow down to the pilaster, causing flaking of the paint. In this area the modillion blocks have split.

- A closer in-depth tactile survey is recommended to fully understand the level of damage and stability of the structure of the ceiling.
- If possible, it would be beneficial to access the upper side of the ceiling to fully understand the condition of the ceiling structure and support system.

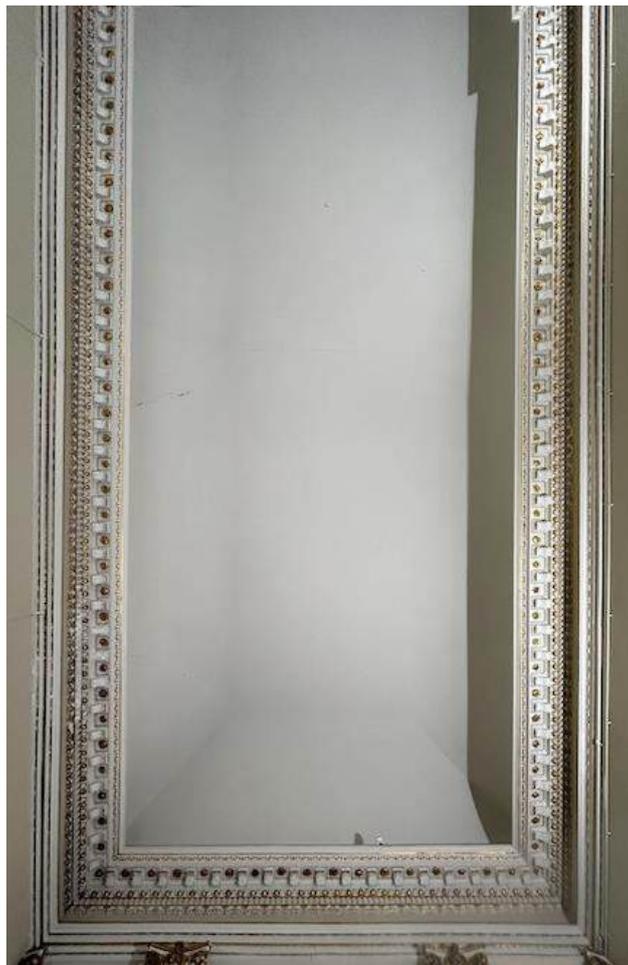
Figure 64. Long Gallery South Section Ceiling.

- Hairline fractures were found running along the full expanse of this section of ceiling (Figure 65). Some fractures were found running through the cornice.
- Fractures with delamination and areas of loss were observed on the East wall cove.
- Potential water ingress or marks of historic water ingress were visible on the West and East wall coves (Figure 66).

- A closer in-depth tactile survey is recommended to fully understand the level of damage and stability of the structure of the ceiling.
- If possible, it would be beneficial to access the upper side of the ceiling to fully understand the condition of the ceiling structure and support system.
- It is important to understand if the ingress is ongoing and requires intervention or is stable.

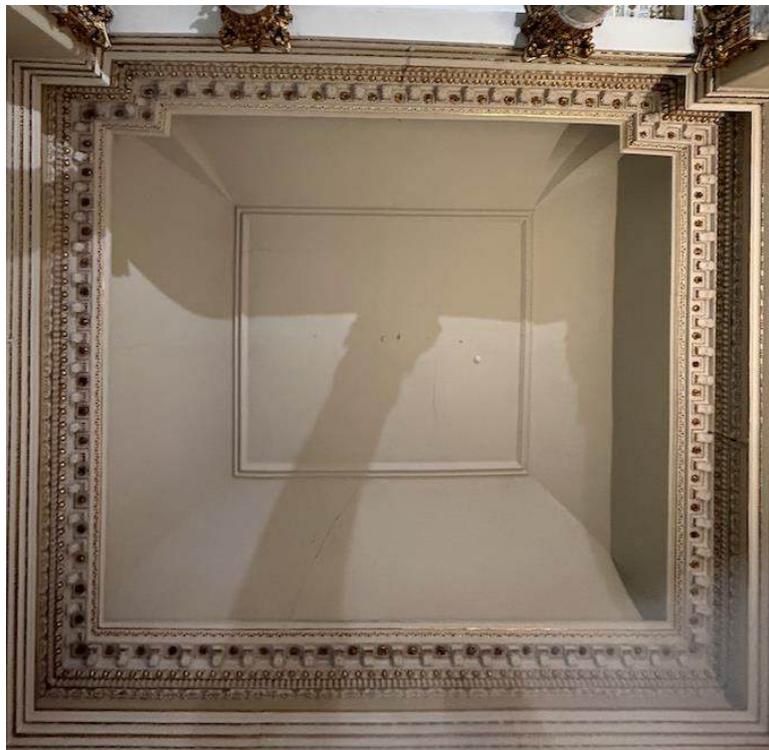
Figure 68. Long Gallery South End Room Plaster Ceiling.

- Multiple hairline fractures were found throughout the expanse of the ceiling (Figure 69). Some fractures were found running through the cornice.
- Fractures were found in the mitres.
- Fractures with areas of loss and delamination of the skim coat of the plaster were observed (Figure 70).
- Possible water ingress or staining was observed (Figure 70).

- A closer in-depth tactile survey is recommended to fully understand the level of damage and stability of the structure of the ceiling.
- If possible, it would be beneficial to access the upper side of the ceiling to fully understand the condition of the ceiling structure and support system.
- It is important to understand if the ingress is ongoing and requires intervention or is stable.

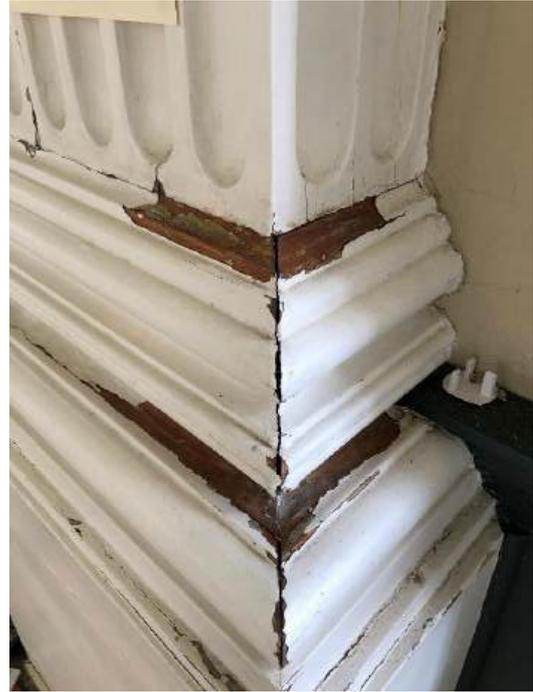
*Figure 76. Flaking paint to the base of the column a result of water ingress causing the wood to swell and paint to delaminated.*

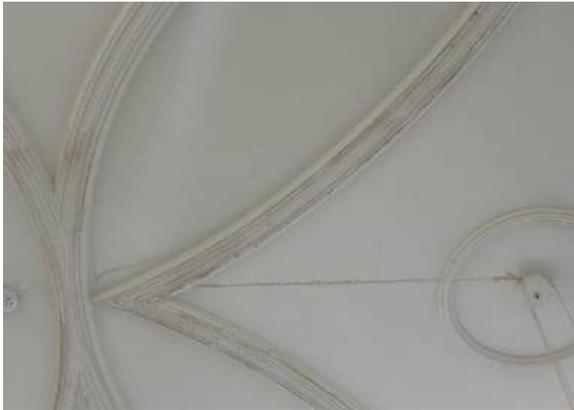
- Multiple hairline fractures were found running West to East along the ceiling expanse (Fig.84).
- Plasterboard was present in the ceiling and there is fracturing along the joint lines between plasterboards.
- There was potential water ingress visible (Fig.85).
- Push testing revealed the plaster ceiling to be solid and stable.

*Figure 84. Hairline fracture on centre rose of ceiling.*

- A closer in-depth tactile survey is recommended to fully understand the level of damage and stability of the structure of the ceiling.
- If possible, it would be beneficial to access the upper side of the ceiling to fully understand the condition of the ceiling structure and support system.
- It is important to understand if the ingress is ongoing and requires intervention or is stable.

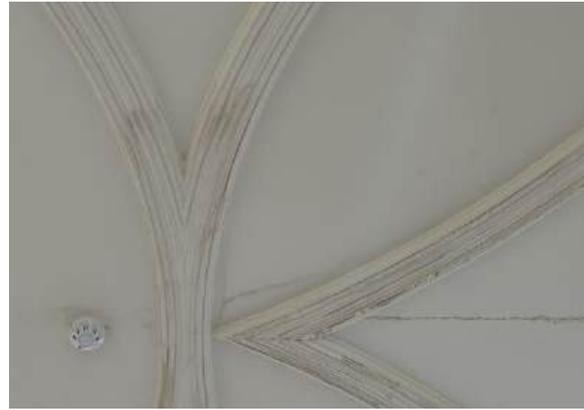
*Figure 85. Possible water ingress marks near fractures.*

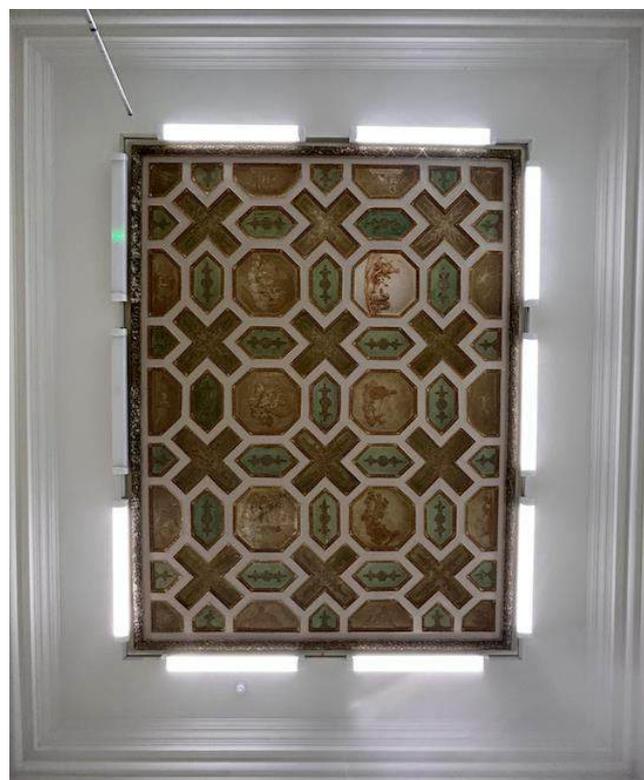
Figure 87. I.C.T. Teaching Room 1 Plaster Ceiling.

- Hairline fractures were observed throughout the ceiling and through multiple painted panels (Fig.88).
- Map crazing was found in multiple panels (Fig.89).
- Possible water ingress was observed on a painted panel. The water ingress appears to have caused damage to the painted work (Figure 90).
- There were variations in the paintwork noted throughout the ceiling. Areas of loss to the painted detail were noted, specifically in areas where fractures and possible ingress were most severe. Additionally, fading and flaking and variations in colour were observed throughout the painted panels.
- Paint loss and fading was noted on the detailed plaster border (Fig.91).
- There was the potential of two different materials used in the ceiling, plasterboard was suspected to be used in the border.
- Tactile testing found the ceiling to be stable and secure.

- A closer in-depth tactile survey is recommended to fully understand the level of damage and stability of the structure of the ceiling.
- If possible, it would be beneficial to access the upper side of the ceiling to fully understand the condition of the ceiling structure and support system.
- It is important to understand if the ingress is ongoing and requires intervention or is stable.

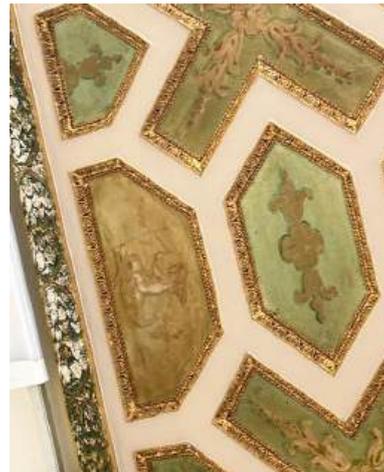
*Figure 91. Fading noted on the painted decorative plaster border. Hairline fractures visible throughout.*

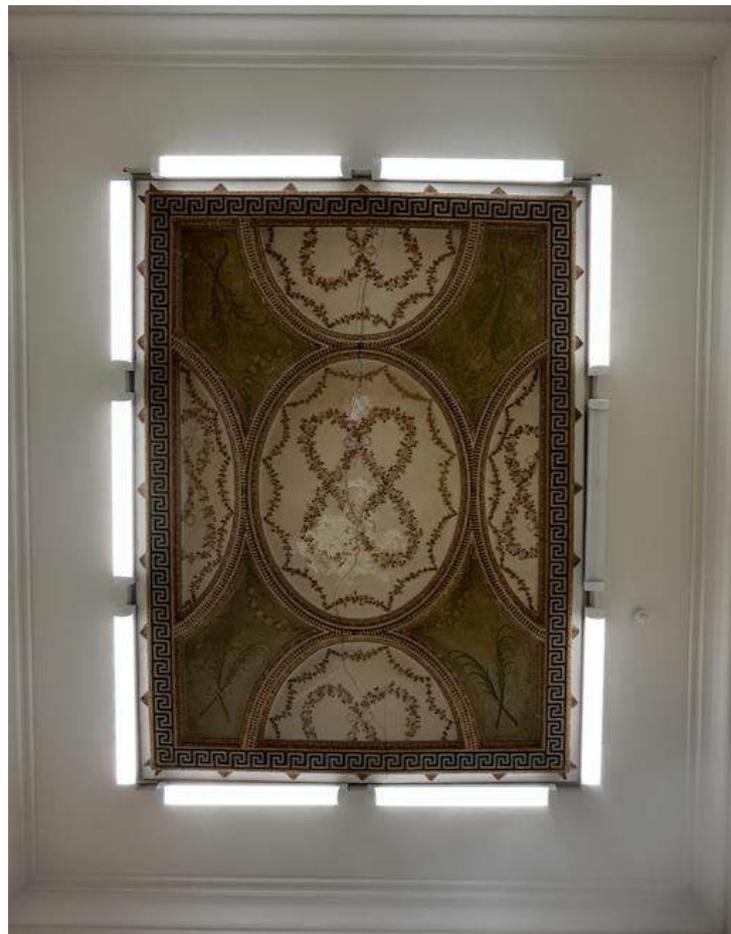
Figure 93. I.C.T Teaching Room 2 Ceiling.

- Multiple fractures observed throughout the ceiling expanse with a significant fracture running through the central panel from East to West. Multiple hairline fractures form out of the larger significant crack (Fig.94).
- Possible water ingress was observed resulting in discolouration of the painted detail (Fig.95)
- Areas of paint loss, flaking, and fading were noted throughout the painted ceiling panel (Fig.96).
- The perimeter ceiling could be composed of a different material from the inner painted ceiling, however, this requires further assessment.

- A closer in-depth tactile survey is recommended to fully understand the level of damage and stability of the structure of the ceiling.
- If possible, it would be beneficial to access the upper side of the ceiling to fully understand the condition of the ceiling structure and support system.
- It is important to understand if the ingress is ongoing and requires intervention or is stable.

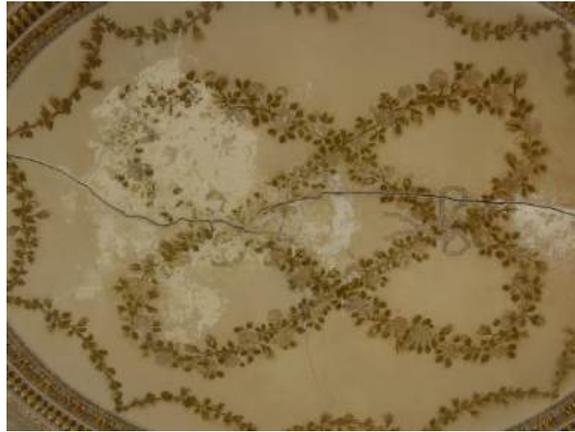
*Figure 94. Multiple fractures run from the central significant fracture.*

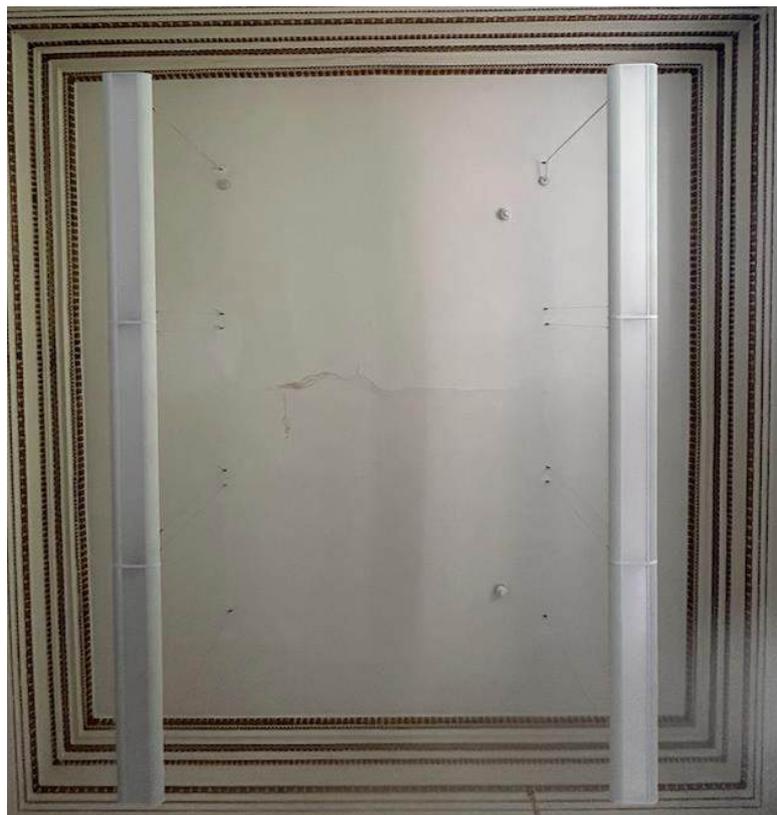
Figure 98. I.C.T. Teaching Room 3 Ceiling.

- Multiple fractures were observed throughout the ceiling expanse (Fig.99). Fractures were found on the mitred corners and along the cornice (Fig.100 and Fig.101).
- Deflection was noted along multiple fracture lines.
- Possible water ingress and staining was observed (Fig.102).
- Tactile push test revealed some movement was present in the ceiling.
- Previous repairs were found in the form of some localized areas which had been previously filled.

- A closer in-depth tactile survey is recommended to fully understand the level of damage and stability of the structure of the ceiling.
- If possible, it would be beneficial to access the upper side of the ceiling to fully understand the condition of the ceiling structure and support system. Additionally, this would aid in pinpointing the possible cause of movement in the ceiling and inform the best course of action for stabilization, if required.
- It is important to understand if the ingress is ongoing and requires intervention or is stable.

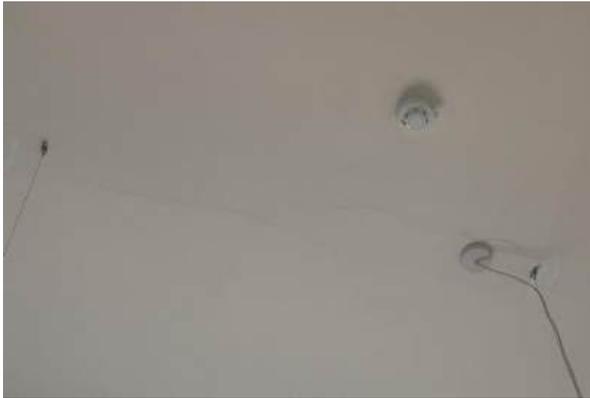
*Figure 99. Fractures found running along the ceiling expanse.*

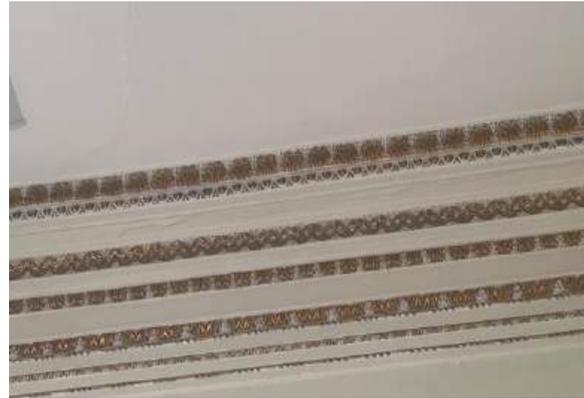
*Figure 100. Fractures found along the cornice.*

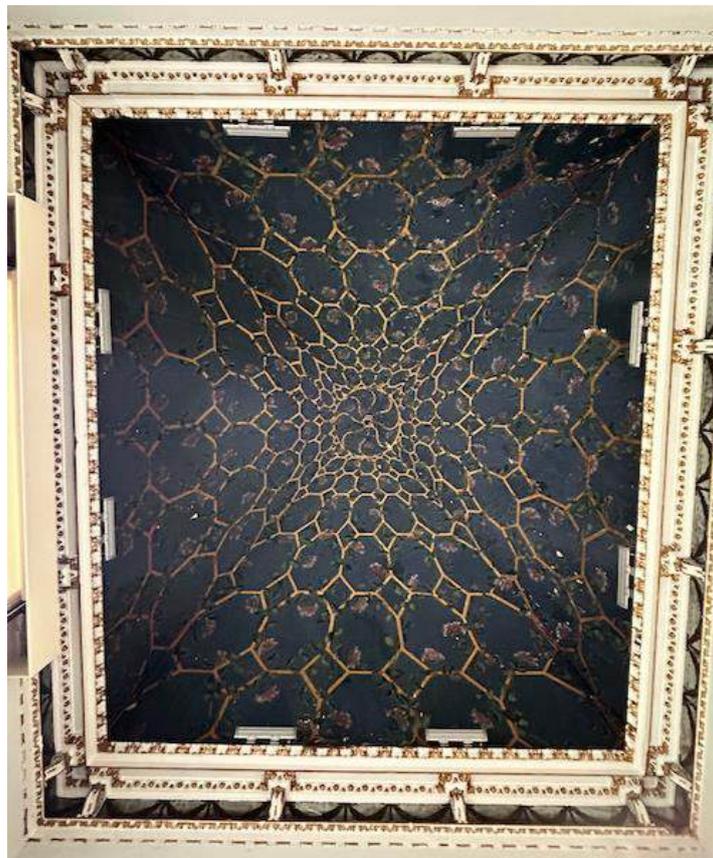
Figure 104. Vice Principal's Office Decorative Ceiling.

- There are multiple fractures noted throughout the ceiling including some significant fractures (Fig.105). The wider and more significant fractures were often found on the edges of the ceiling coves. Fractures were noted down the mitred corners. Some fractures extend into the cornice. Cracks were also found to extend into the mirrored frieze, causing cracks, breaks, and glass in the painted mirrors (Fig.106).
- Multiple of the painted mirrors of the frieze were cracked or missing (Fig.107).
- Possible water ingress and staining was observed.
- Multiple enrichments were noted to be missing.
- There is a significant loss of the painted detail throughout. Flaking and areas of loss were observed throughout (Fig.108)). Additionally, portions of the paintwork were noted to be discoloured (Fig.109 & 110).
- Previous fills were observed reflecting previous intervention.

- A closer in-depth tactile survey is recommended to fully understand the level of damage and stability of the structure of the ceiling.
- If possible, it would be beneficial to access the upper side of the ceiling to fully understand the condition of the ceiling structure and support system.
- It is important to understand if the ingress is ongoing and requires intervention or is stable.
- For aesthetic considerations the hairline fractures can be filled and painted. Areas of loss and flaking can be consolidated and retouched.

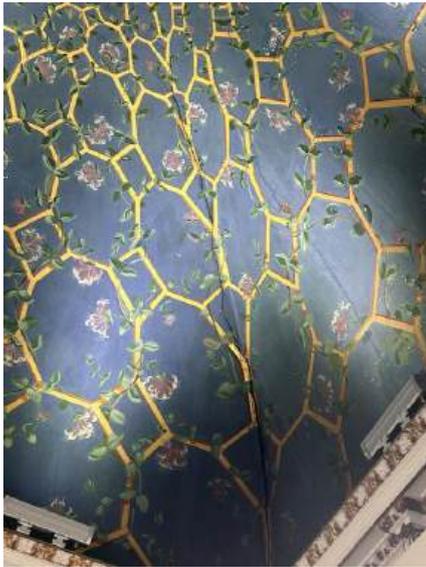
*Figure 105. Significant crack running down mitre of cove.*

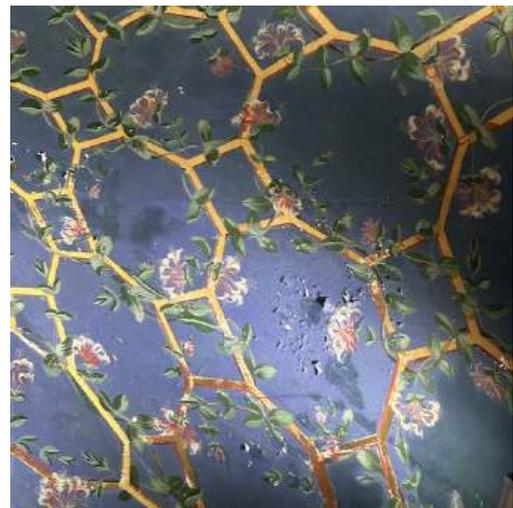
*Figure 108. Significant paint flaking and loss throughout ceiling.*

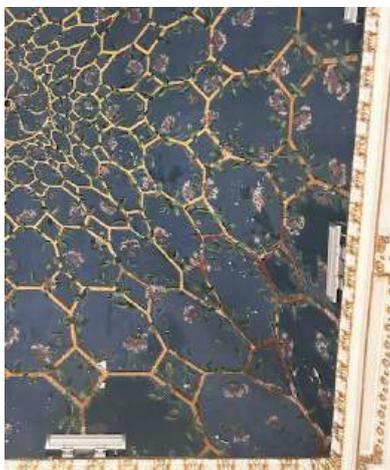
*Figure 109. Discolouration noted in the paintwork.*

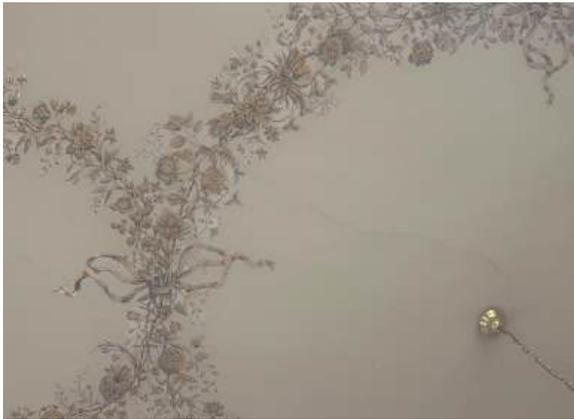
- Multiple hairline fractures were observed throughout the ceiling (Figure 113 & 114). Fractures were found extending into the cornice (Figures 115 & 116).
- Possible water ingress or staining was observed.
- Paint loss was observed along many of the fracture lines. Paint loss, flaking, and fading was found throughout the ceiling. Areas of discolouration and possible overpainting were noted (Figure 117).

*Figure 113. fractures found along the ceiling expanse.*

- Consolidation methods can be employed to ensure the stability of the ceiling due to the lack of solid nibs and laths.
- The boards found in the underside of the ceiling should be removed if found to have no securing purpose.
