# Wentworth Castle

## Plaster Ceiling Survey

02/08/2024

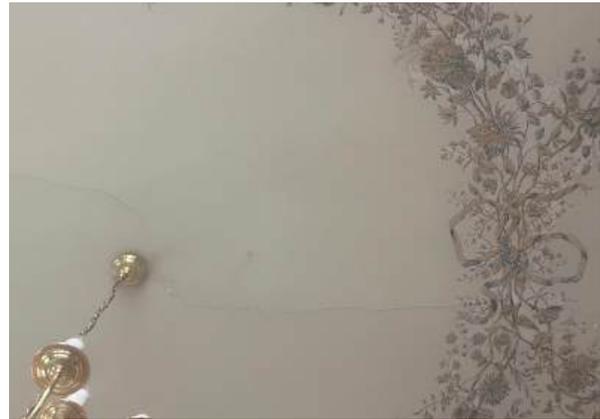
- Multiple hairline fractures were observed throughout the ceiling (Figure 113 & 114). Fractures were found extending into the cornice (Figures 115 & 116).
- Possible water ingress or staining was observed.
- Paint loss was observed along many of the fracture lines. Paint loss, flaking, and fading was found throughout the ceiling. Areas of discolouration and possible overpainting were noted (Figure 117).

*Figure 114. Fractures found along the ceiling expanse.*

- Consolidation methods can be employed to ensure the stability of the ceiling due to the lack of solid nibs and laths.
- The boards found in the underside of the ceiling should be removed if found to have no securing purpose.

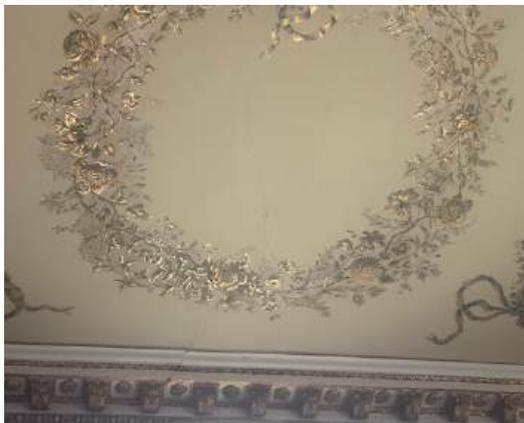
*Figure 115. Fractures running through cornice.*

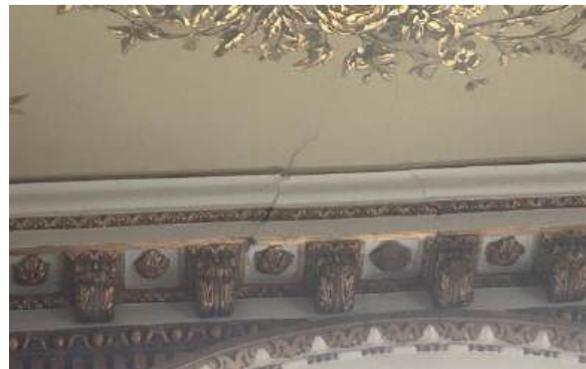
*Figure 116. Fractures running through cornice.*

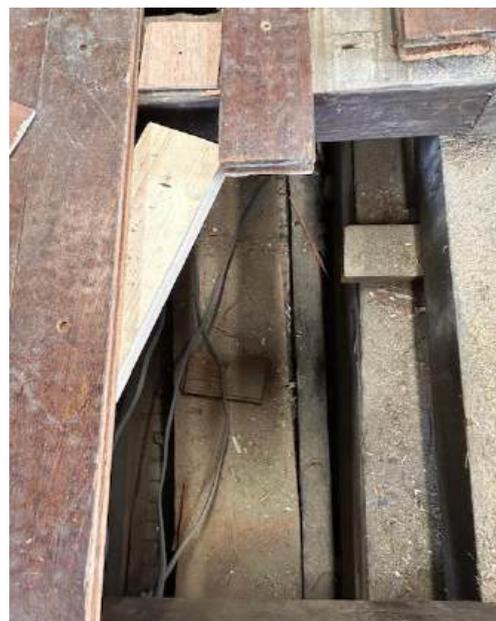
- Nibs were found to be present but were found to be in poor condition (Fig.118).
- Nibs were found to be intermittent with some missing (Fig.119).
- Laths were found to be tightly spaced but were not found to be springing.
- Timber boards were found resting directly on top of the plaster laths and nibs adjacent to the main beans, their purpose and reason for placement is unknown.

*Figure 118. View into the upper side of the Principal's Office ceiling.*

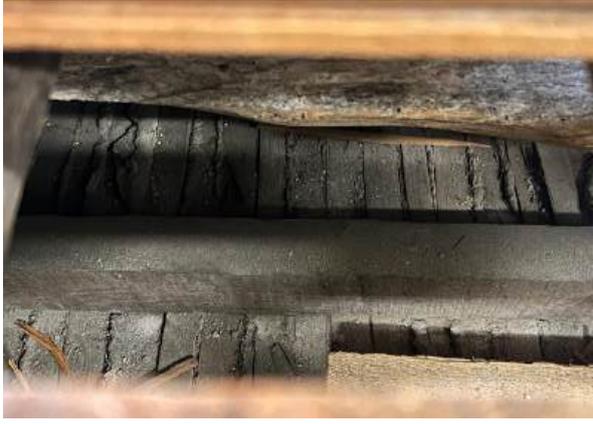
*Figure 119. View of laths and nibs, many nibs are missing.*
