Arboricultural Consultancy for Lloyds Bank

Insured	Mr & Mrs Brian & Janet Ivermee	Address	51 Lund Avenue, Barnsley, S71 5NW		
Client	Subsidence Management Services	Contact	Ian Domigan	Claim No.	IFS-LBG-SUB-22-0100956
ES Ref	SA-250094	Consultant	Keith Burgess	Contact No.	0330 380 1036
Report Date	01/09/2022

51 Lund Avenue, Barnsley, S71 5NW

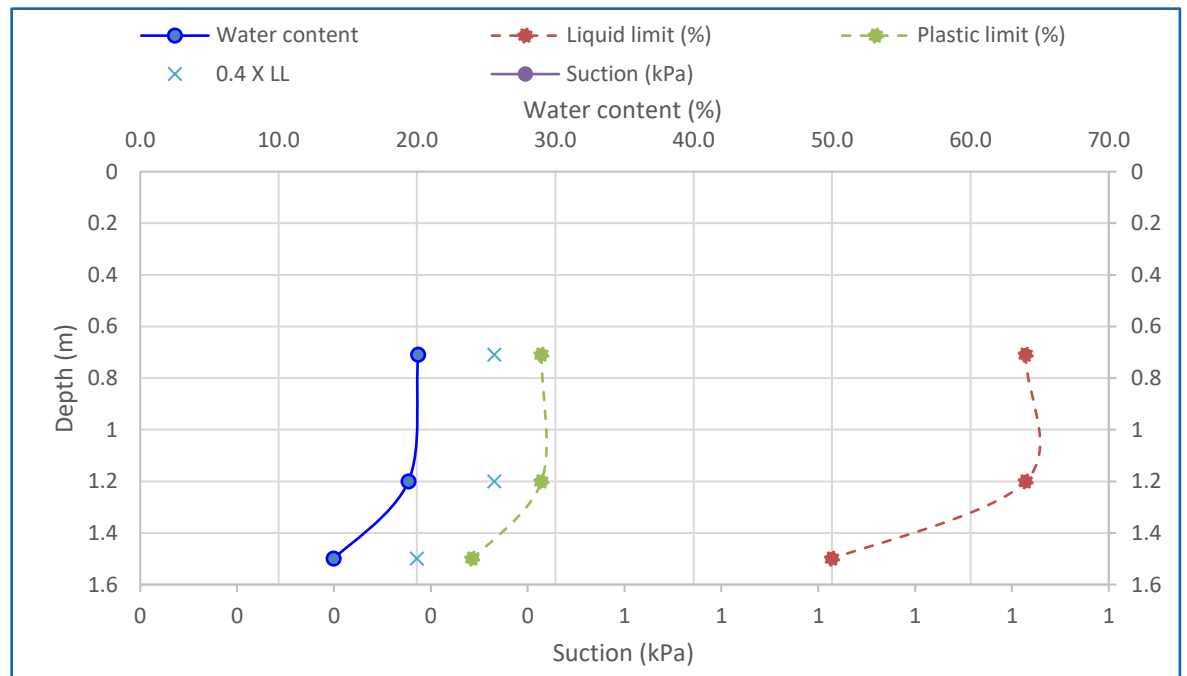
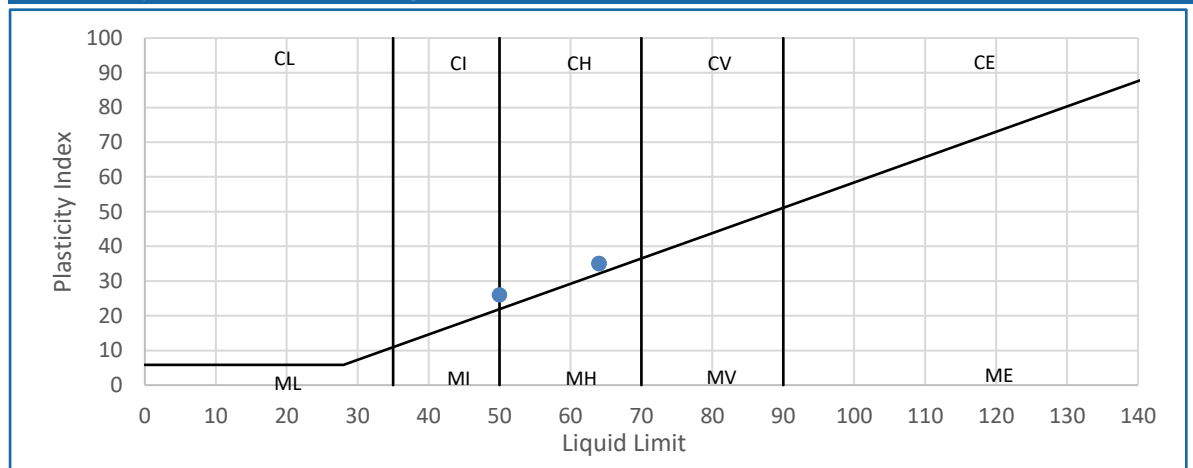
Samples from BH1

Lab Ref	Depth (m)	WC (%)	LL (%)	PL (%)	PI (%)	.425 mm(%)	mod. PI (%)	Av. Suc. (kPa)	Description
1	0.71	20.1	64	29	35	95	33		Very stiff brown/orange-brown/grey mottled silty CLAY
2	1.2	19.4	64	29	35	95	33		Very stiff brown/orange-brown/grey mottled silty CLAY
3	1.5	14.0	50	24	26	74	19		Very stiff brown/orange-brown/grey mottled gravelly CLAY/SILT . Gravel is fine, medium and coarse.

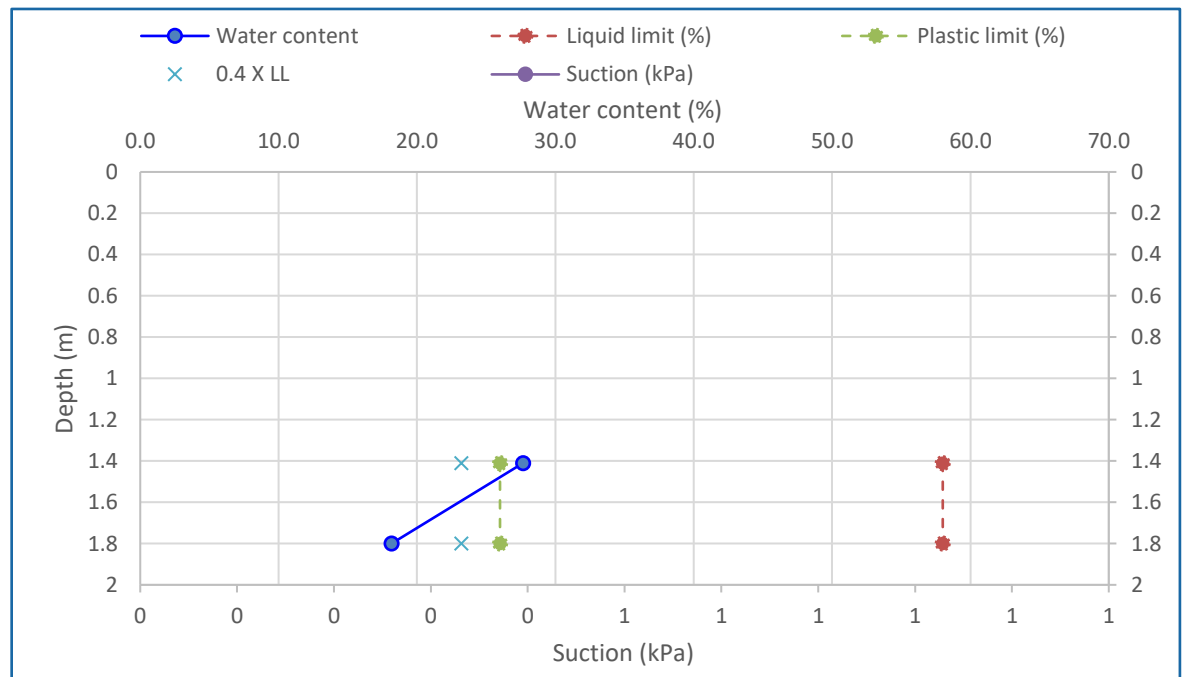
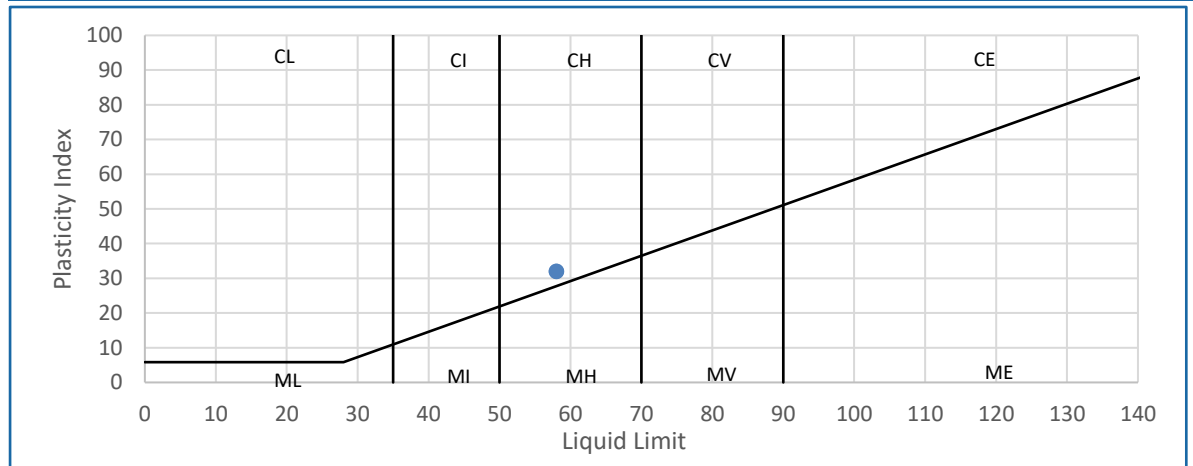
Samples from BH2

Lab Ref	Depth (m)	WC (%)	LL (%)	PL (%)	PI (%)	.425 mm(%)	mod. PI (%)	Av. Suc. (kPa)	Description
4	1.41	27.7	58	26	32	100	32		Firm brown/orange-brown/grey mottled silty CLAY
5	1.8	18.2	58	26	32	100	32		Firm brown/orange-brown/grey mottled silty CLAY
