**Structural Inspection Report**  
for

**Lower Coates Farm**

**Silkstone**

**September 2020**

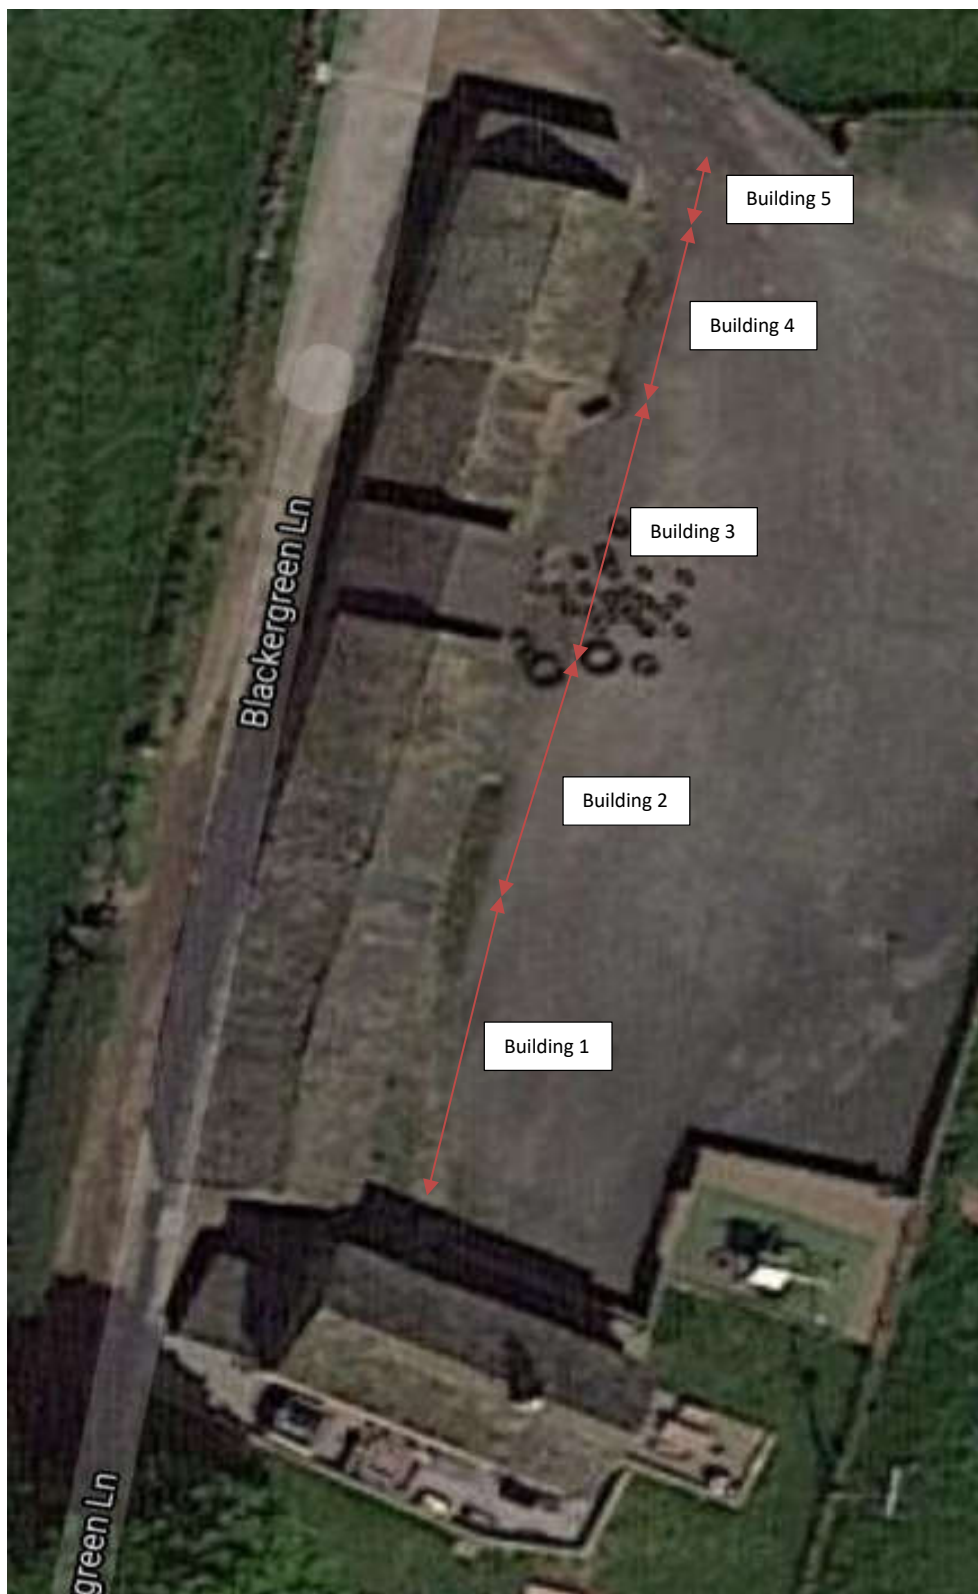
The image above shows the general layout of buildings on the site and references to the descriptions used below.

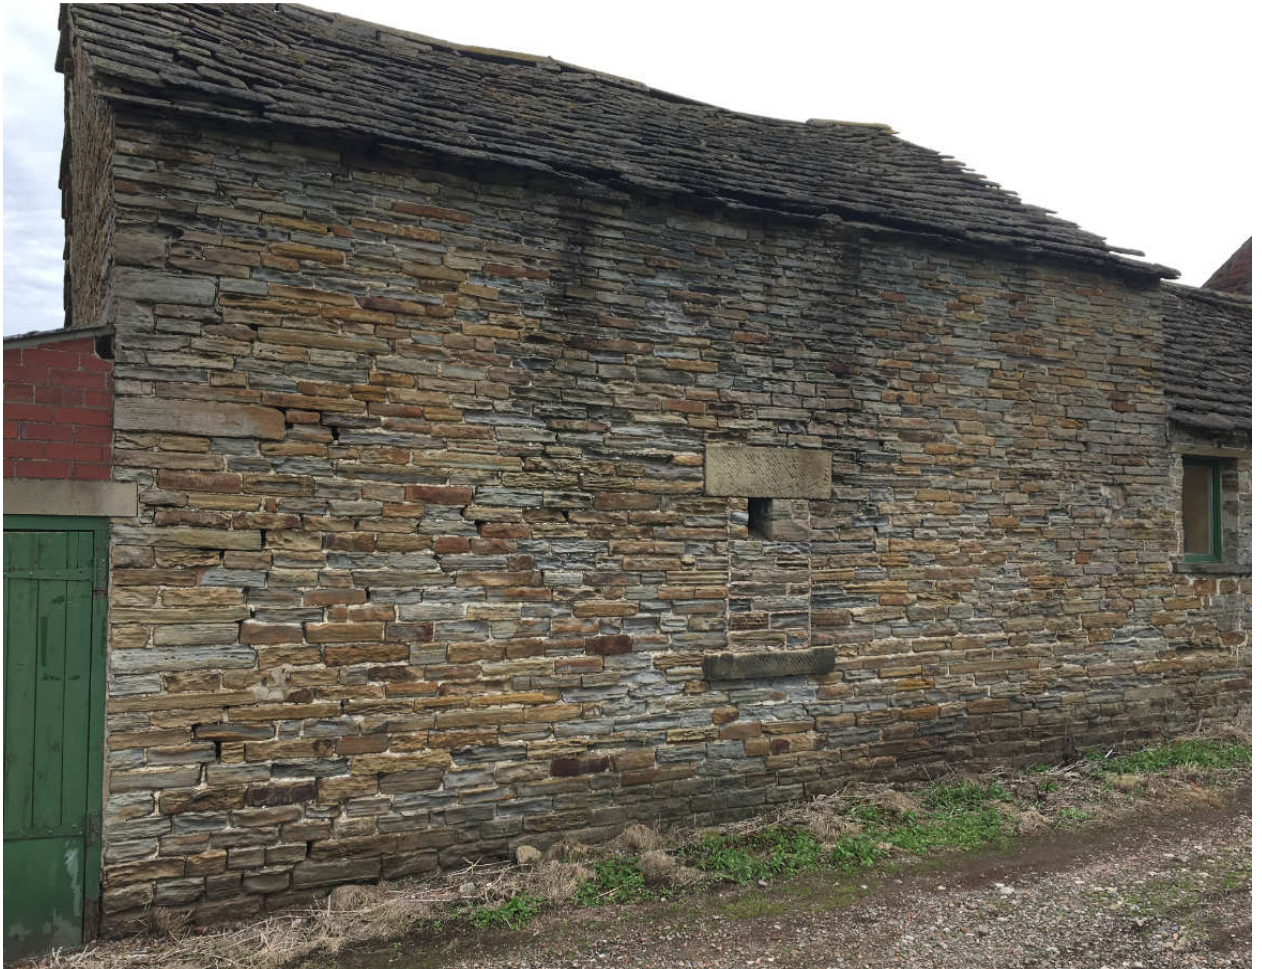
5. West Elevation of Building 4

- 4.16 The walls to all four elevations appeared to be reasonably plumb, but exhibited signs of weathering, both to mortar joints and the outer faces of individual stones. Severe cracking and spalling were noted to the stone surrounds to the first-floor window on the east elevation.

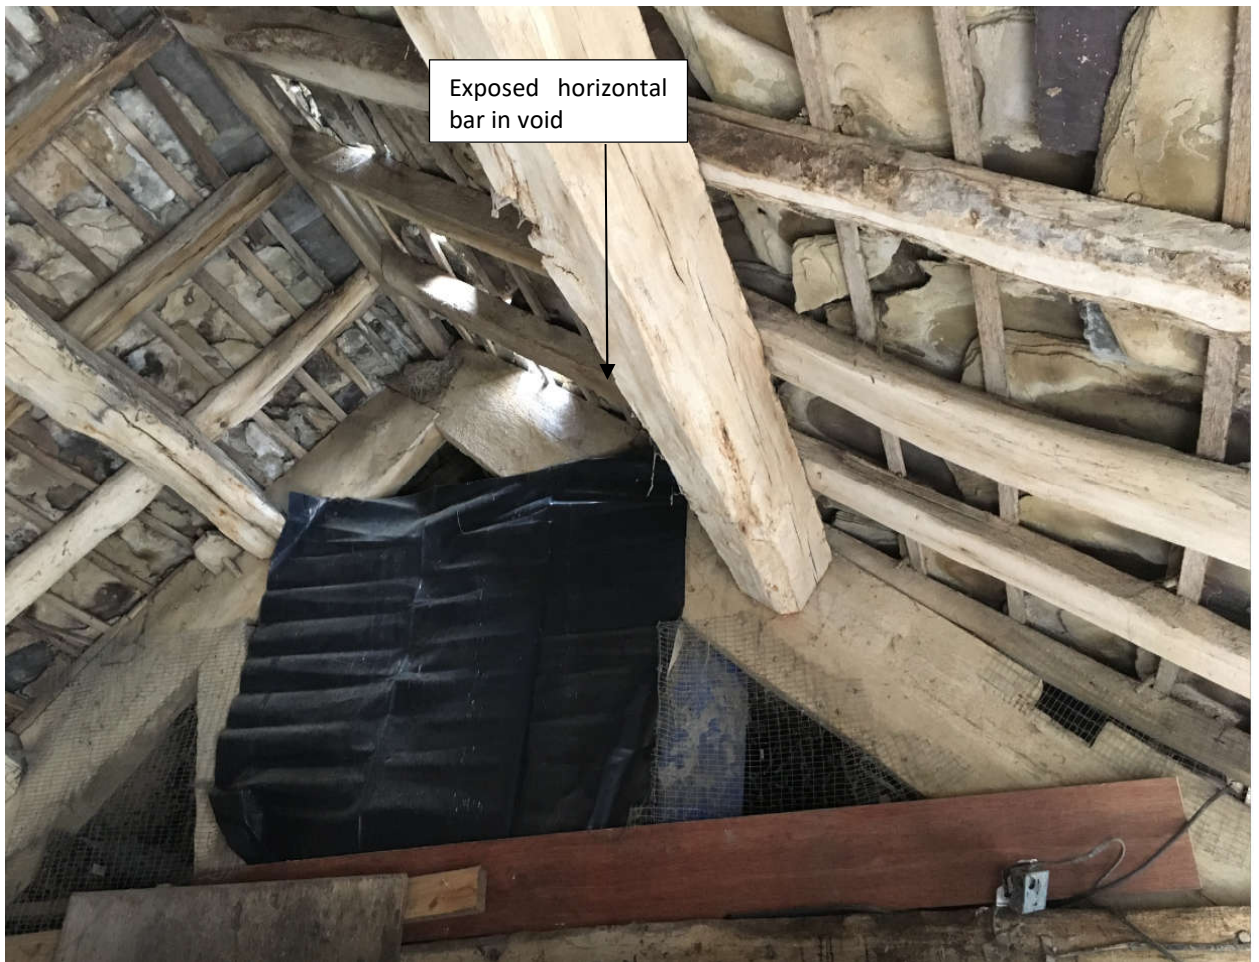
17. Roof Structure to Building 3 (Single storey part)

- 4.12 The condition of the slated roof appeared reasonable, with no open holes apparent, two slipped slates and a relatively level ridge line. Internally, the timber purlins, rafters and battens were noted to be in relatively

good condition, with no obvious indications of water ingress, rot, or insect damage, though a slight bow in the purlins was evident.

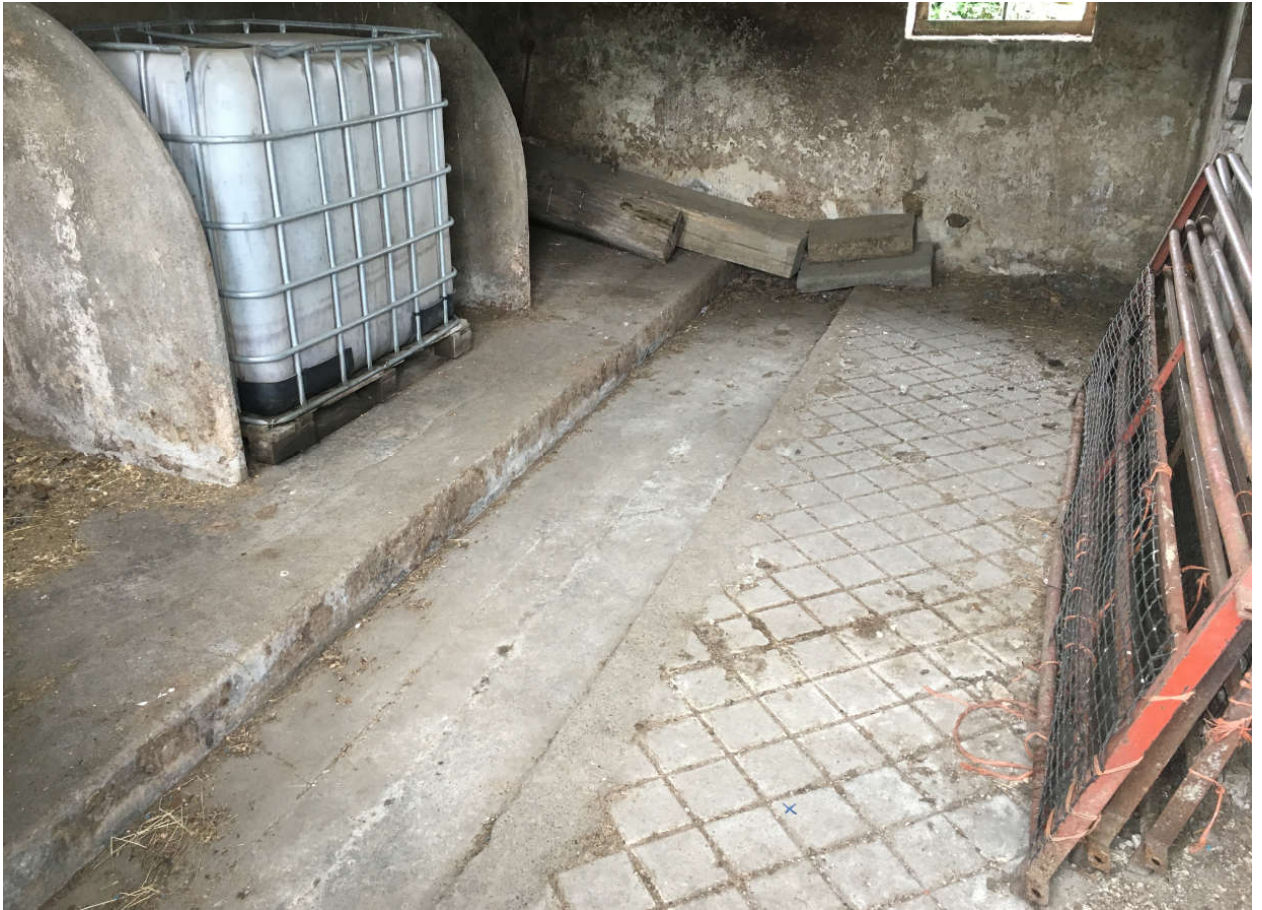
27. Floor to Building 3

- 4.13 The condition of the first floor appeared to be generally poor in areas, due to water ingress through an opening in the gable above the single storey roof. Localised areas of rot and decay were evident from above but the floor soffit could not be inspected due to lack of access.
- 4.14 The floor finish was only evident local to the door in the east elevation due to the rest of the floor being covered in straw. Where exposed, the tiles were in reasonable condition.

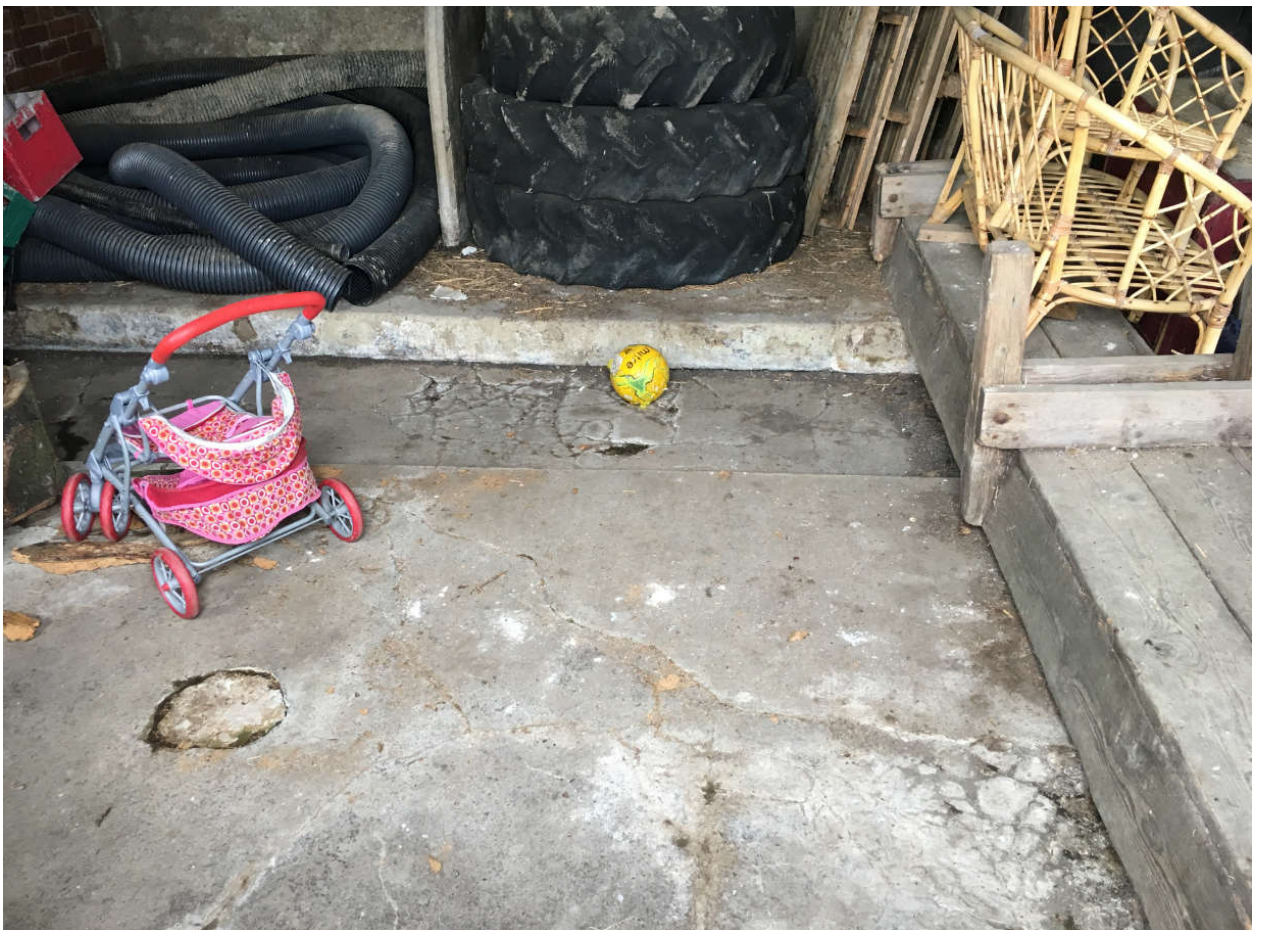
28. Floor to Building 4

- 4.18 The condition of the first floor appeared to be generally poor, with water ingress having caused rot and decay. Evidence of damage caused by wood boring insect larvae was noted in the majority of the first-floor timbers.

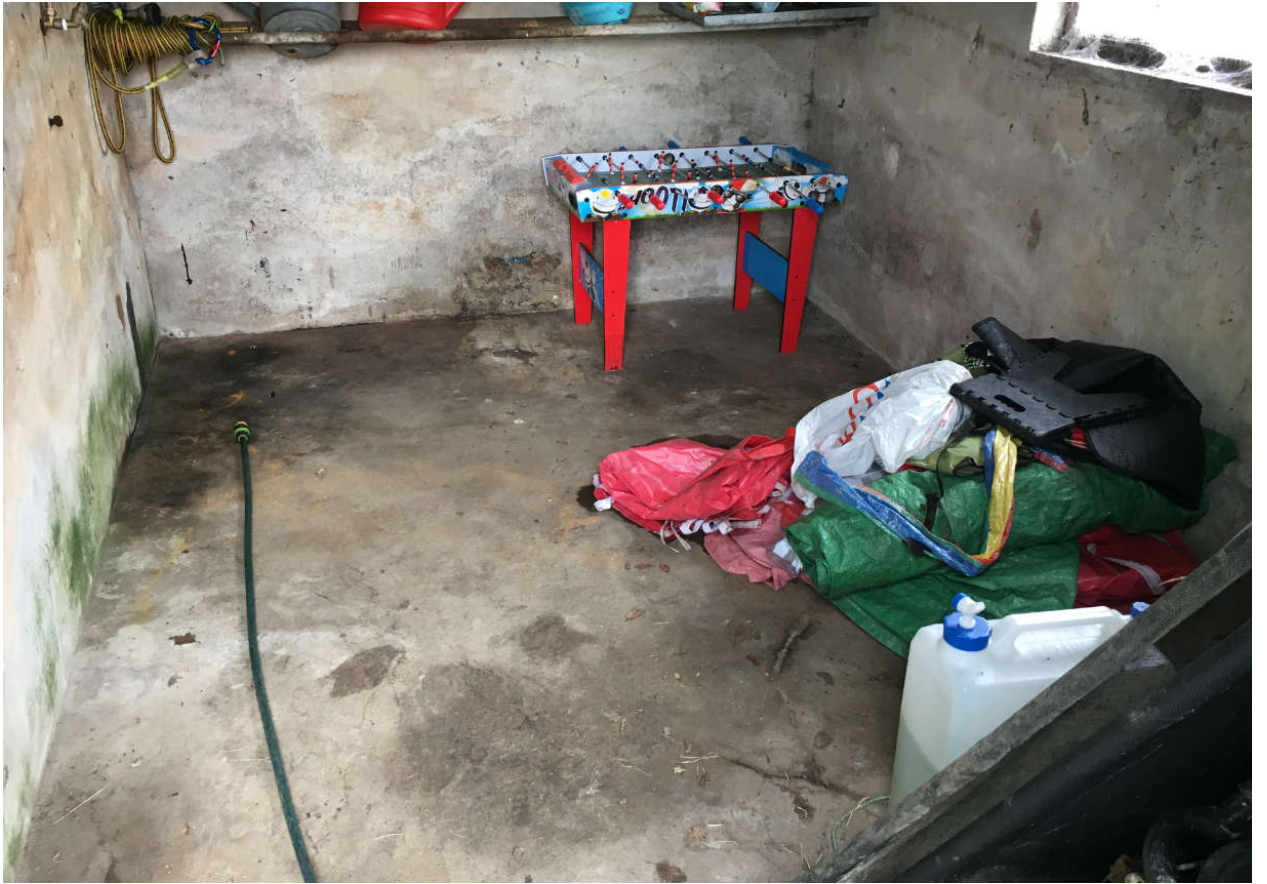
29. Floor to Building 5

- 4.20 This building comprised a brick-built lean-to on the north end of Building 4. The roof was a mono-pitch span of corrugated cement sheet (possibly asbestos containing) supported on two small timber purlins. The floor slab was cast concrete.
- 4.21 The walls to all three elevations appeared to be relatively plumb and indications of weathering, either to brickwork or mortar joints, were minimal. Lintels to door and window openings were cast stone items and appeared in good condition.
- 4.22 The roof structure appeared in reasonable condition, with no indications of structural distress or leakage noted.
- 4.23 The concrete ground floor slab appeared in reasonable condition.
