Drainage Report

Barnsley Hospital, Gawber Road

Barnsley Hospital - CCTV Survey Report : 28/01/19

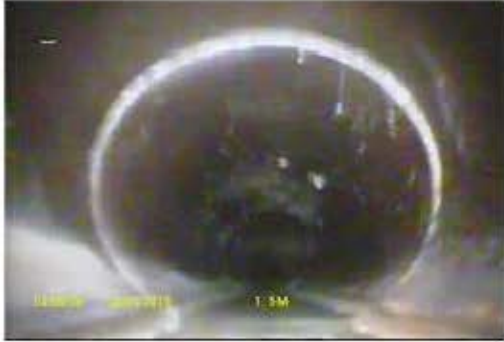
Pos	Video Ref	Code	Description	Image
00.00m		MH	Start node type, manhole MH01	
00.00m	0:00:00	WL	Water level: 0% Height/Diameter	
01.60m	0:00:27	JDM	Joint displaced medium - Severity 3	<p>Image Provided - Ref: 0_2</p>

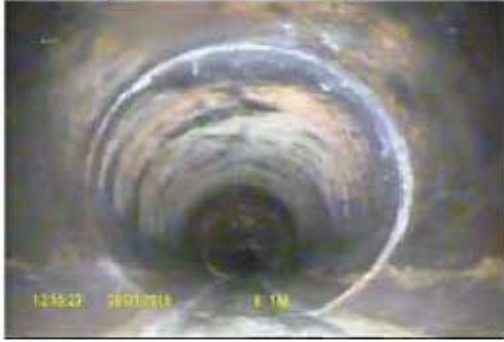
08.10m	0:00:42	JDM	Joint displaced medium - Severity 3	<p>Image Provided - Ref: 0_3</p>

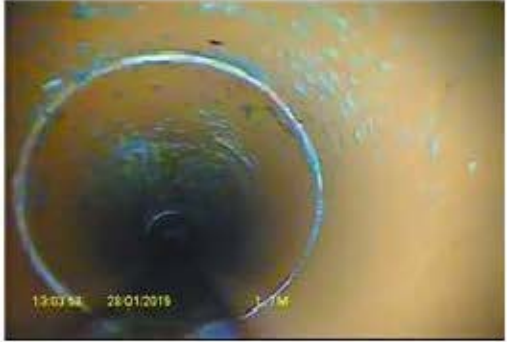
Pos	Video Ref	Code	Description	Image
00.00m		MH	Start node type, manhole MH01	
00.00m	0:00:00	WL	Water level: 0% Height/Diameter	
01.70m	0:00:18	JDM	Joint displaced medium - Severity 3	<p>Image Provided - Ref: 1_2</p>

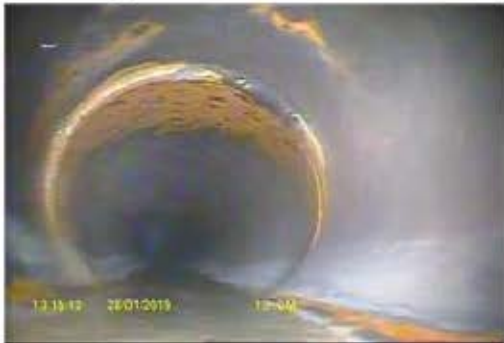
Pos	Video Ref	Code	Description	Image
00.00m		MH	Start node type, manhole MH01	
00.00m	0:00:00	WL	Water level: 0% Height/Diameter	
07.20m	0:00:33	S1 WL	Water level 7.2m - 11.3m: 20% Height/Diameter	
12.00m	0:00:43	JDM	Joint displaced medium - Severity 3	<p>Image Provided - Ref: 2_3</p>

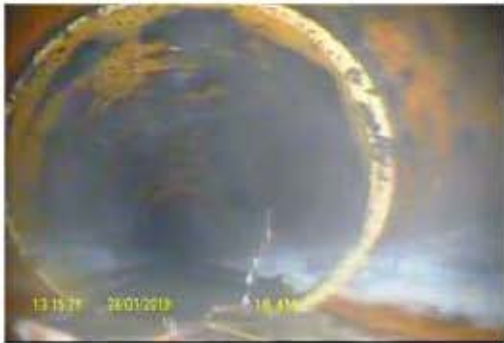
16.40m	0:00:58	JDM	Joint displaced medium - Severity 3	<p>Image Provided - Ref: 2_4</p>

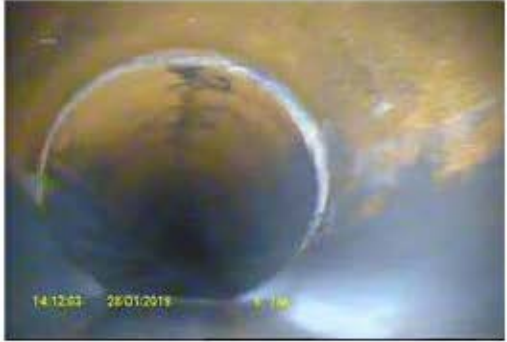
Pos	Video Ref	Code	Description	Image
00.00m		MH	Start node type, manhole MH02	
00.00m	0:00:00	WL	Water level: 0% Height/Diameter	
06.70m	0:00:33	JDM	Joint displaced medium - Severity 3	<p>Image Provided - Ref: 3_2</p>

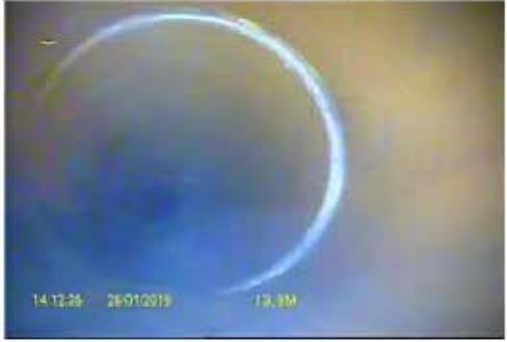
13.90m	0:01:04	JDM	Joint displaced medium - Severity 3	<p>Image Provided - Ref: 3_3</p>

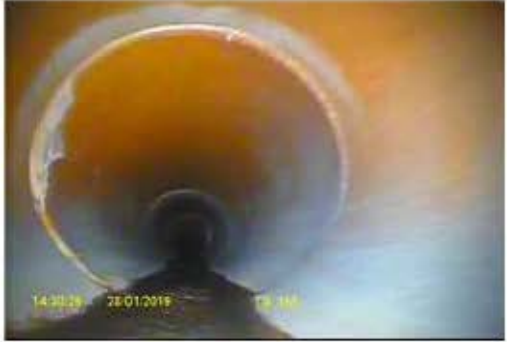
Pos	Video Ref	Code	Description	Image
00.00m		MH	Start node type, manhole MH02	
00.00m	0:00:00	WL	Water level: 0% Height/Diameter	
18.10m	0:00:41	JDM	Joint displaced medium - Severity 3	Image Provided - Ref: 4_2

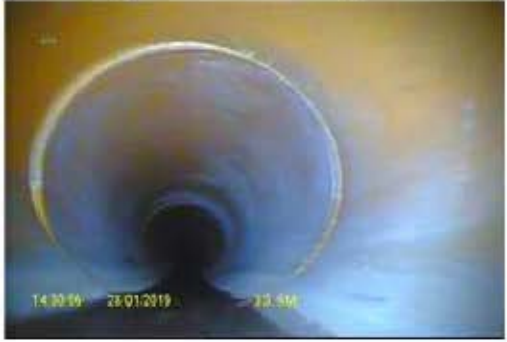
33.90m	0:01:11	JDM	Joint displaced medium - Severity 3	Image Provided - Ref: 4_3

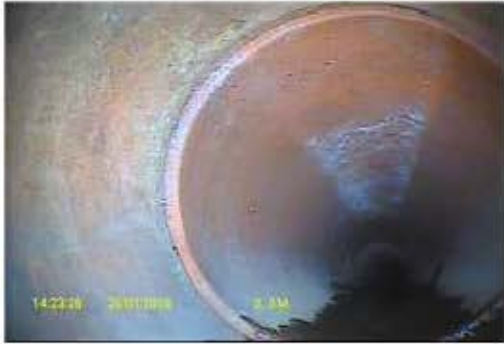
Pos	Video Ref	Code	Description	Image
00.00m		MH	Start node type, manhole MH02	
00.00m	0:00:00	WL	Water level: 0% Height/Diameter	
00.10m	0:00:15	JDM	Joint displaced medium - Severity 3	Image Provided - Ref: 5_2

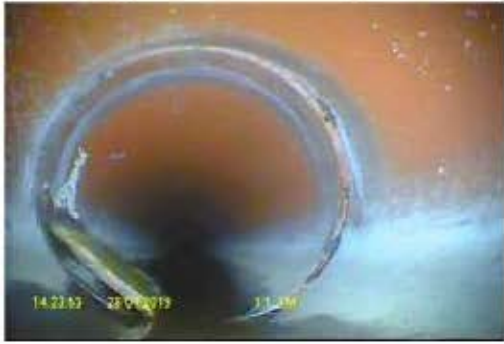
11.30m	0:00:42	JDM	Joint displaced medium - Severity 3	Image Provided - Ref: 5_3

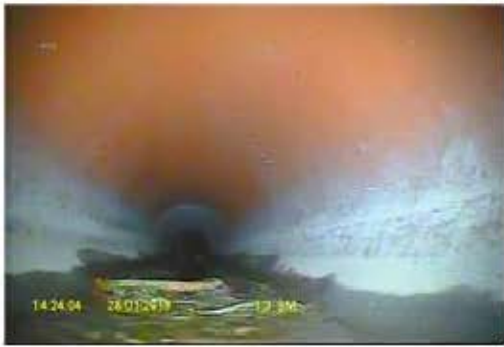
Pos	Video Ref	Code	Description	Image
11.30m	0:00:53	DER	Settled deposits coarse: 20% Cross sectional area loss - Severity 3	Image Provided - Ref: 5_5

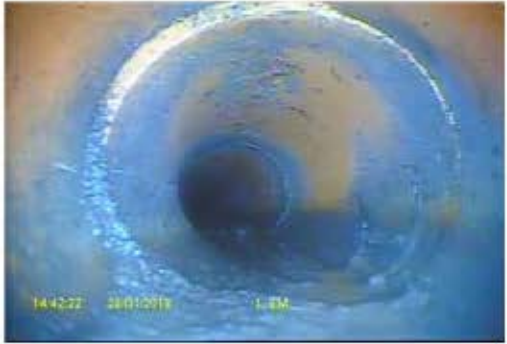
Pos	Video Ref	Code	Description	Image
00.00m		MH	Start node type, manhole MH02	
00.00m	0:00:00	WL	Water level: 0% Height/Diameter	
02.00m	0:00:14	LLQ	Line of drain/sewer deviates left [quarter]	<p>Image Provided - Ref: 6_2</p>

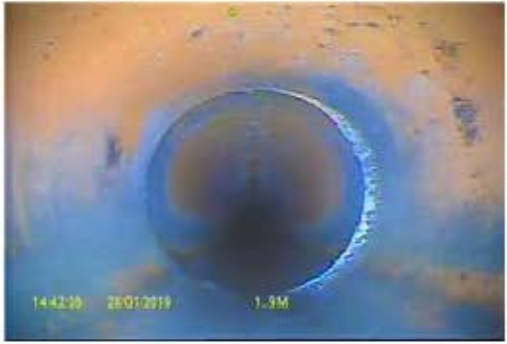
02.20m	0:00:27	JDM	Joint displaced medium - Severity 3	<p>Image Provided - Ref: 6_3</p>

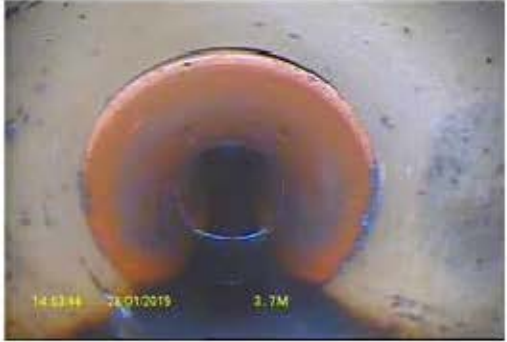
Pos	Video Ref	Code	Description	Image
00.00m		MH	Start node type, manhole MH02	
00.00m	0:00:00	WL	Water level: 0% Height/Diameter	
03.70m	0:00:27	JDM	Joint displaced medium - Severity 3	<p>Image Provided - Ref: 7_2</p>

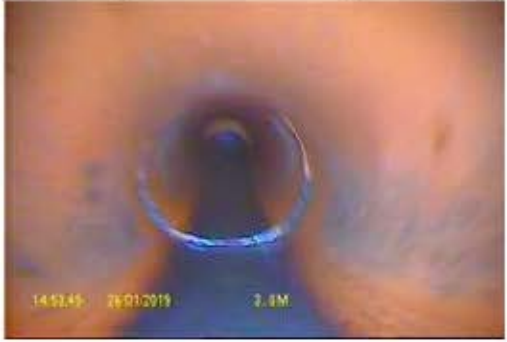
03.90m	0:00:28	LUQ	Line of drain/sewer deviates up [quarter]	<p>Image Provided - Ref: 7_3</p>

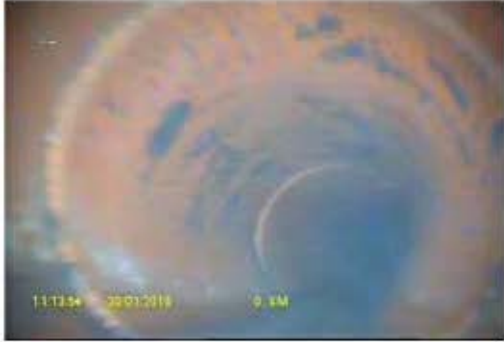
Pos	Video Ref	Code	Description	Image
00.00m		MH	Start node type, manhole MH03	
00.00m	0:00:00	WL	Water level: 0% Height/Diameter	
00.80m	0:00:11	LRQ	Line of drain/sewer deviates right [quarter]	Image Provided - Ref: 8_2

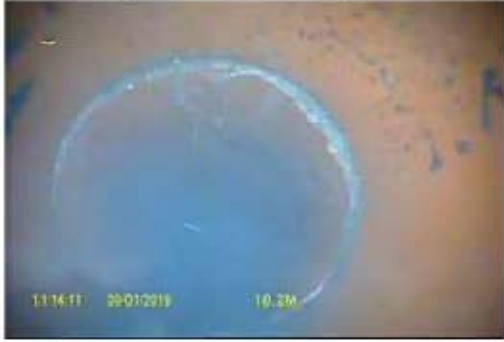
10.20m	0:00:28	JDM	Joint displaced medium - Severity 3	Image Provided - Ref: 8_3

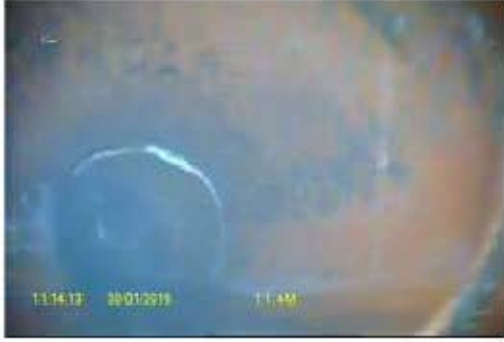
11.40m	0:00:30	LLH	Line of drain/sewer deviates left [half]	Image Provided - Ref: 8_4

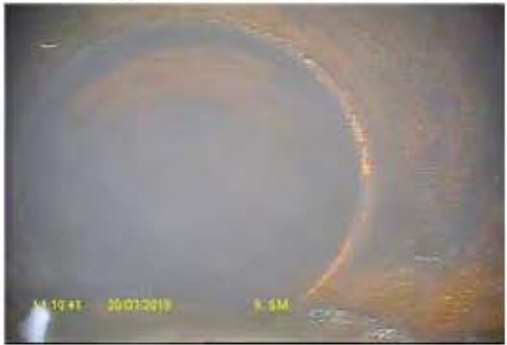
Pos	Video Ref	Code	Description	Image
00.00m		MH	Start node type, manhole MH03	
00.00m	0:00:00	WL	Water level: 0% Height/Diameter	
00.00m	0:02:18	S1 WL	Water level 0m - 22.7m: 40% Height/Diameter	
09.50m	0:00:50	JDM	Joint displaced medium - Severity 3	<p>Image Provided - Ref: 9_2</p>

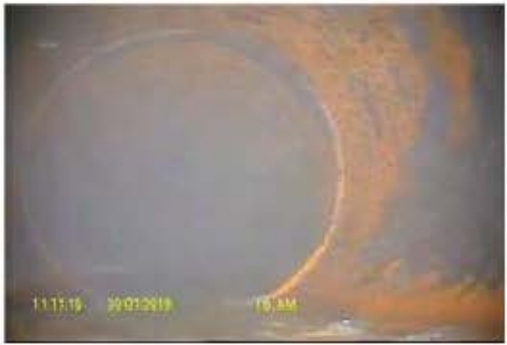
15.80m	0:01:24	JDM	Joint displaced medium - Severity 3	<p>Image Provided - Ref: 9_3</p>

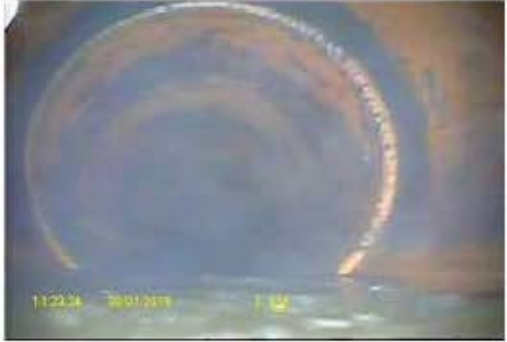
Pos	Video Ref	Code	Description	Image
00.00m		MH	Start node type, manhole MH03	
00.00m	0:00:00	WL	Water level: 0% Height/Diameter	
03.90m	0:00:19	JDM	Joint displaced medium - Severity 3	Image Provided - Ref: 10_2

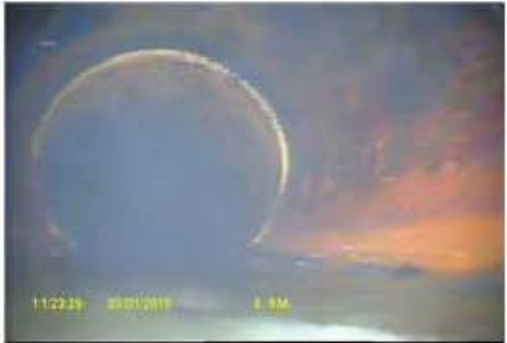
07.00m	0:00:25	CU	Loss of vision	
09.00m	0:00:34	JDM	Joint displaced medium - Severity 3	Image Provided - Ref: 10_4

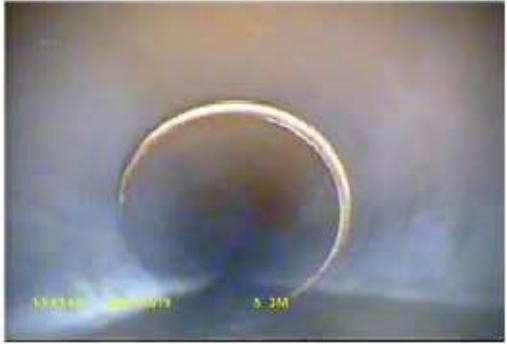
Pos	Video Ref	Code	Description	Image
05.30m	0:00:29	JDM	Joint displaced medium - Severity 3	Image Provided - Ref: 12_5

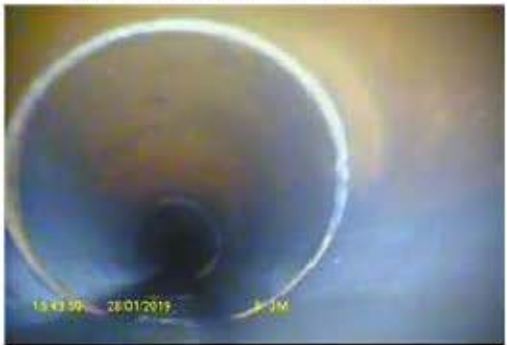
08.30m	0:00:36	JDM	Joint displaced medium - Severity 3	Image Provided - Ref: 12_6

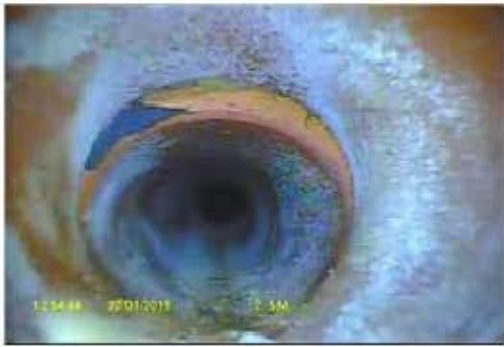
Pos	Video Ref	Code	Description	Image
02.50m	0:00:15	JDL	Joint displaced large - Severity 4	Image Provided - Ref: 18_5

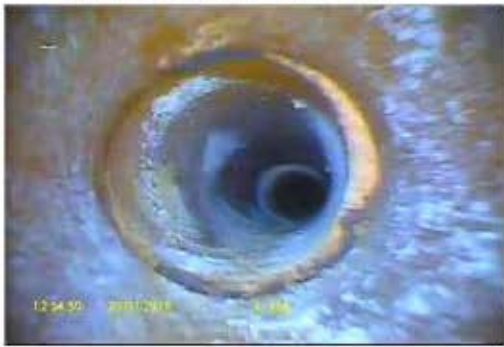
04.80m	0:00:22	JDM	Joint displaced medium - Severity 3	Image Provided - Ref: 18_6

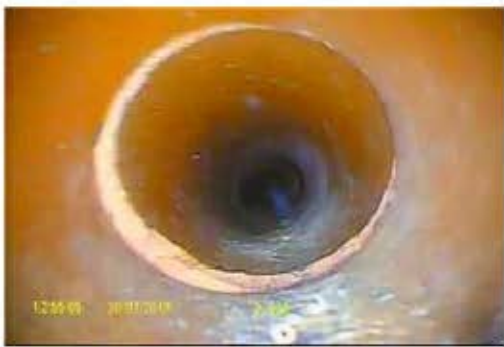
09.00m	0:00:37	JDM	Joint displaced medium - Severity 3	Image Provided - Ref: 18_7

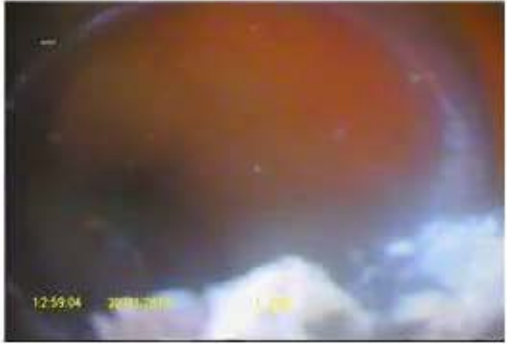
Pos	Video Ref	Code	Description	Image
01.20m	0:00:27	LLH	Line of drain/sewer deviates left [half]	Image Provided - Ref: 19_5

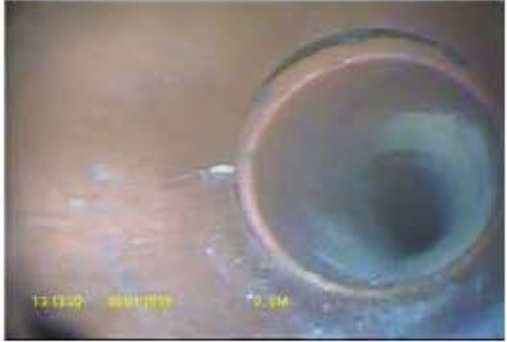
Pos	Video Ref	Code	Description	Image
00.00m		MH	Start node type, manhole MH07	
00.00m	0:00:00	WL	Water level: 0% Height/Diameter	
00.10m	0:00:07	JDL	Joint displaced large - Severity 4	Image Provided - Ref: 20_2

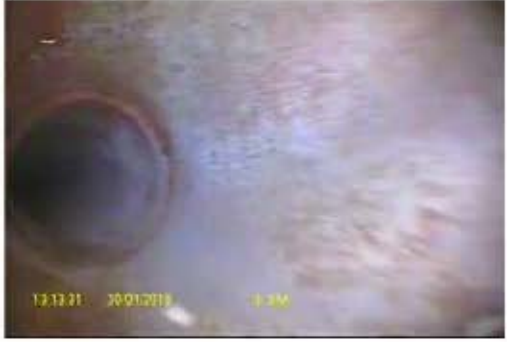
05.90m	0:00:18	LLQ	Line of drain/sewer deviates left [quarter]	Image Provided - Ref: 20_3

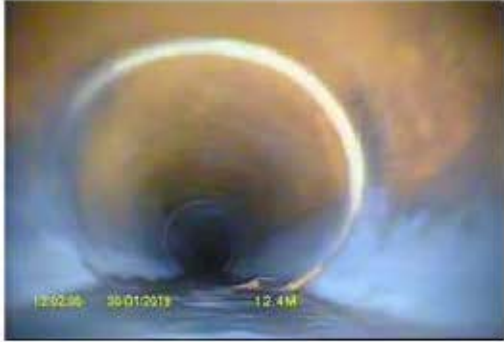
Pos	Video Ref	Code	Description	Image
00.00m		MH	Start node type, manhole MH08	
00.00m	0:00:00	S1 WL	Water level 0m - 44.8m: 10% Height/Diameter	
12.40m	0:00:29	JDM	Joint displaced medium - Severity 3	Image Provided - Ref: 22_2

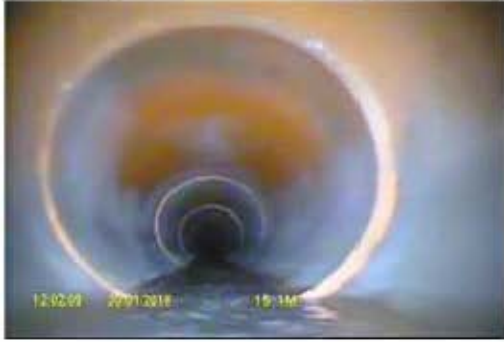
15.10m	0:00:33	JDM	Joint displaced medium - Severity 3	Image Provided - Ref: 22_3

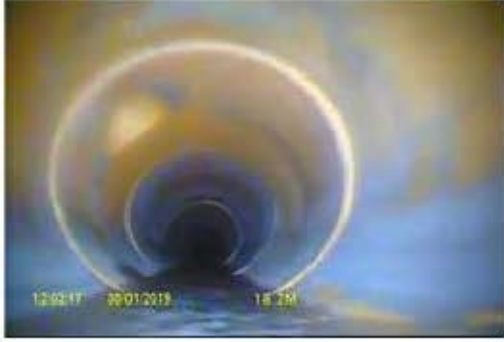
18.20m	0:00:41	JN	Junction at 10 o'clock: 100mm Diameter	Image Provided - Ref: 22_4

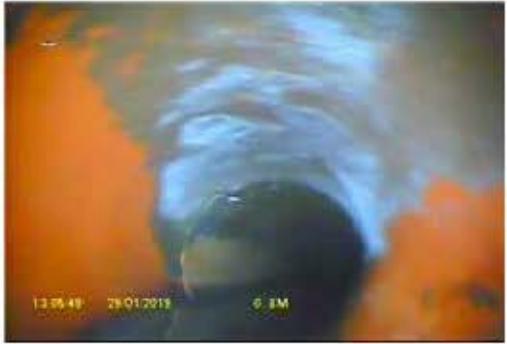
Pos	Video Ref	Code	Description	Image
00.00m		MH	Start node type, manhole MH09	
00.00m	0:00:00	WL	Water level: 0% Height/Diameter	
00.80m	0:00:11	LRQ	Line of drain/sewer deviates right [quarter]	Image Provided - Ref: 27_2

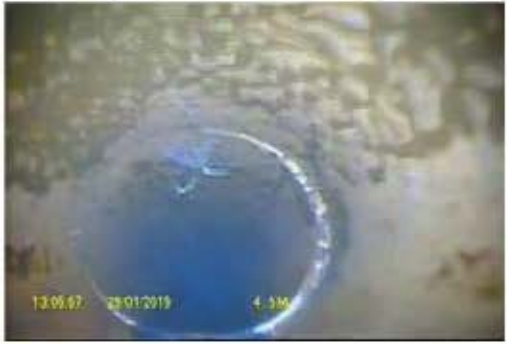
04.50m	0:00:19	JDM	Joint displaced medium - Severity 3	Image Provided - Ref: 27_3

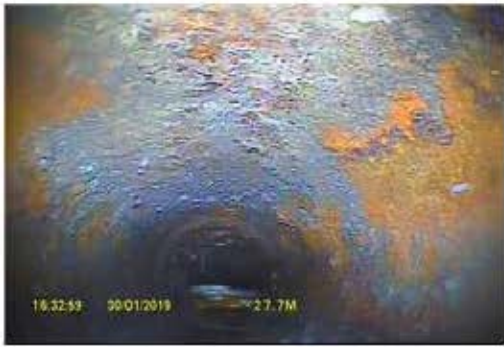
Pos	Video Ref	Code	Description	Image
27.70m	0:01:24	DER	Settled deposits coarse: 60% Cross sectional area loss - Severity 3	Image Provided - Ref: 34_5
