# Engineer's Report

| Our Reference | <b>IFS-RBS-SUB-11-0031530</b> |

| Address | <b>The Gables, Carlton Road, Carlton, Barnsley,<br/>S71 3JD</b> |

The Gables, Carlton Road, Carlton, Barnsley

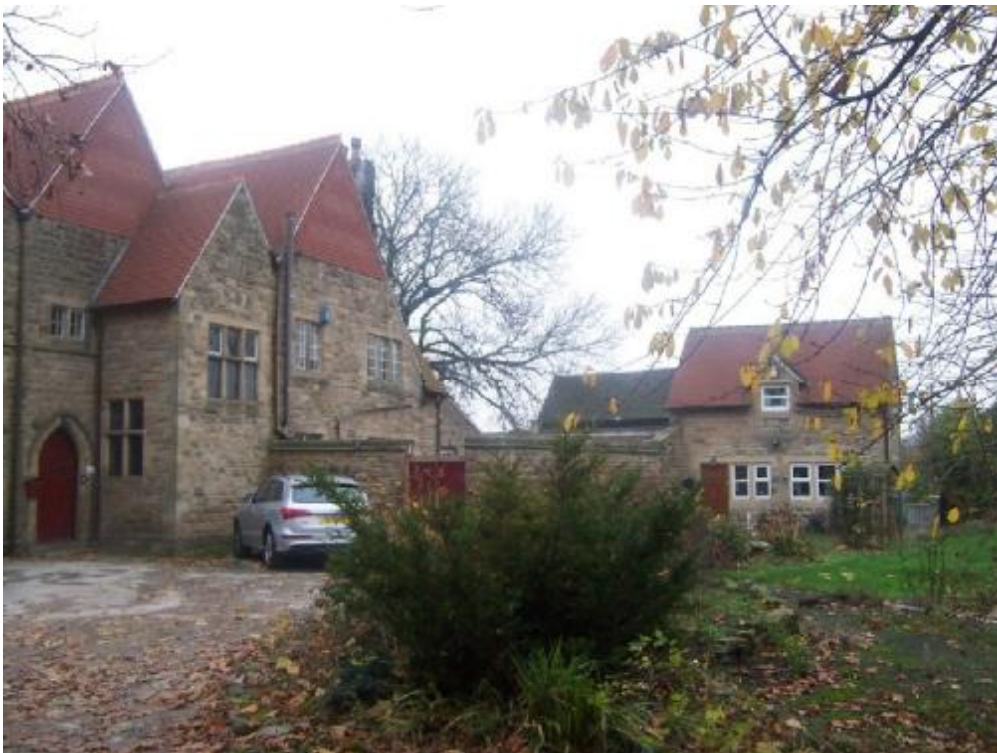
FIGURE 2 Front Elevation

The property has 9 bedrooms. The insured property is a grade II listed building. There is a detached cottage at the right hand side of the main building, forming part of the insured premises. No recent structural alterations appear to have been undertaken to the cottage.
